Downlights in Papakowhai homes

Nine homes in Papakowhai, Porirua, were renovated as part of Beacon's Papakowhai Renovation project. The extent of improvements varied from limited insulation, to full insulation and double glazing. These homes were ordinary 1970s houses and reflect typical styles and approaches to previous renovation. As these houses were monitored before and after renovation, it was possible to calculate the impact of downlights on the homes' insulation performance.

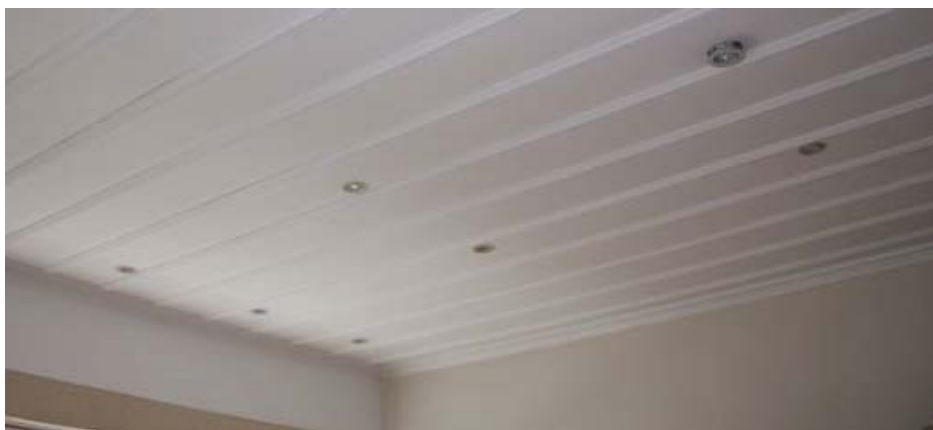
Another home had 47 downlights throughout the house, equating to 1 downlight per 1.2m^2 and 6.1m^2 of uninsulated ceiling. Although the ceiling insulation was designed to reach R4.0, the number of downlights meant that it effectively reached only R2.2.

The best options: To get the most benefit from your ceiling insulation, replace your downlights with non-downlight fittings and fill in the hole in the insulation. You may be able to source a surface-mounted or pendant fitting which will cover and seal the downlight hole, or if you are undertaking major renovations, re-do your ceiling plasterboard.

Alternatively replace your downlights with new IC rated lights which can have insulation abutting and covering the lights.

Until you can renovate: Replace your old downlights with ‘CA-rated’ downlights. These downlights allow insulation to be butted directly up to them (‘closed abutted’ or ‘CA-rated’). They have an enclosed canister to stop the insulation being exposed to the heat from the bulb. However, you still cannot fit insulation (such as a blanket) over the top of the downlights. As well as changing your downlights, you should consider upgrading your ceiling insulation to compensate for the lost warmth. There is a range of CA-rated downlights available on the market. If you are not sure of the type you
