**BBS/10**

# **Spreydon 1: Build Back Smarter Case Study**

**A report prepared by Beacon Pathway Incorporated  
November 2013**

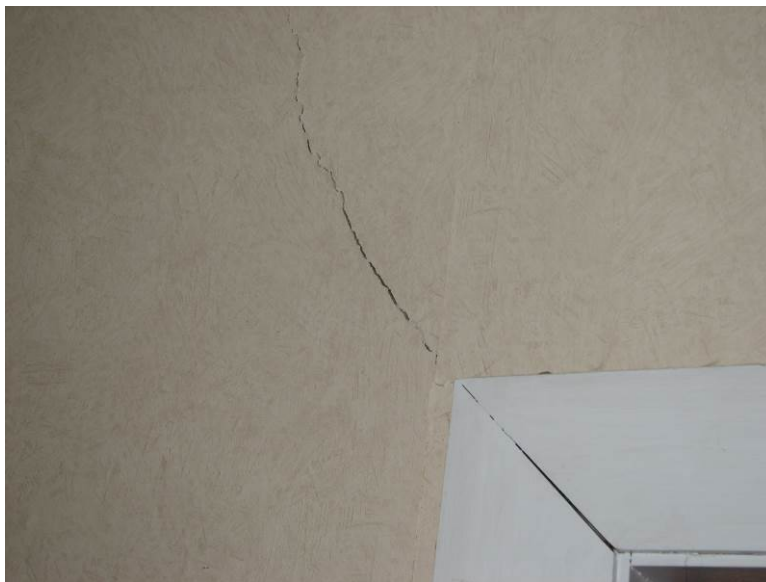
The house suffered from significant damage to foundations from the earthquakes. Ground movement caused uneven settlement of ring foundation and piles, damage to sewer and stormwater drains. Most interior lath and plaster ceiling and wall linings were badly cracked. Because of the foundation failure, repair also required the removal of the internal brick chimney.

**Figure 2: Earthquake damage to Spreydon 1 wall linings**

- The house was jacked up and the concrete ring foundation replaced, including piling down to 6 metres
- Lath and plaster ceiling linings were replaced throughout
- Lath and plaster wall linings replaced throughout
- Doors and windows were eased and adjusted throughout
- Sewer and stormwater drainage was checked and minor repairs were made
- Full interior and exterior redecoration.

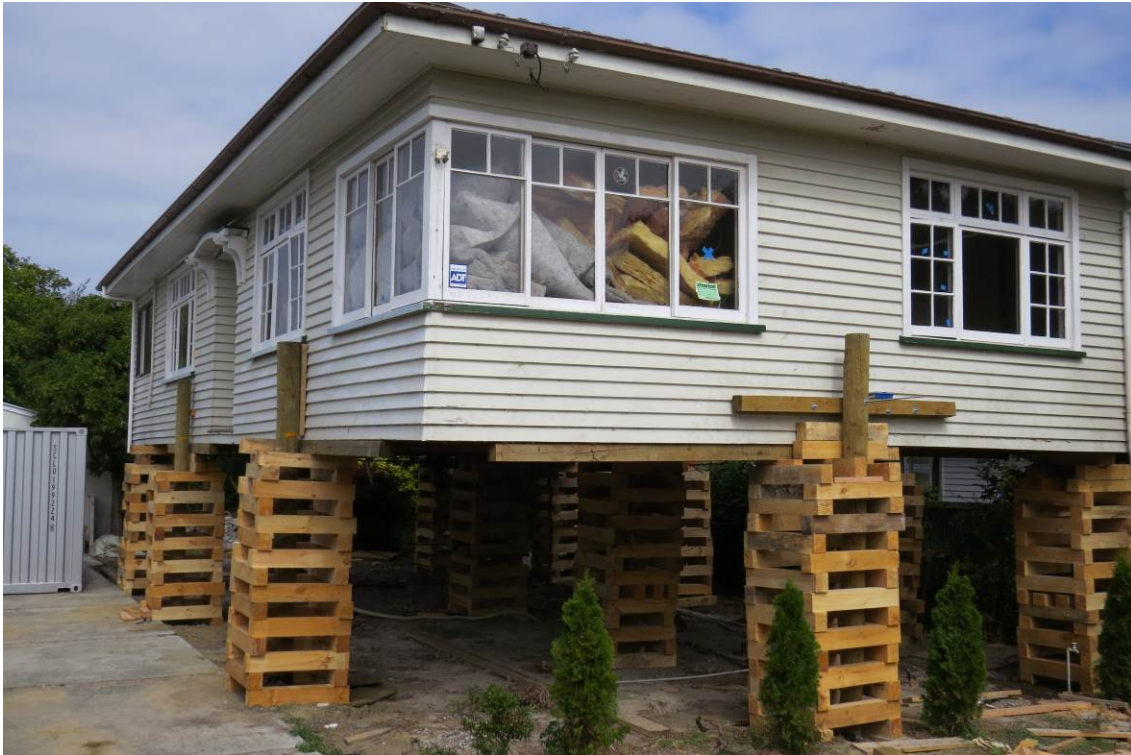
**Figure 3: The house was lifted up for foundation repair – enabling access to install underfloor insulation and a ground vapour barrier in Spreydon 1**

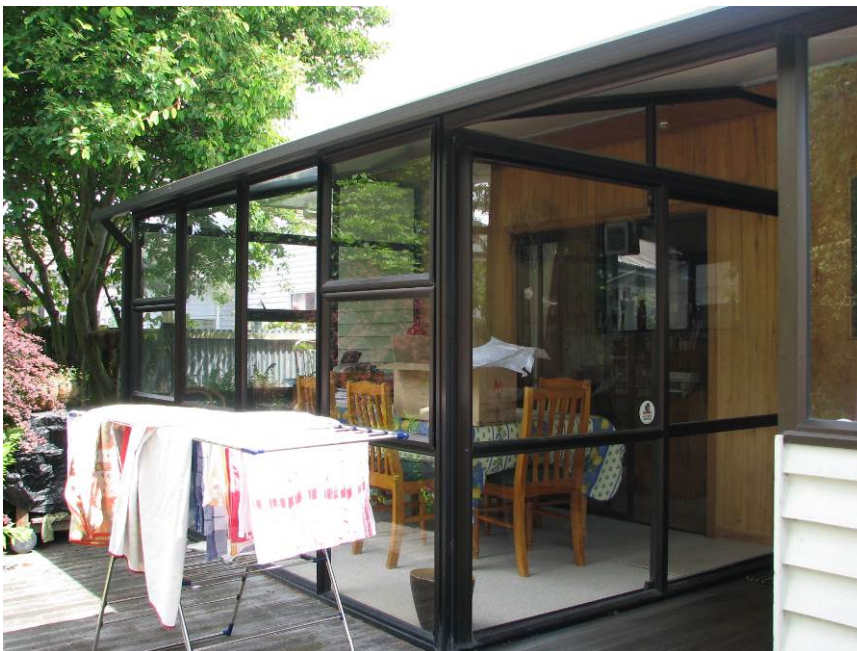
**Figure 4: South facing conservatory / dining area. The homeowner removed this and extended the house into the area, including double glazed windows.**

As a result of the earthquakes, the homeowners decided that the time of repair was a good time to address a number of other issues in the house, and take some steps to modernise it. The conservatory was recognised as a major problem – facing south it made the house very cold. The homeowner noted that in undertaking renovations she did a lot of research, and read widely about the options. In this respect she found the Upgrade Plan and Homeowner Manual particularly helpful. Unfortunately, the homeowners were already out of the house, and the design of the extension was largely complete by the time the Home Assessment was undertaken. As result, this was not able to influence the design of the extension in any way.

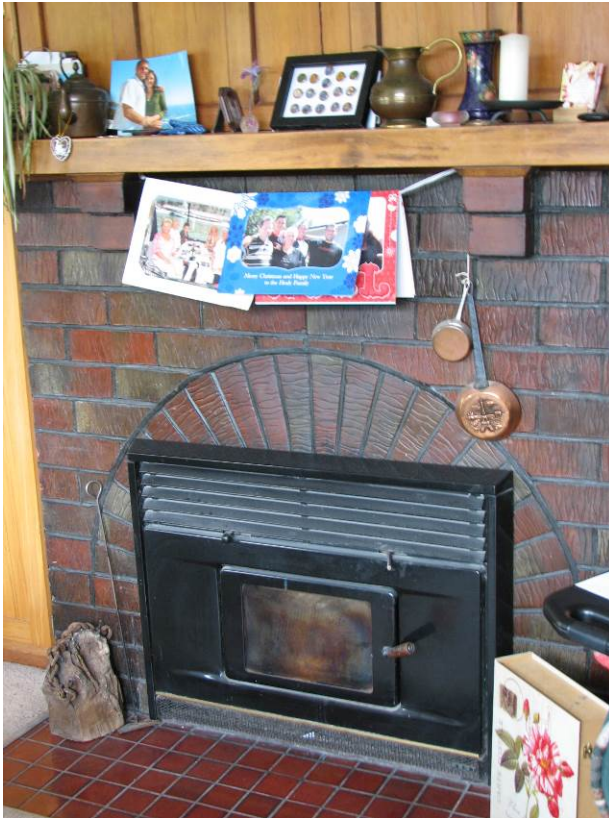
**Figure 5: An old inset wood burner with a wetback was replaced with a modern freestanding woodburner, wetback and new hot water cylinder.**

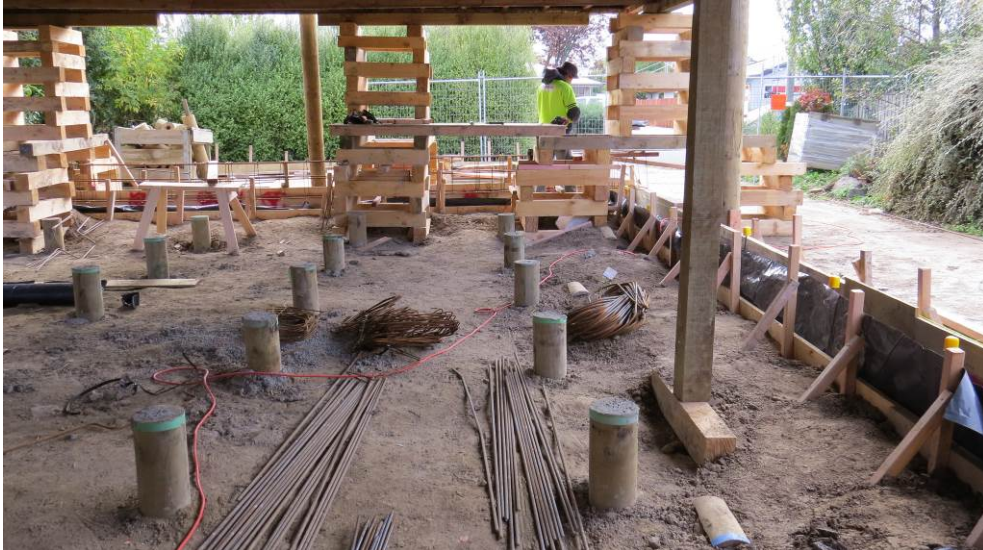
**Figure 6:** A new system of installing pile foundations was trialled by the repairer of Spreydon 1.

The repiling of Spreydon 1 used a new technique developed specifically for repairing earthquake-damaged foundations. The Spreydon 1 house was the first IAG/Hawkins house to utilise this methodology so a fixed price wasn't available to the PMO/Insurer. The length of time and complexity involved was far greater than anybody anticipated, and this would have caused a significant escalation in costs to the insurer. In hindsight, it is quite likely that, if they had known the costs, this house would have been tipped into the "rebuild" rather than "repair" category.

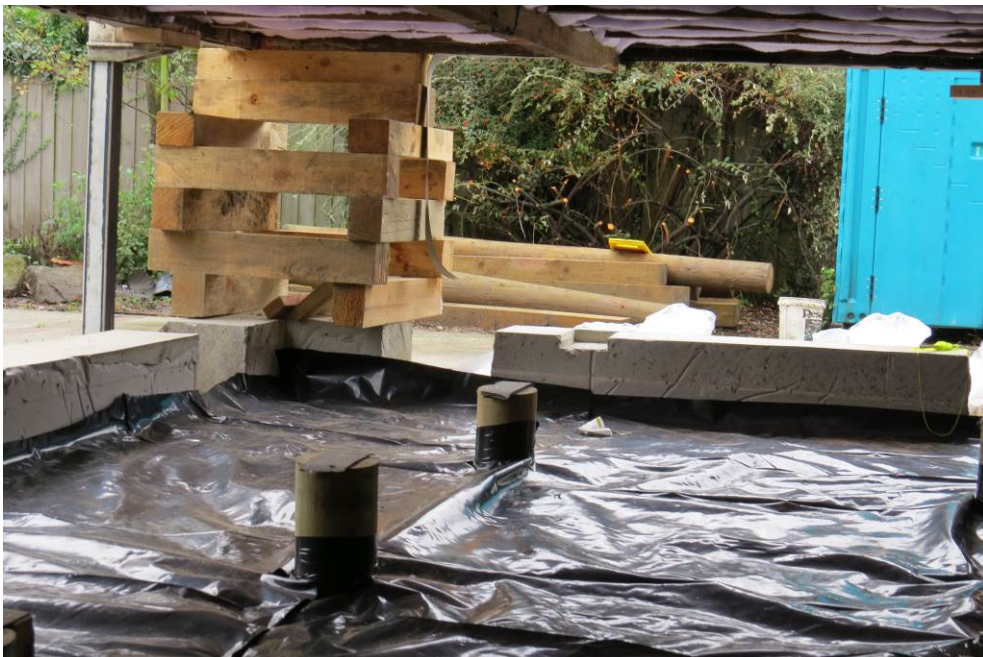
**Figure 7:** Lifting the house up to replace the foundations enabled easy access for both underfloor insulation and ground vapour barrier installation for this previously cold and damp house underfloor

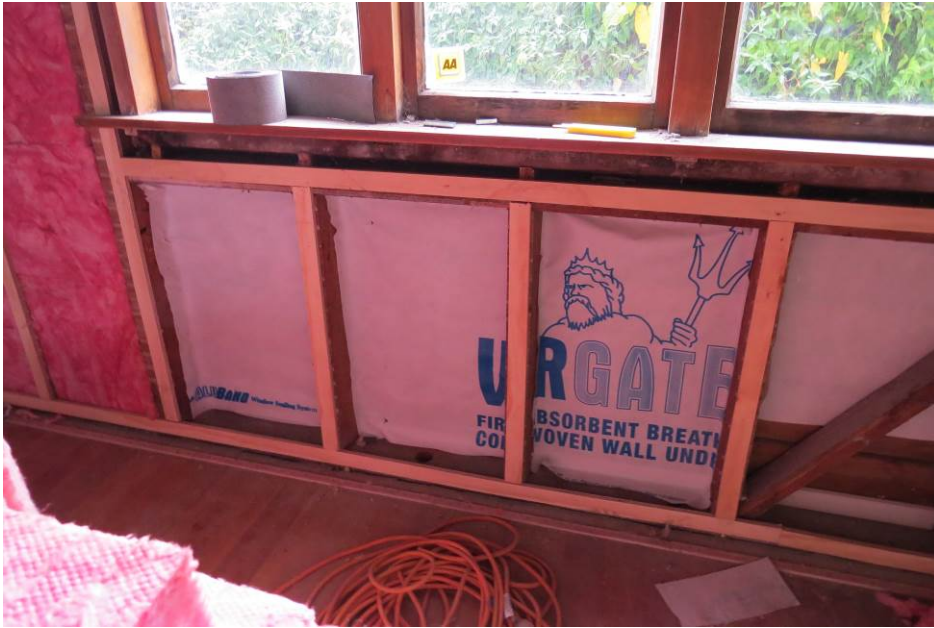
**Figure 8: Building wrap inserts were stapled into the framing as part of the wall insulation installation process**

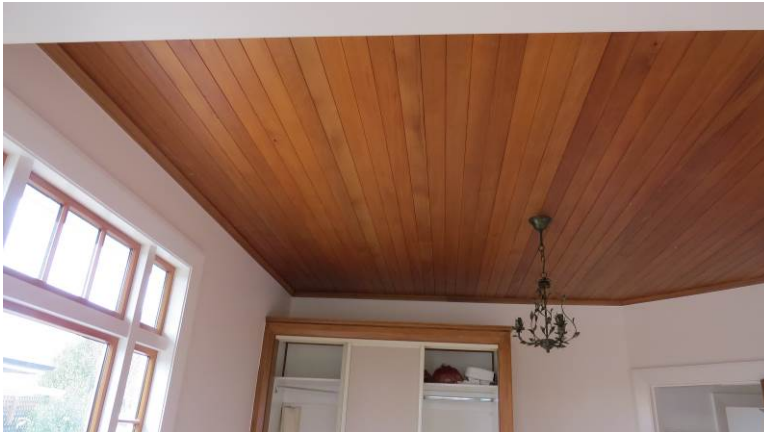
- The outlet from the heat transfer system was not installed in the master bedroom – the homeowner decided to reuse the tongue and groove ceiling from the kitchen extension in the bedroom, and didn't want it disfigured. The outlet was instead installed in the hallway outside the bedroom. While the homeowner was happy with this arrangement, research indicates that heat transfer outlets should be located in the room where the heat is required. Location in hallways is ineffective for heating adjacent spaces.

**Figure 9: Unknown to Beacon, a new ceiling was installed in Bedroom 1 as part of the homeowner funded improvements – as a result the homeowner got the builder to install the heat transfer outlet in the hall rather than the bedroom.**

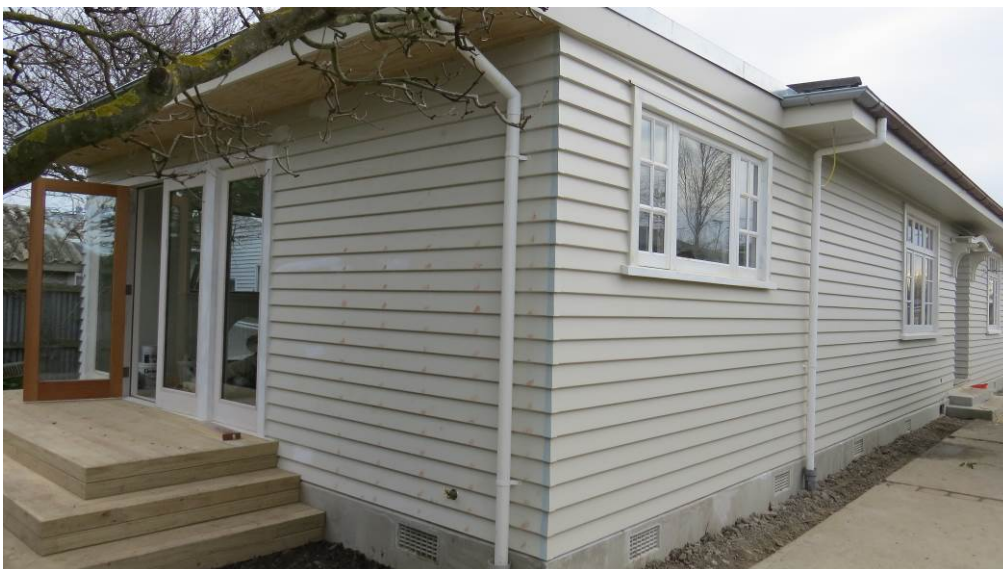
**Figure 10: Homeowner-funded house extension replacing the south-facing conservatory**

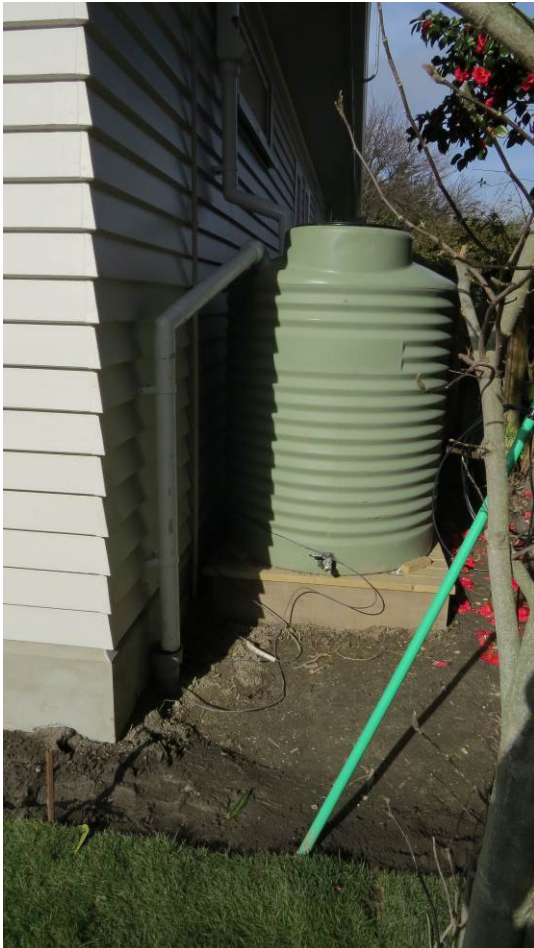
The house also received a dual flush toilet cistern, and was the first in which a rainwater tank had been installed. The tank is a 1000 litre tank with a leaf guard and plumbed overflow and was installed by CEA, with the primary purpose of garden watering and a secondary purpose as

an emergency water supply. As with the hot water cylinder, the materials/product prices being charged to installers in Christchurch appears to be substantially higher than other parts of the country with the final price of this modest system being double what might be expected in other parts of the country.

*Figure 11: A 1000 litre rainwater tank was installed as part of the water retrofit measures*
