BBS/11

Somerfield 1: Build Back Smarter Case Study

**A report prepared by Beacon Pathway Incorporated
October 2013**

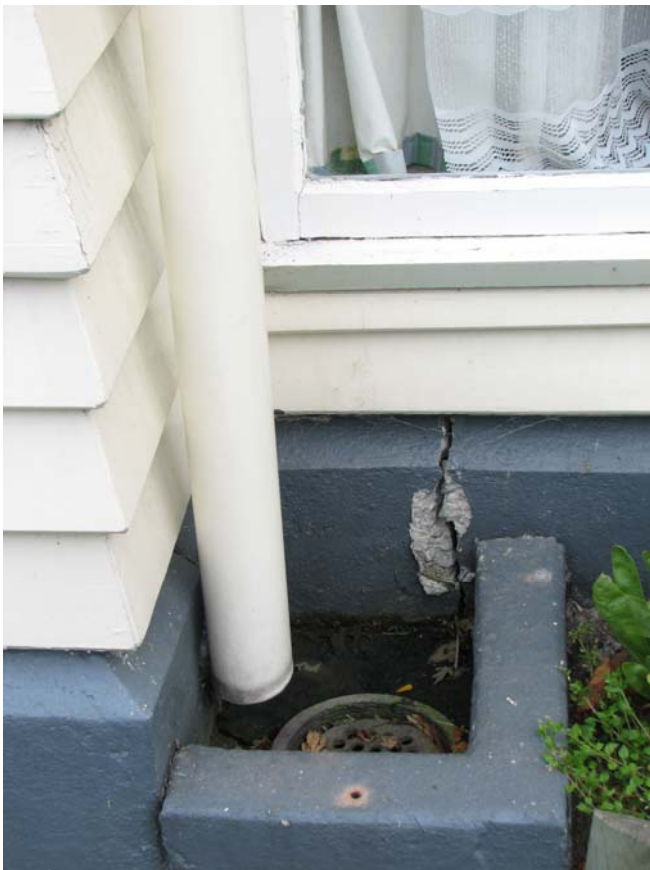
The house suffered from significant damage to foundations from the earthquakes. Ground movement caused uneven settlement of ring foundation and piles, damage to sewer and stormwater drains, the concrete terrace, external paths and the driveway. All interior lath and plaster ceiling and wall linings were badly cracked. Because of the foundation failure, repair also required the removal of the internal brick chimney.

Figure 2: Earthquake damage to Somerfield 1 ring foundation

- The house was jacked up and the concrete ring foundation replaced with timber piles and baseboards
- Lath and plaster ceiling linings were replaced throughout
- Lath and plaster wall linings replaced throughout
- Doors and windows were eased and adjusted throughout
- The concrete deck was replaced with a wooden deck
- Driveway, paths and patio paving were replaced
- Sewer and stormwater drainage was checked and minor repairs were made
- The house was re-wired at the insurer's cost.

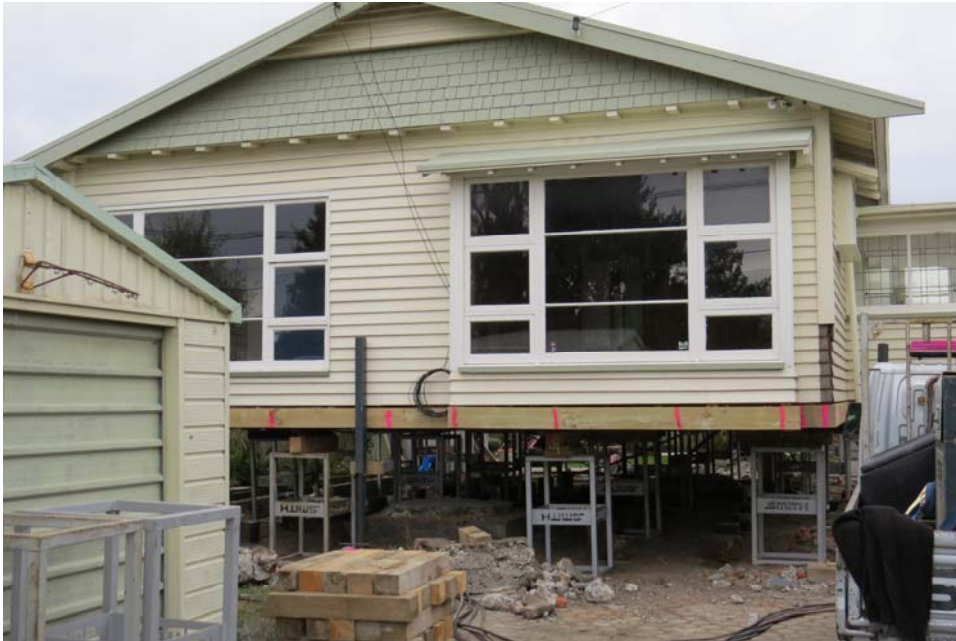
Figure 3: The house was lifted up for foundation repair – enabling access to install underfloor insulation and a ground vapour barrier in Somerfield 1

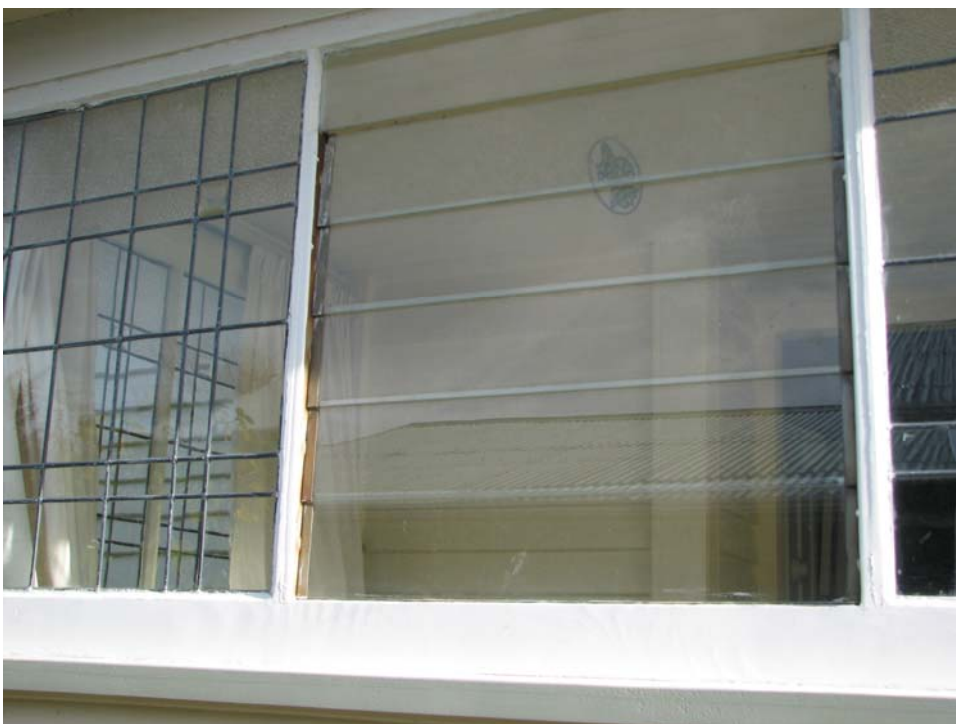
Figure 4: Louvre window in sun porch. This was causing significant draughts but the homeowner didn't want it replaced.

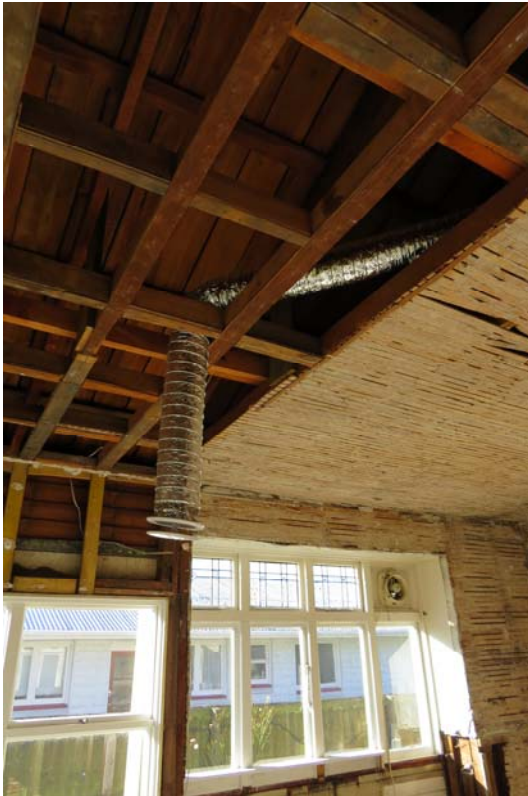
Figure 5: A positive pressure ventilation system had been installed by the homeowners to try and reduce the dampness in the house; however, mould and condensation were still prevalent

Prior to the earthquakes, the homeowners had taken what they thought were the best steps to reduce the dampness of the house and installed the positive pressure ventilation system, even though there was only a low level of insulation in their ceiling. The homeowner reported this had a slight improvement on the overall level of dampness in the house but that there was still mould growing in some rooms.

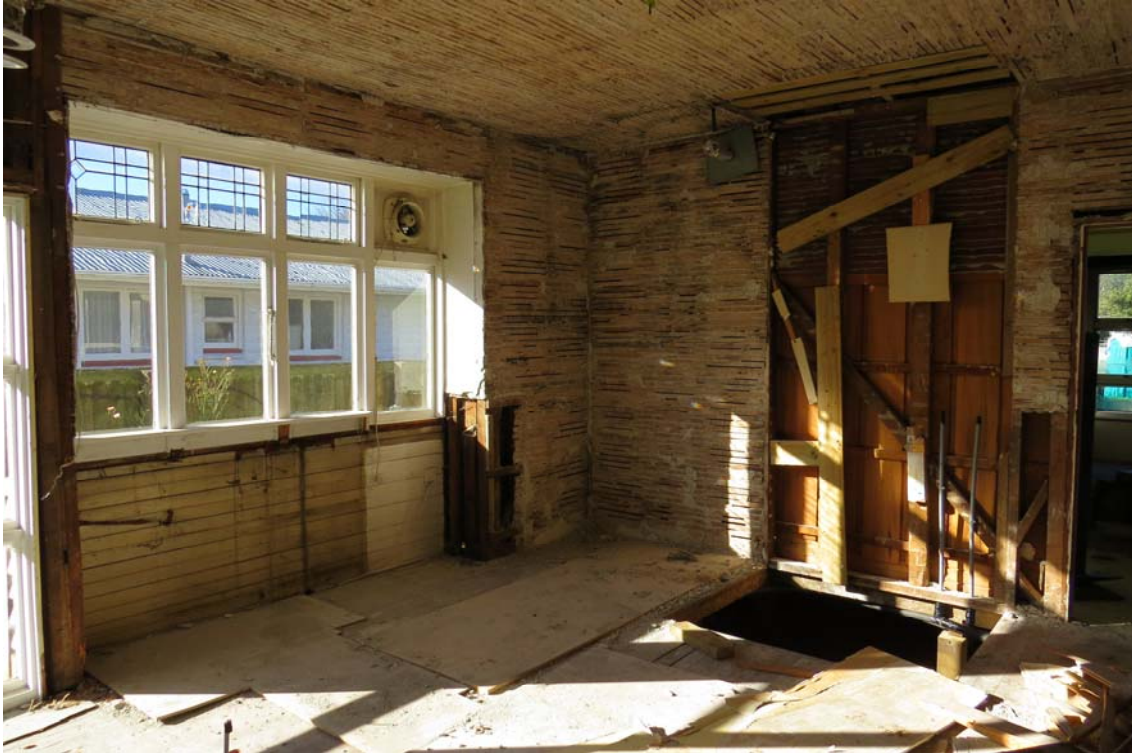
Figure 6: Lath and plaster linings were replaced with plasterboard as part of the repair, enabling wall and ceiling insulation installation
