**BBS/12**

# **Mt Pleasant 1: Build Back Smarter Case Study**

**A report prepared by Beacon Pathway Incorporated  
February 2014**

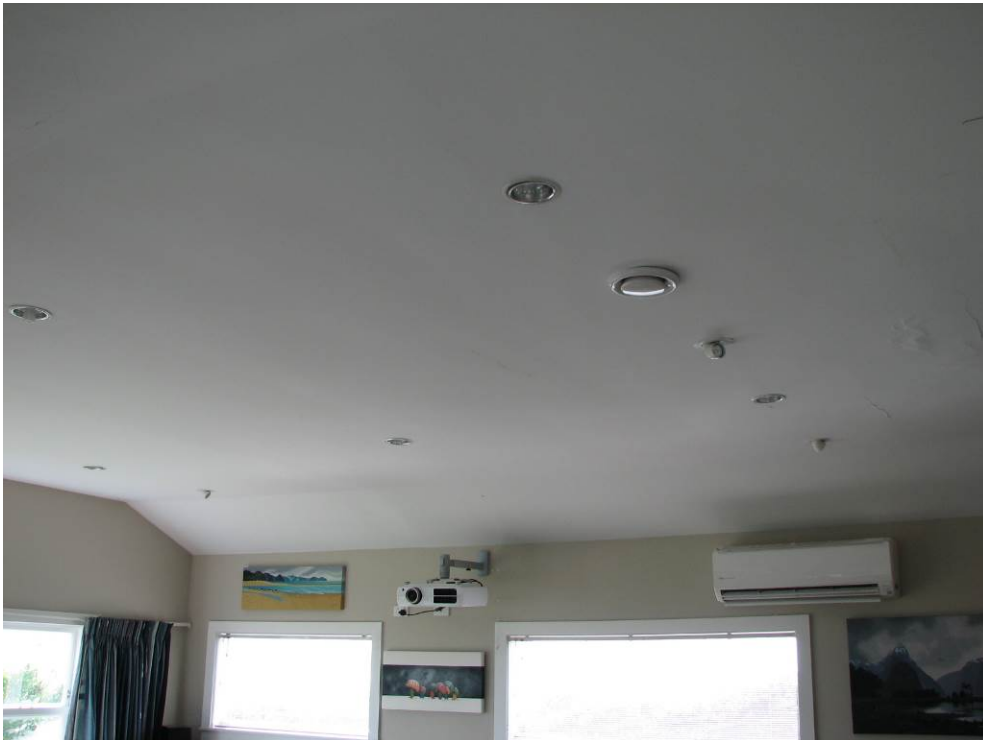
The house suffered from significant damage to foundations from the earthquakes, made more complex by the two different foundation types. Ground movement caused uneven settlement of ring foundation and piles of the older part of the home, and voids formed beneath the 32m<sup>2</sup> concrete slab to part of the extension. Damage also included damage to the roof cladding, window joinery, exterior paintwork, entry floor tiles, tongue and groove flooring finish, retaining walls, fencing and driveway. Most interior lath and plaster ceiling and wall linings were badly cracked.

**Figure 2: Ceiling damage to Mt Pleasant 1**

- Repair of the foundations by packing and replacing floor piles, grout pumping into the voids beneath the concrete slab, epoxy injections into the cracks in the ring foundation.
- Replacement of the roof
- the driveway, fencing and retaining walls
- Most lath and plaster ceiling linings were replaced throughout
- Most lath and plaster wall linings replaced throughout
- Internal doors were eased and adjusted throughout
- Full interior and exterior redecoration.

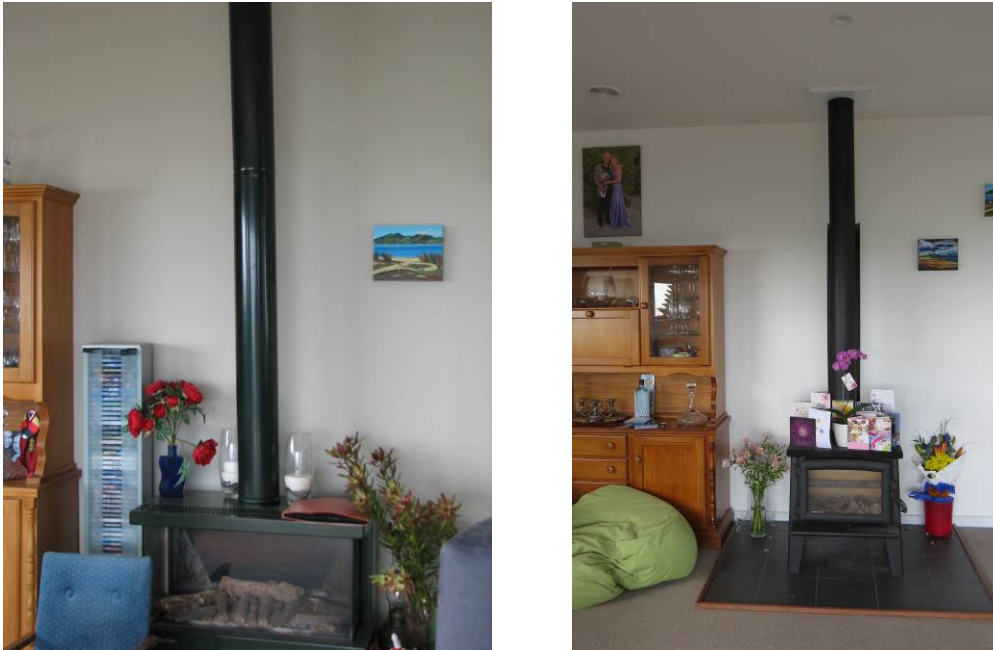
**Figure 3: A gas effect fire (left) replaced by woodburner (right)**

The gas effect fire was originally installed in the living room for heating, but because it was so costly to run a 10kW heat pump was installed post earthquakes and gas effect fire was not used. During repairs, the homeowners paid to replace this with a woodburner.

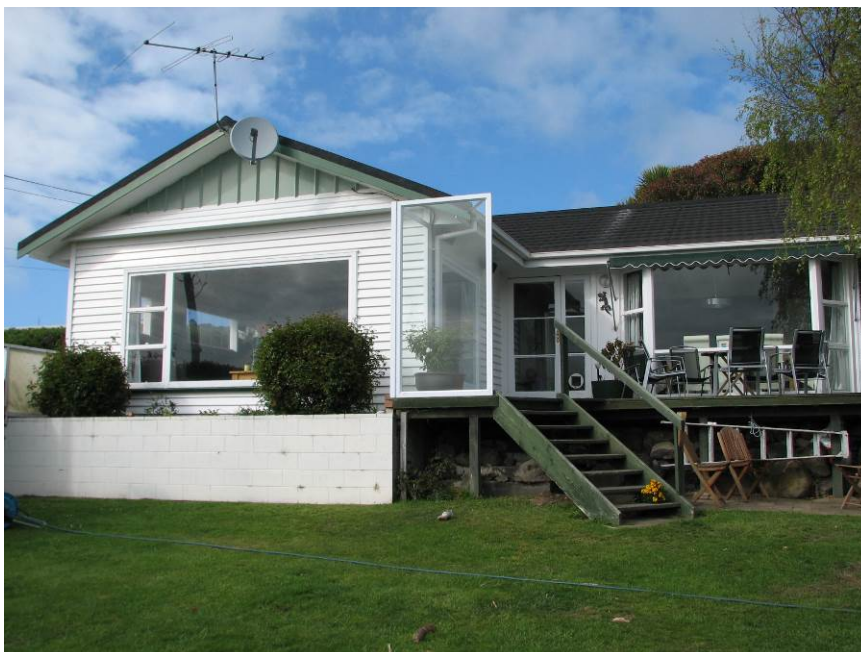
**Figure 4: Extensive north-facing glazing to take advantage of the views has led to overheating – some awnings already installed**

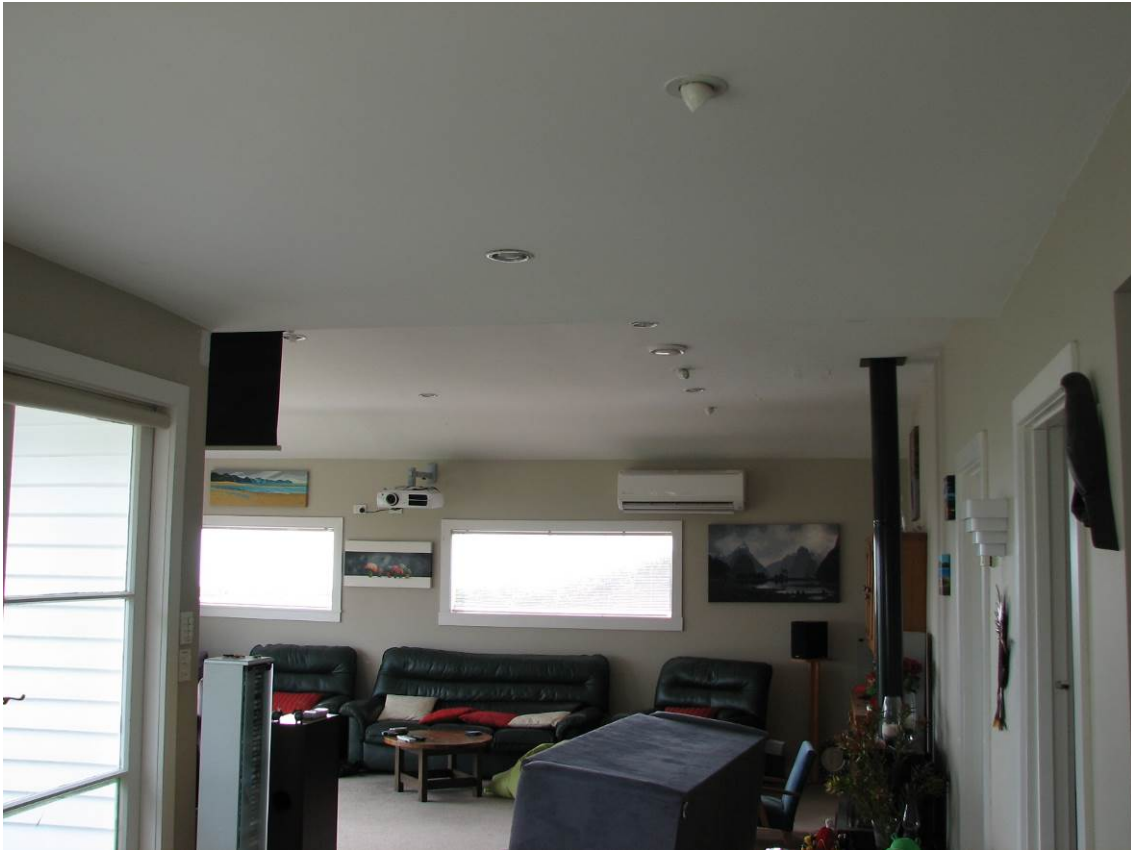
**Figure 5: Downlights were widespread in the house with halogen and incandescent bulbs.**

Mt Pleasant 1	Pre-retrofit condition	Interventions	Cost (excl GST)
	Heat transfer from living room to south facing entrance hall.		
Lighting	33 downlights – a mix of halogen and incandescent bulbs throughout. Ceiling insulation covering the downlights (macerated paper and fibreglass)	Replacement with LED/ IC rated downlights.	\$1,188
Ventilation	Ineffective bathroom extract fan in main bathroom – ducted to ceiling. Externally ducted bathroom extract in ensuite.  No kitchen rangehood, stove located under a window.	New bathroom extract installed – was specified to be ducted externally but builder didn't do so. Under dispute.  Bench level extractor fan repaired by homeowner.	\$172.44
Water	Two high flow showerheads.  High flow kitchen and bathroom taps.  Two dual flush toilets.  Good opportunity for rainwater tank installation.	New lowflow tapware installed by homeowner.  Low flow showerheads installed.  1000 litre rainwater tank installed.	\$1200 (homeowner cost)  \$308.88 install cost  \$2582

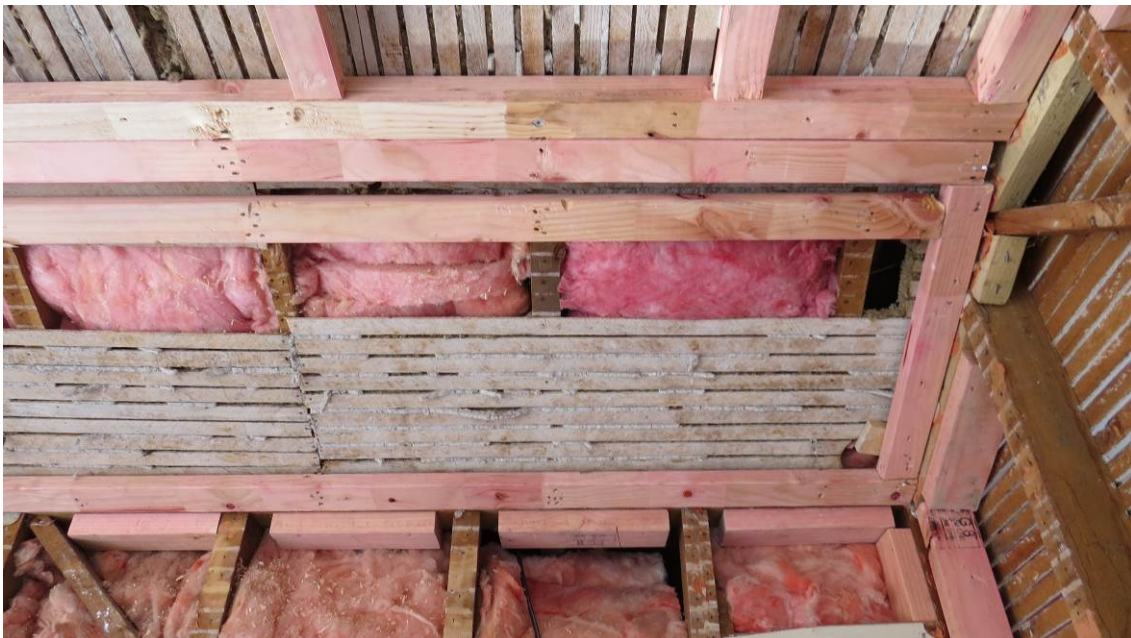
The builder used a method for replacing lath and plaster ceiling and wall linings whereby not all the lining was removed. This meant that, in places, only partial insulation of insulation was possible.

**Figure 6:** Lath and plaster ceiling and wall linings were not completely removed so insulation had to be fitted where possible.

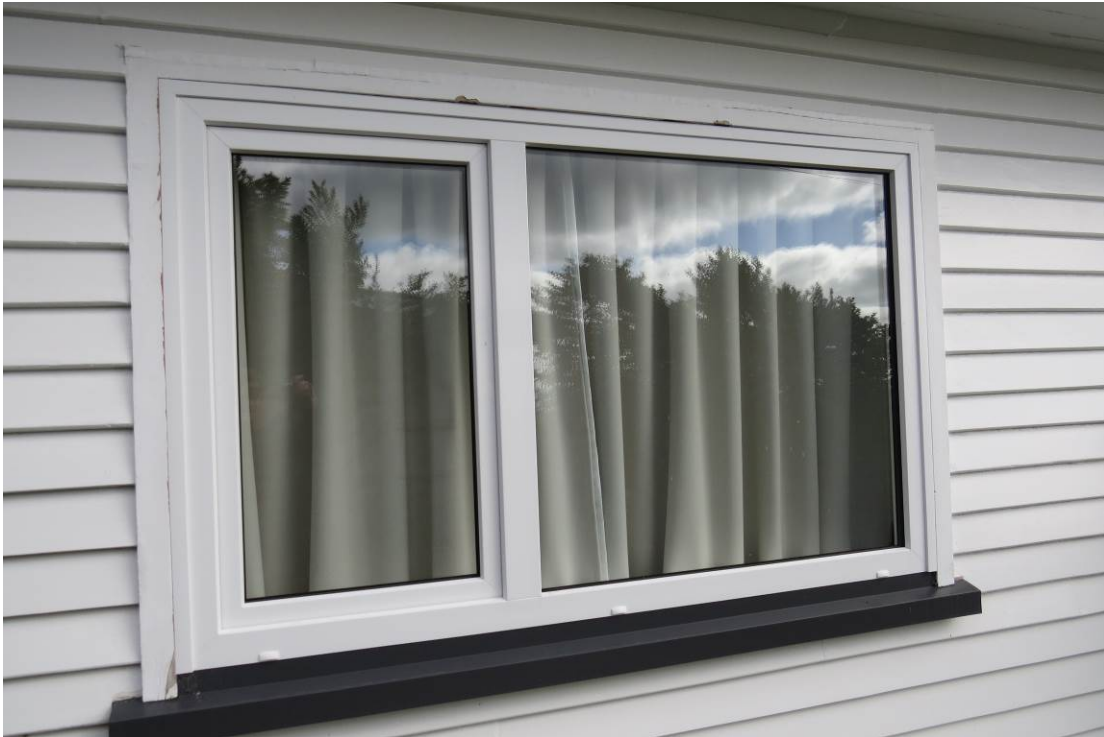
*Figure 7: Windows were replaced with double glazed uPVC windows at the homeowner's cost.*
