BBS/13

Redcliffs 1: Build Back Smarter Case Study

**A report prepared by Beacon Pathway Incorporated
March 2014**

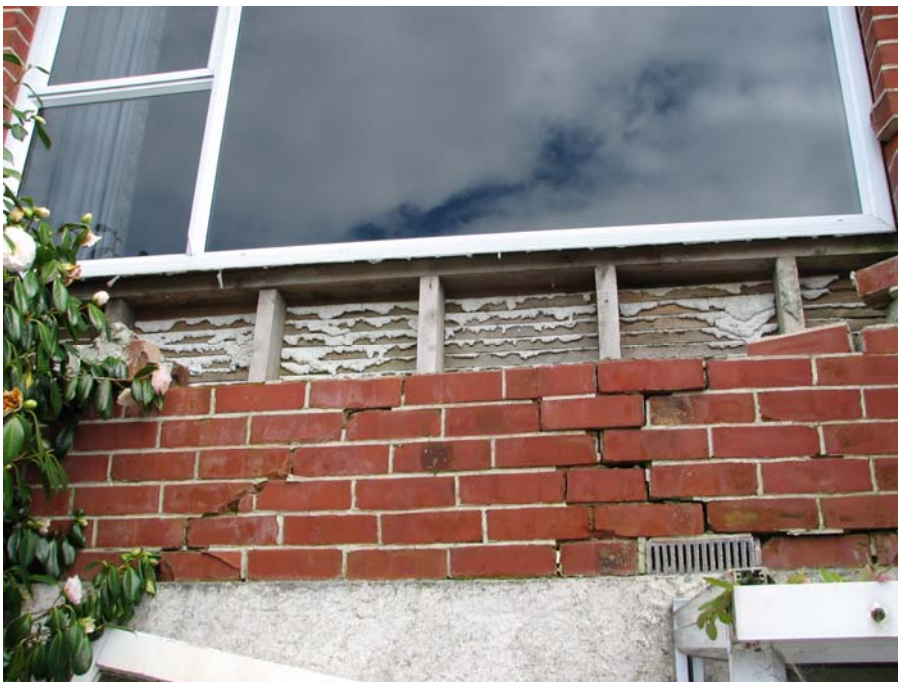
The house suffered from significant damage to the roof, windows and cladding during the earthquakes. The house was regarded as unlivable post earthquakes, but only temporary measures were used to weatherproof it. As a result the interior of the house – the insulation, wiring, all the fixtures, walls and ceilings suffered extensive water damage with mould spreading throughout.

Figure 2: Cladding damage to Redcliffs 1

- Foundation repairs
- Lath and plaster ceiling linings were replaced throughout
- Lath and plaster wall linings replaced throughout
- Doors and windows were eased and adjusted throughout
- Sewer and stormwater drainage was checked and minor repairs were made
- Full interior and exterior redecoration.

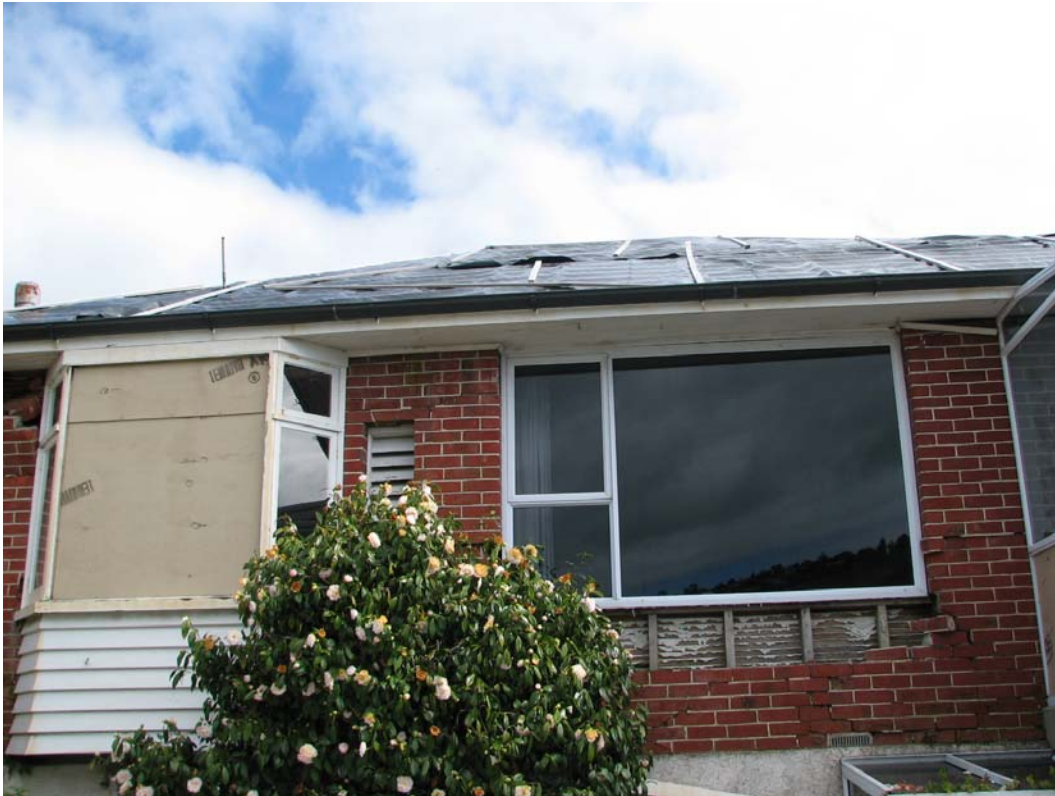
Figure 3: Roof and window damage to Redcliffs 1 with temporary weatherproofing

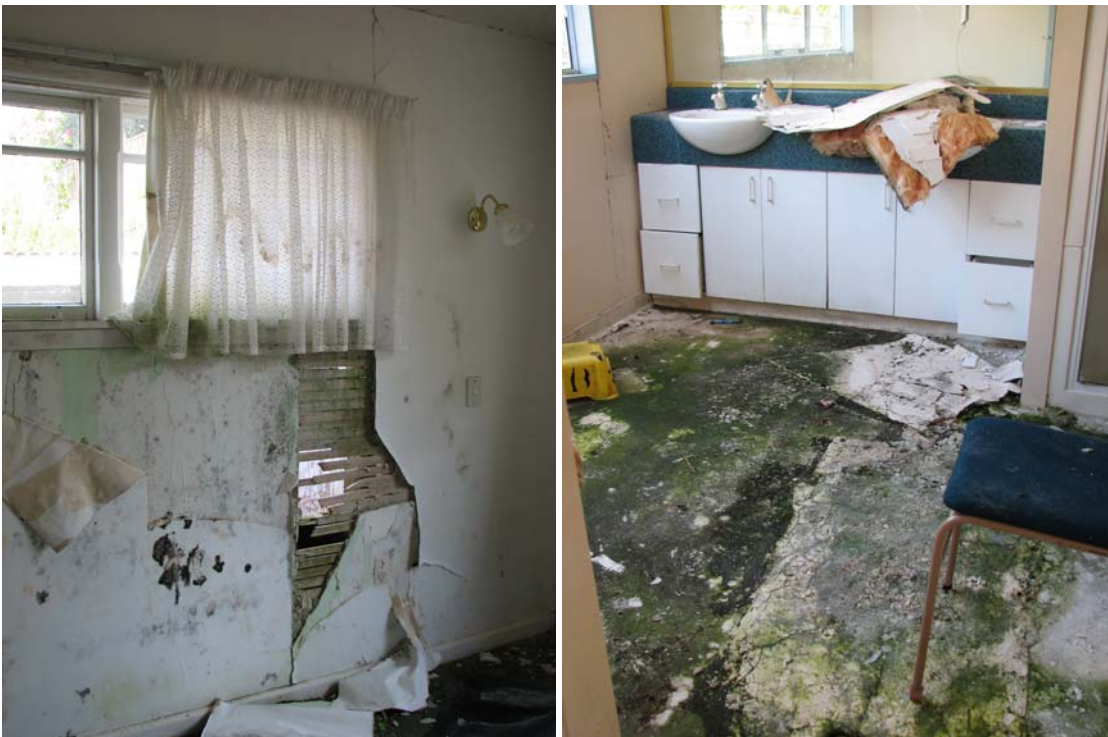
Figure 4: Internal water damage to Redcliffs 1 – damage was extensive throughout the house
