BBS/14

Papanui 1: Build Back Smarter Case Study

**A report prepared by Beacon Pathway Incorporated
June 2014**

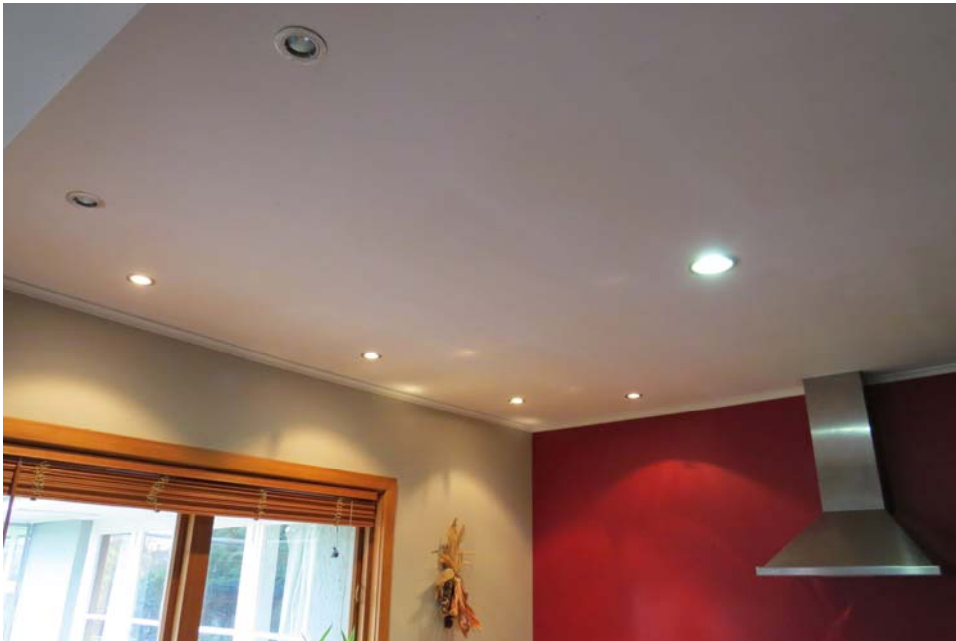
Figure 3: Extensive downlights were replaced with LED/IC-F rated downlights

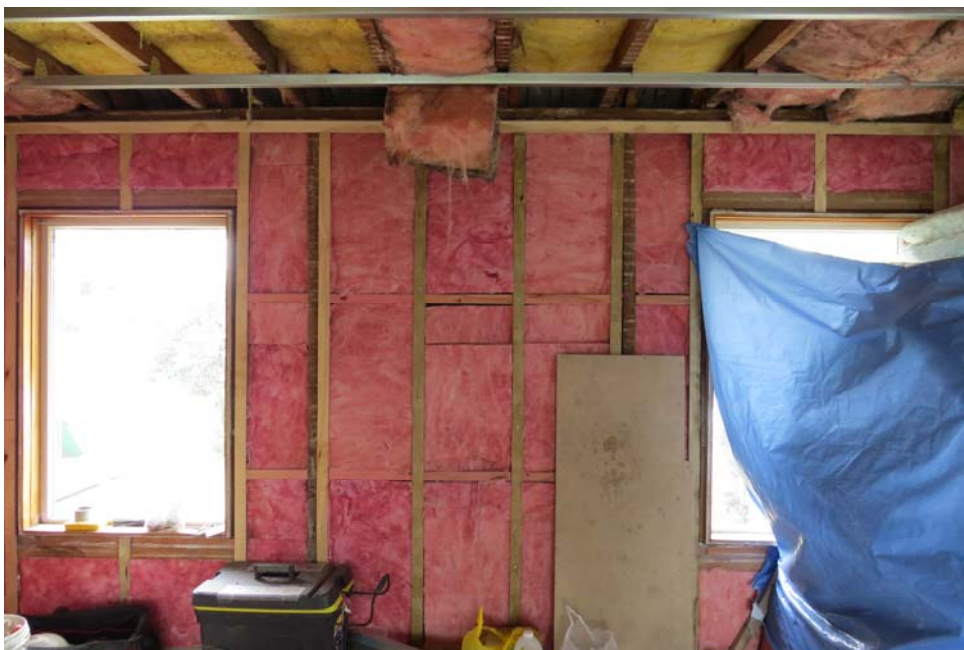
Figure 4: Wall insulation was installed and existing ceiling insulation topped up to cover the downlights
