BBS/6

Huntsbury 2: Build Back Smarter case study

**A report prepared for Beacon Pathway Incorporated
January 2013**

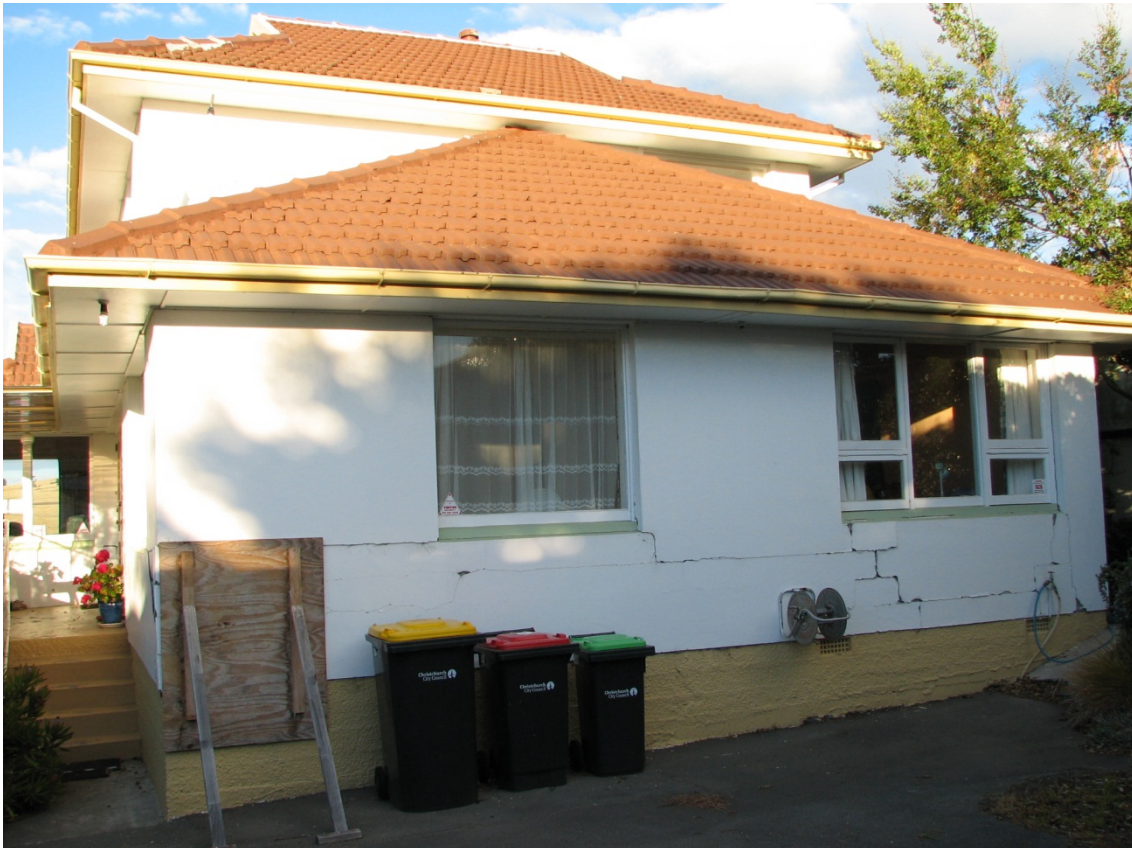
The house suffered no damage in the September 2010 earthquake, but was substantially affected by the February 2011 earthquake, with damage to exterior stucco block cladding (see Figure 2 below), cracked ceiling and wall linings as well as a range of minor damage to tiles, and some other fixtures.

Figure 2: Earthquake damage to Huntsbury 2 exterior cladding

- Most of the block-work and stucco veneer cladding on the ground floor was replaced and building wrap installed.
- Ceiling linings were replaced in the living room, hall and all four bedrooms.
- Wall linings were replaced in the dining room, living room, hall, and a bedroom due to cracking and damage.
- Wall linings in the kitchen, stairwell and the other 3 bedrooms were also replaced because it was more cost effective for the builder than removing the wall paper and replastering.
- The non-compliant (emissions) woodburner was replaced.
- Once wall linings in the dining room were removed, extensive earthquake damage to the inset woodburner flue and chimney were discovered, the steel flue was replaced and some repairs done to the open fireplace chimney were made.

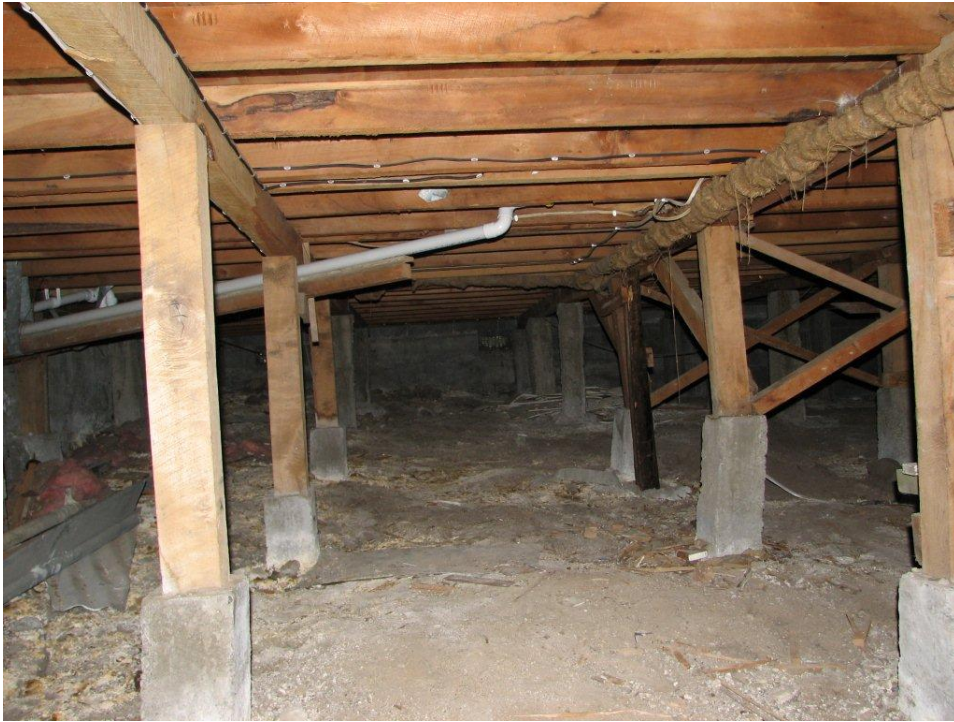
Figure 3: Uninsulated suspended timber floor in Huntsbury 2

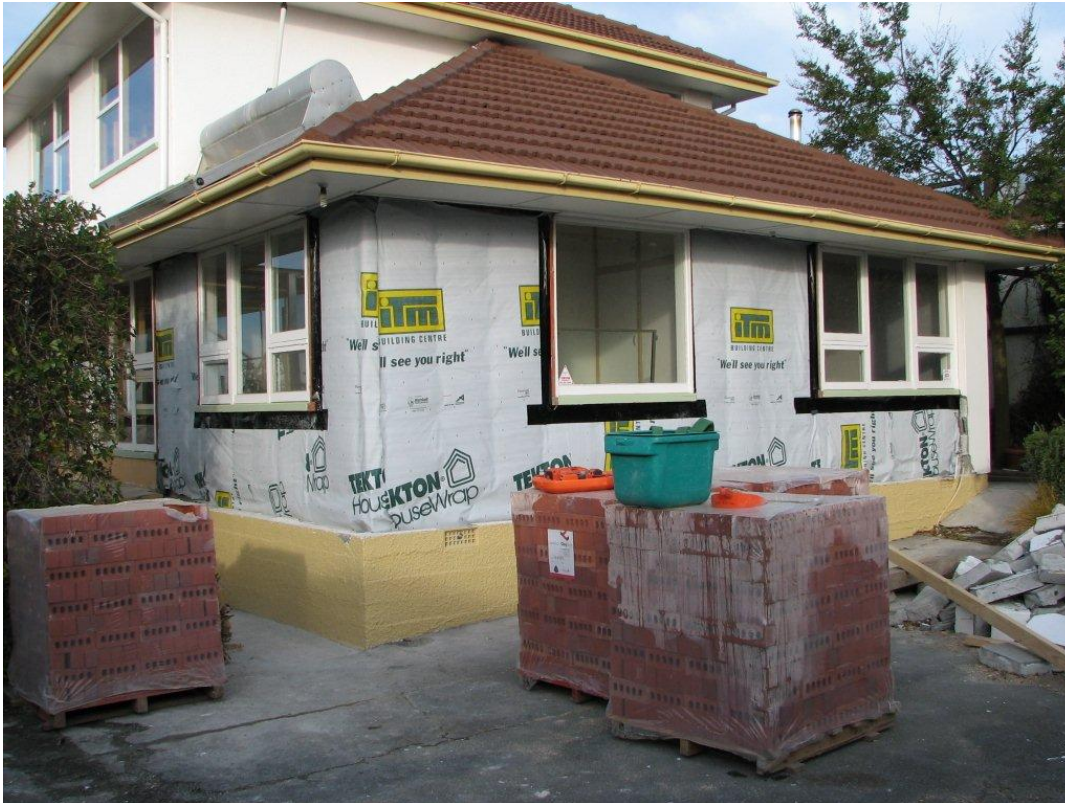
Figure 4: Huntsbury 2 mid repair – Exterior cladding being replaced

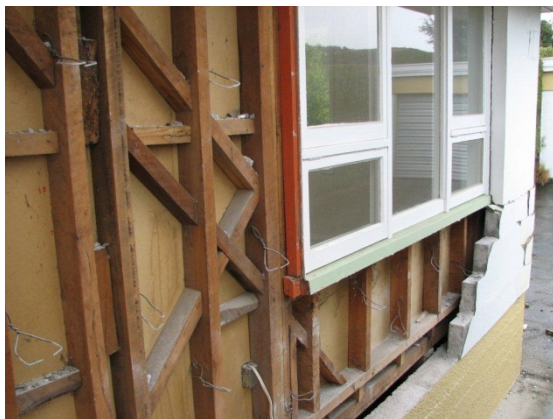
Figure 5: Uninsulated wall with cladding removed – a classic Build Back Smarter opportunity

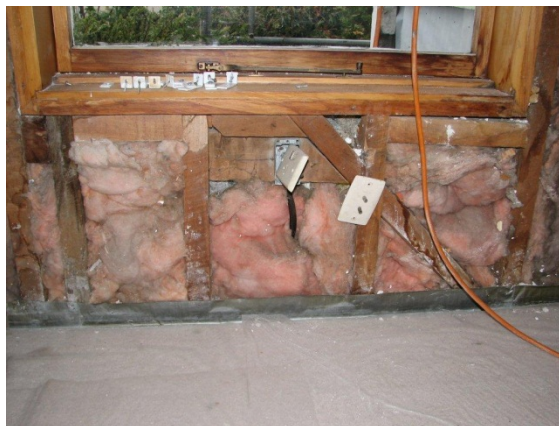
Figure 6: Old insulation in the living room walls (this wasn't expected but was replaced as part of the Build Back Smarter work)

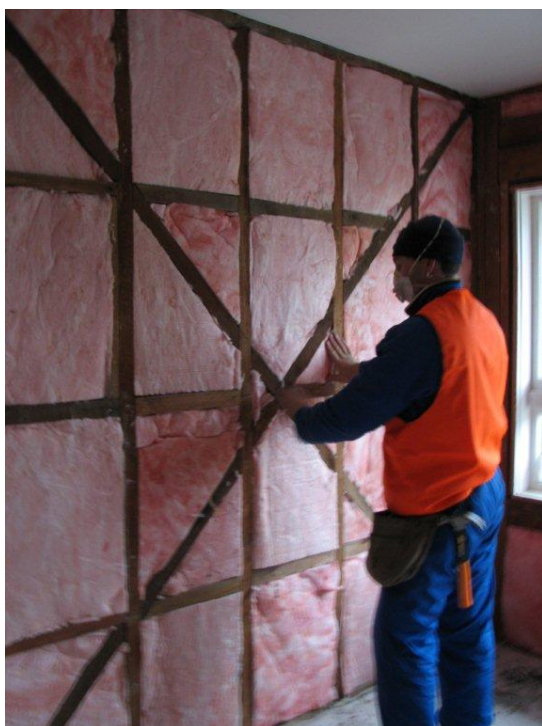
Figure 7: Wall insulation being installed prior to relining

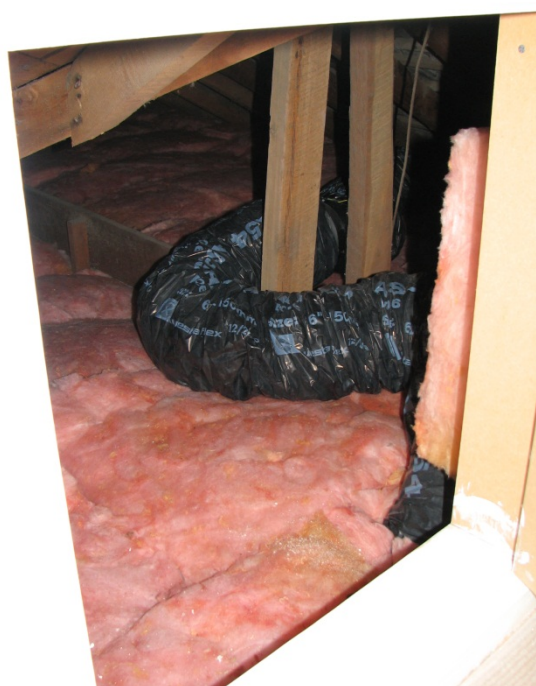
Figure 8: Ceiling insulation topped up with heat transfer system also installed

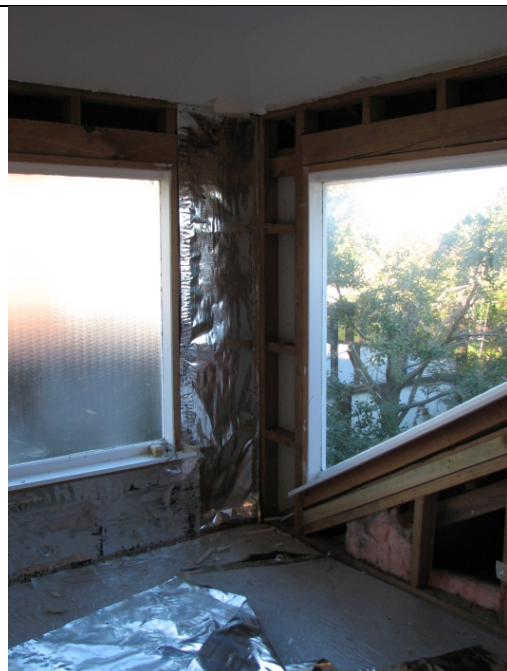
Figure 9: Foil sheet behind plasterboard was found in the upper storey when the linings were removed.

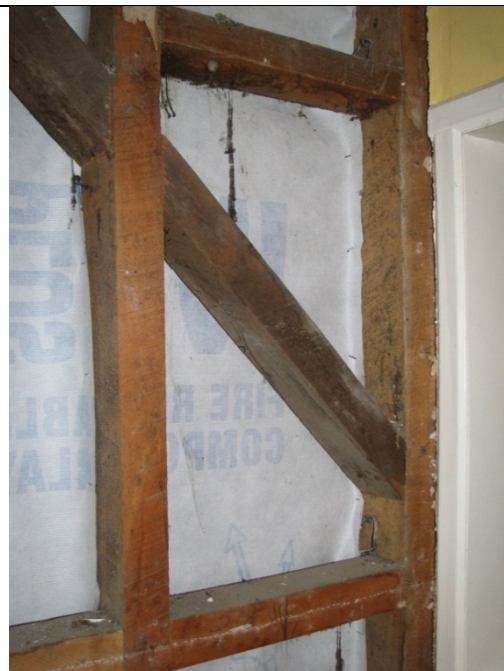
Figure 10: Inserts of building paper were stapled into the cavities prior to insulation installation where wall linings, but not cladding, were replaced

Because the cladding was not removed, no exterior-applied building wrap was installed. This meant that the insulation installers had to use the method outlined in NZS 4246: 2006, which involves installing inserts of building wrap into the cavities – a time consuming (and therefore more costly) installation method, but still deemed to be very worthwhile.

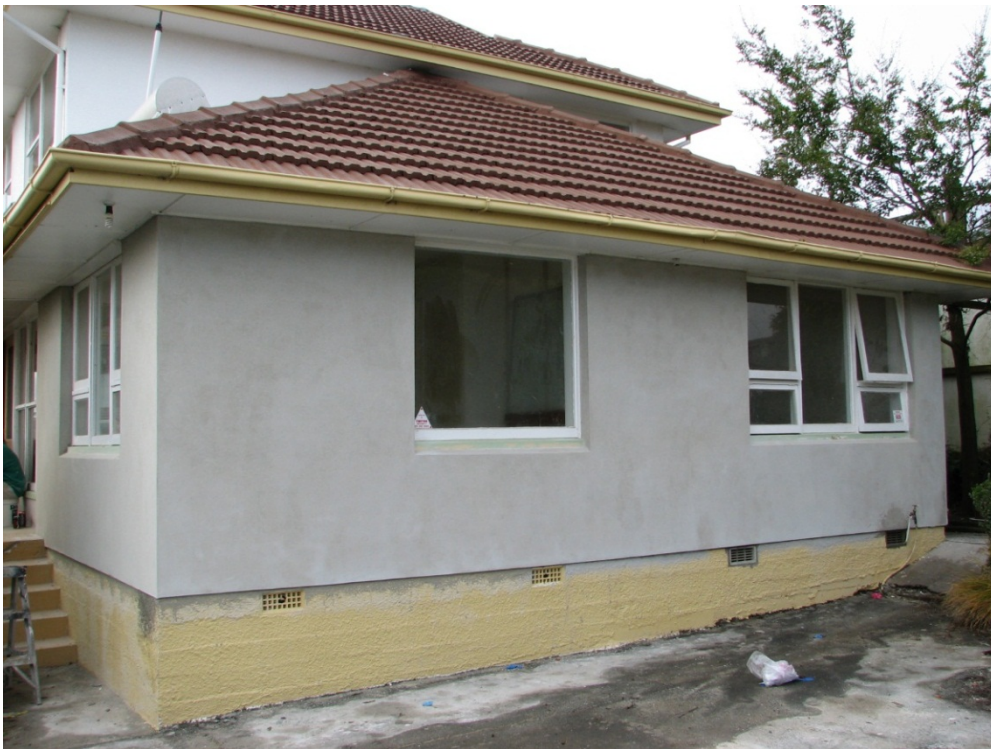
Figure 11: Completed stucco block veneer replacement – additional fibreglass reinforcing was included at the homeowner’s cost

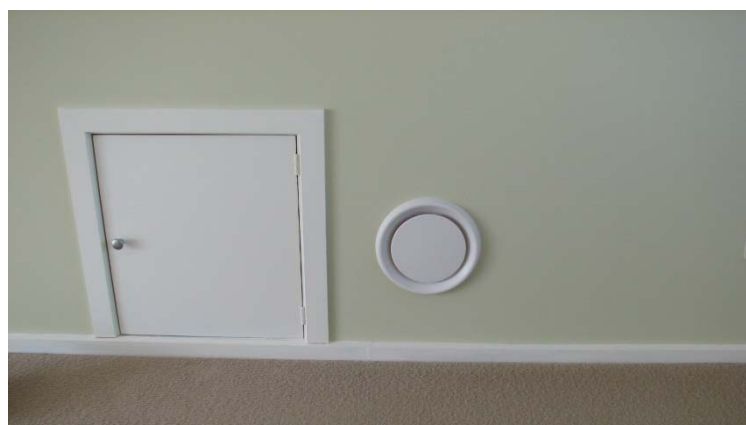
Figure 12: An access hatch to install ceiling insulation, and heat transfer kit to the master bedroom were installed as part of the upgrade.
