**BBS/9**

# **Halswell 1: Build Back Smarter Case Study**

**A report prepared by Beacon Pathway Incorporated  
August 2013**

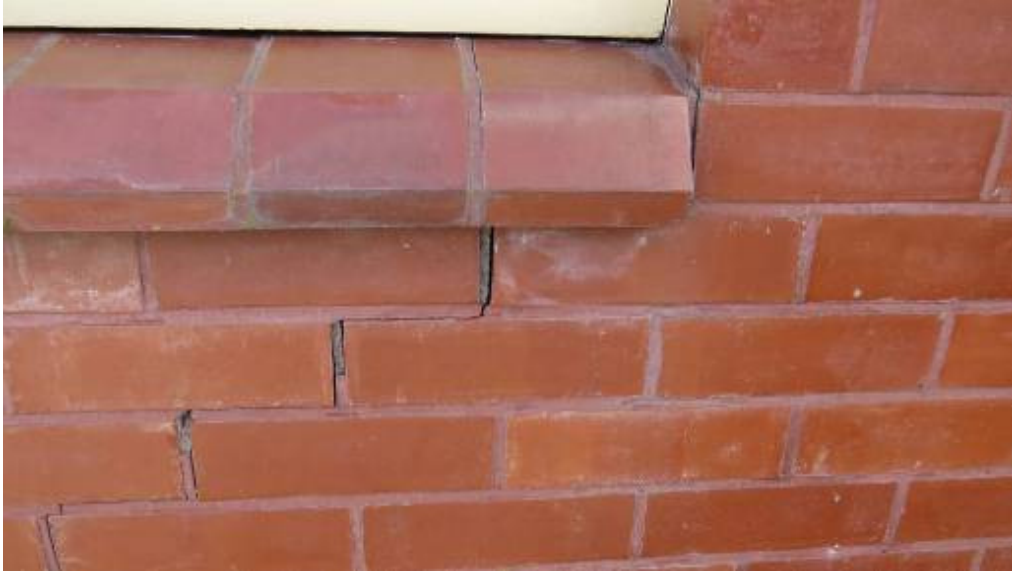
The house and grounds suffered from substantial liquefaction in several of the earthquakes, as well as the ground level dropping. There was also damage to exterior brick cladding (see Figure 2 below), ceiling damage in one room, as well as minor damage to wall linings, and some other fixtures.

**Figure 2: Earthquake damage to Halswell 1 exterior cladding**

- All of the brick cladding on the ground floor was replaced and building wrap installed
- Ceiling linings were replaced in 3 bedrooms, hallway and lounge
- Wall linings were repaired and redecorated
- Doors were eased and adjusted throughout
- Contaminated liquefaction was removed from the sub-floor
- The floor was levelled through pile repacking
- Ring foundation cracks were repaired and foundation re-plastered
- Driveway, paths and patio paving were replaced
- Additional stormwater drainage was installed

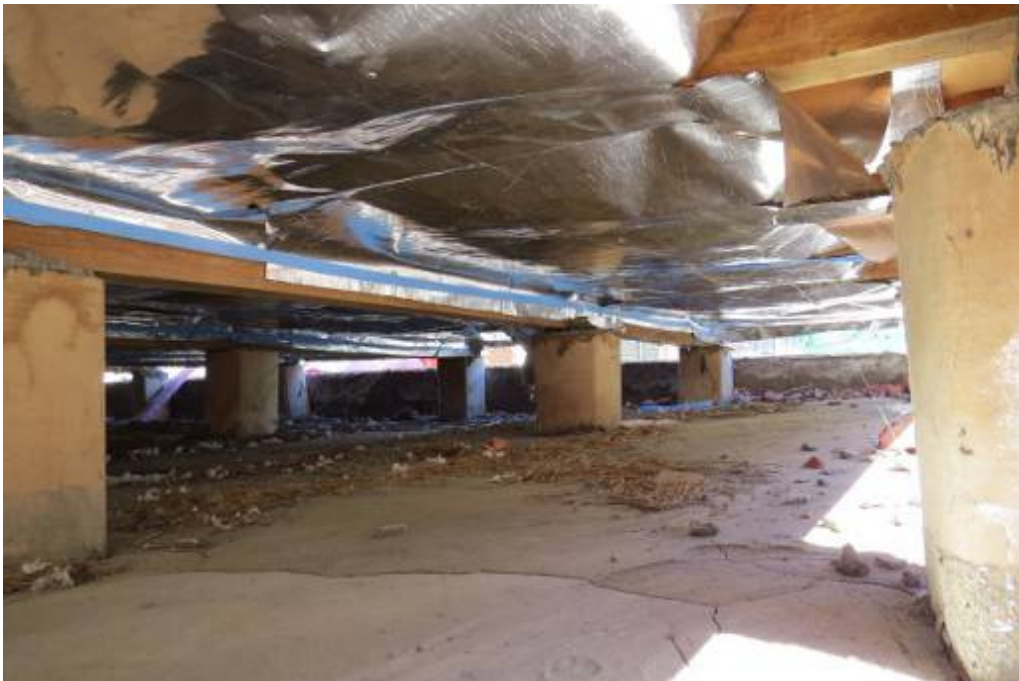
**Figure 3: Contaminated liquefaction under Halswell 1**

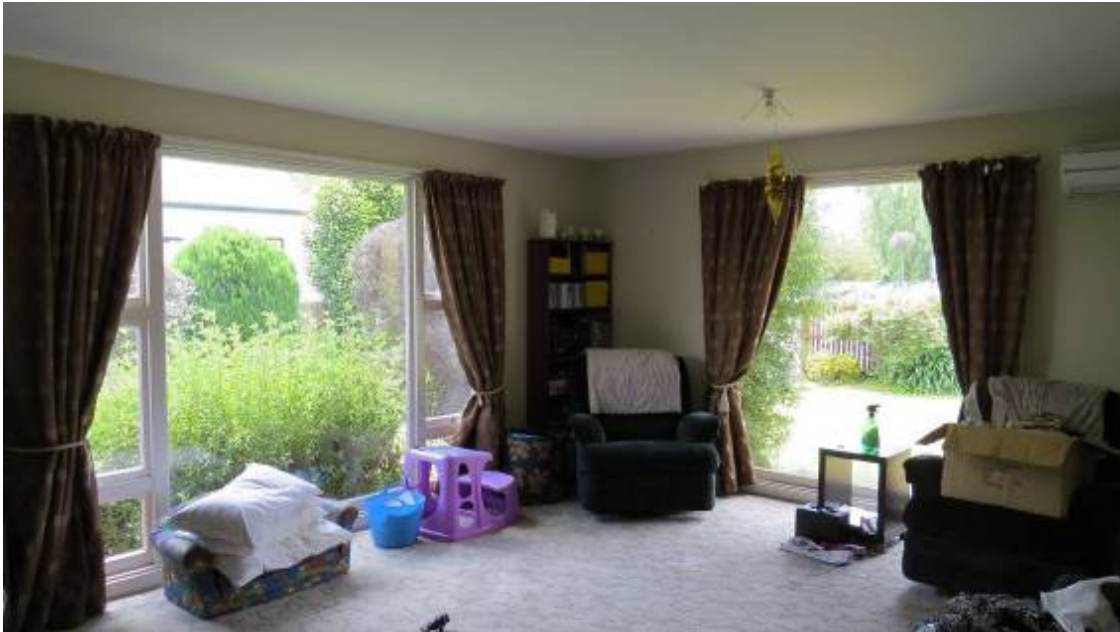
***Figure 4: Large draughty windows facing north and west causing overheating in Halswell 1***

As part of the repairs, the homeowner was very keen to upgrade the windows to double glazing, and replace the wooden frames which were draughty and in poor condition. This was funded through an extension to her mortgage – although she indicated the approximately \$20,000 was about the limit of what she could afford, and that the bank would allow. The homeowner was motivated by previous experience living in homes with double glazing, and was also keen to address glare and overheating issues in the main living room.

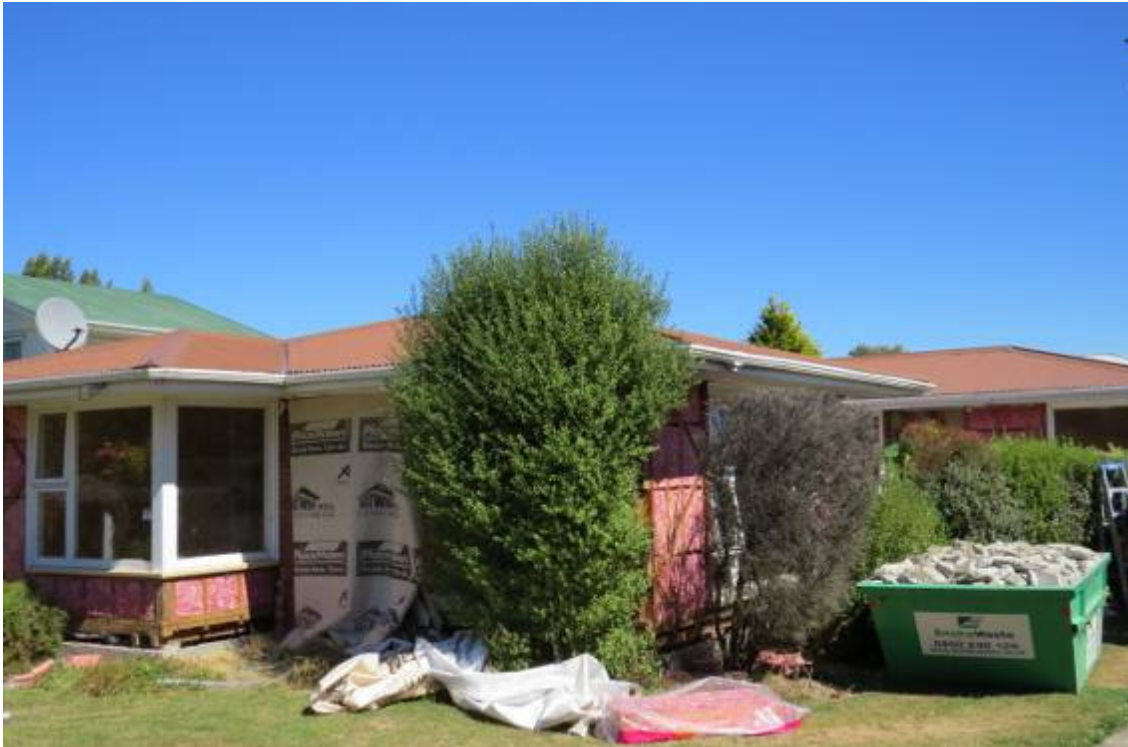
**Figure 5: Mid-repair – Wall insulation being installed from the outside prior to building wrap and recladding**

The Halswell 1 house had only a small amount of relining as part of the repair scope, but a full reclad. As such, installation of wall insulation from the outside, prior to the installation of building wrap, was the method used, and this enabled the entire house to have wall insulation installed. While a very effective method, this requires very timely action and better co-ordination between the on-site contractor and the specialist insulation installer. The builder wants to get the building wrap on the building as quickly as possible, in order to protect the framing from the weather. In the case of the Halswell 1 case study, some confusion did occur, and this did result in a small delay of work on site. As a result, it was the builder's view, that it would be better if the insulation could be installed by the builder, rather than a separate subcontractor.

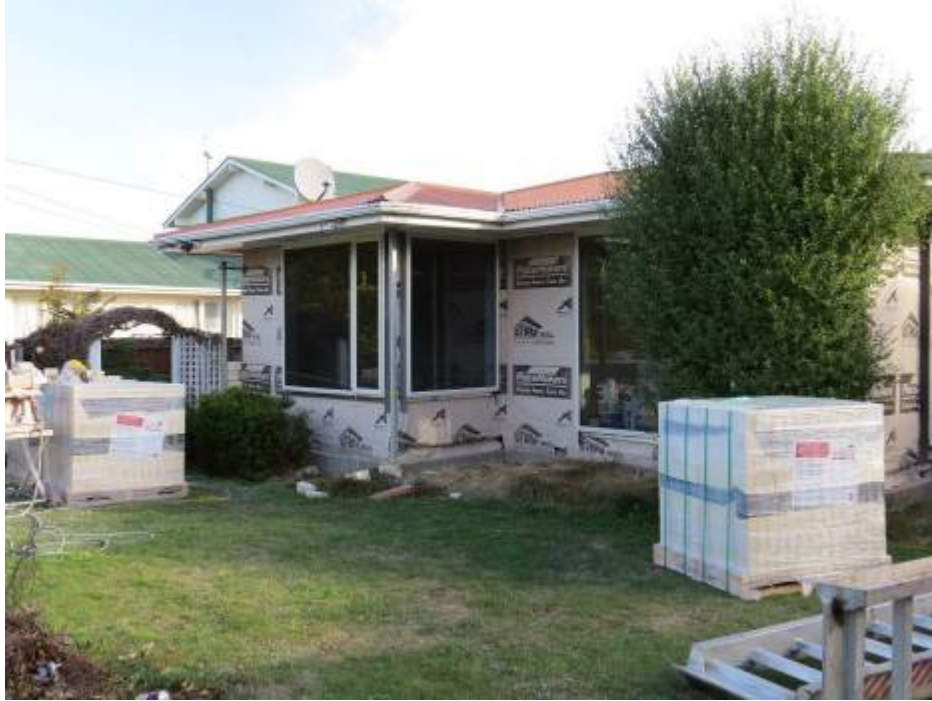
**Figure 6: New windows installed while cladding was removed – a classic Build Back Smarter opportunity**

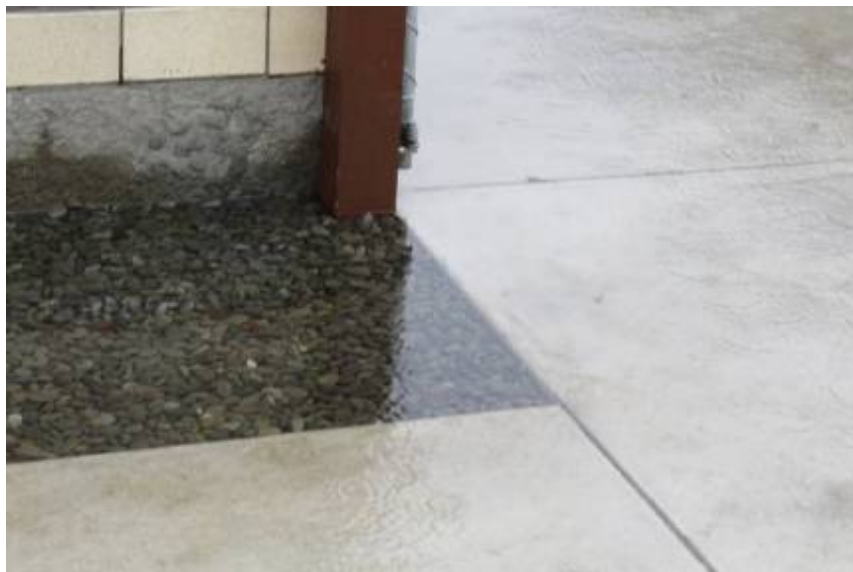
**Figure 7: Post completion flooding on the driveway during June 2013 floods**  
**The combination of too much paving, absence of drainage systems and ground subsidence means this home will always have issues with stormwater during heavy rain events.**

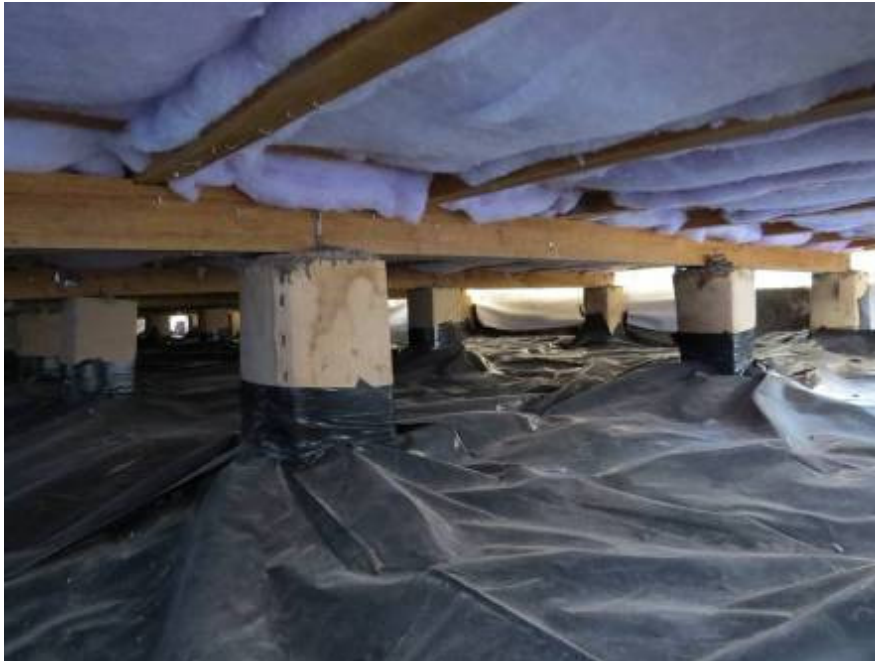
**Figure 8: Ground vapour barrier and underfloor insulation**  
While the liquefaction was removed from under the house, substantial dampness remains. The ground vapour barrier is a critical intervention to prevent the return of mould and excessive moisture into this house.

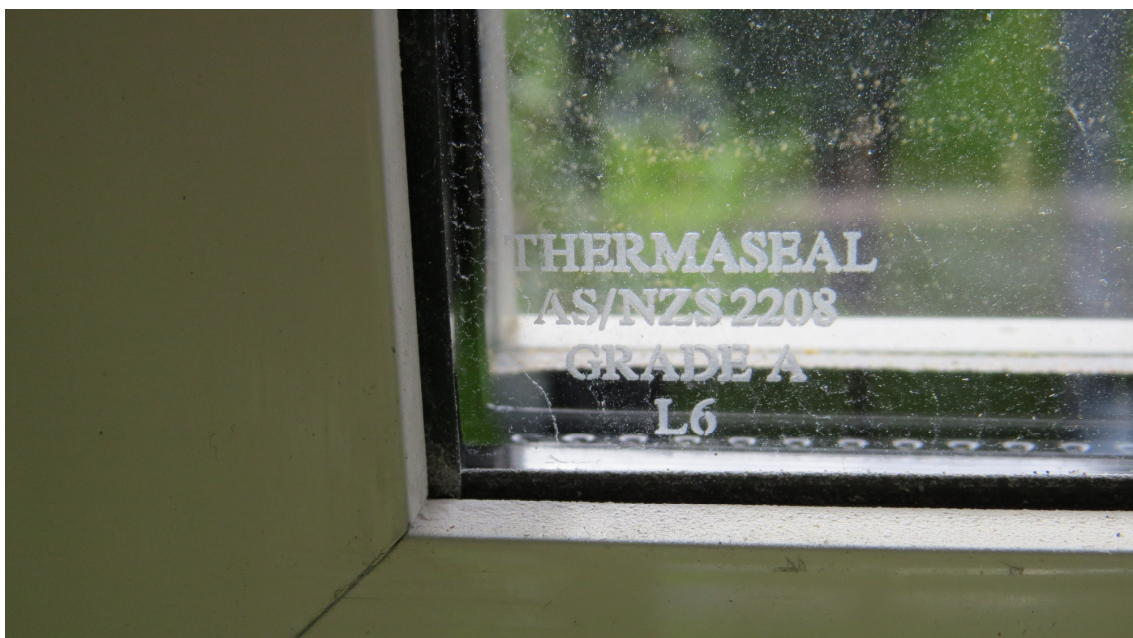
**Figure 9: Double glazing with thermally broken aluminium frames, low emissivity and argon filled glass with a glare tint in living areas**

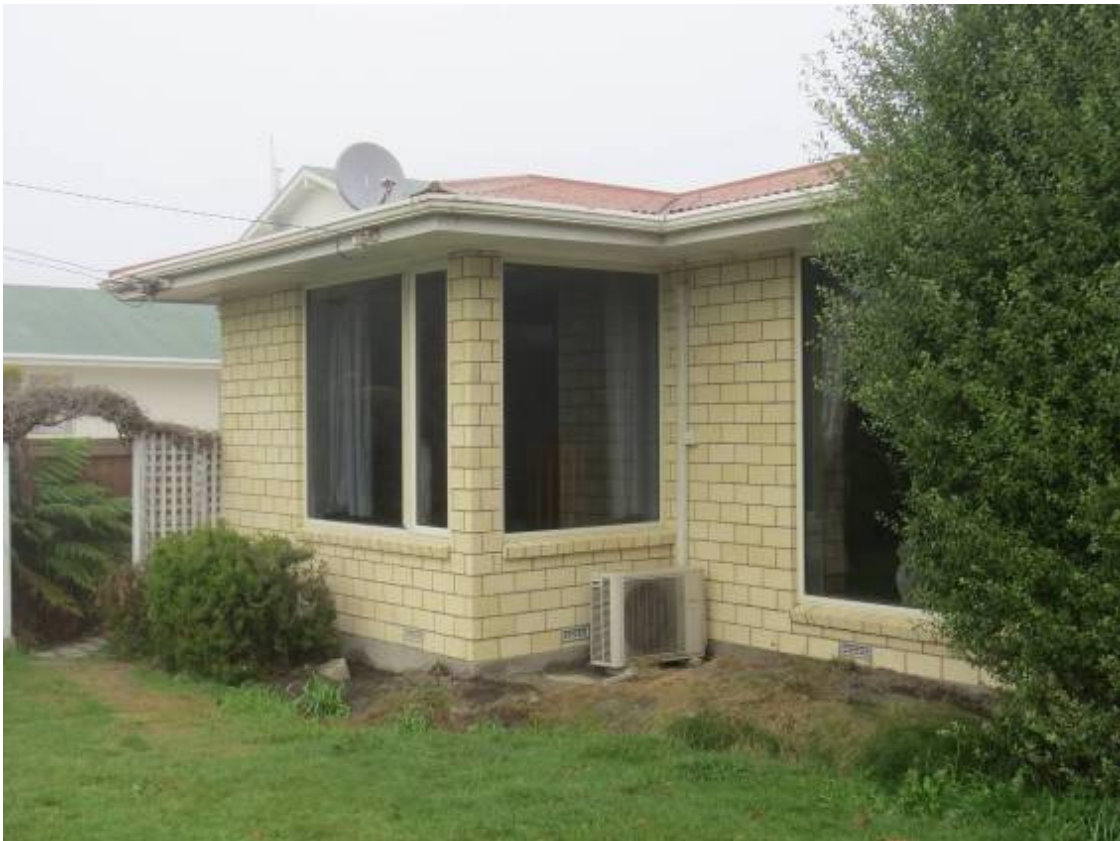
**Figure 10: Completed brick veneer replacement and new double glazed windows installed at homeowner's cost.**

**Note liquefaction has been cleared from the perimeter foundation, but still needs to be excavated from the adjacent area.**
