Report TE106/18

Papakowhai Renovations: Project Summary and Case Studies

**A report prepared for Beacon Pathway Limited
June 2009**

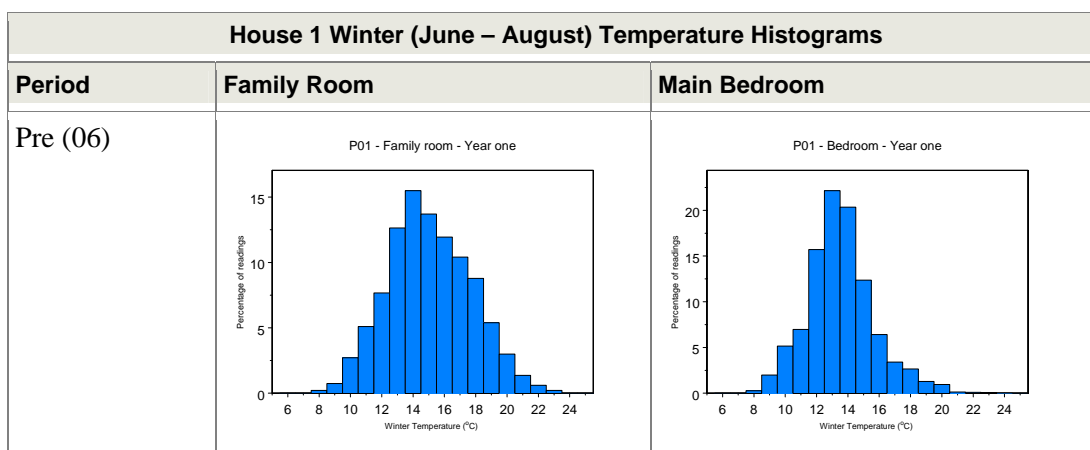
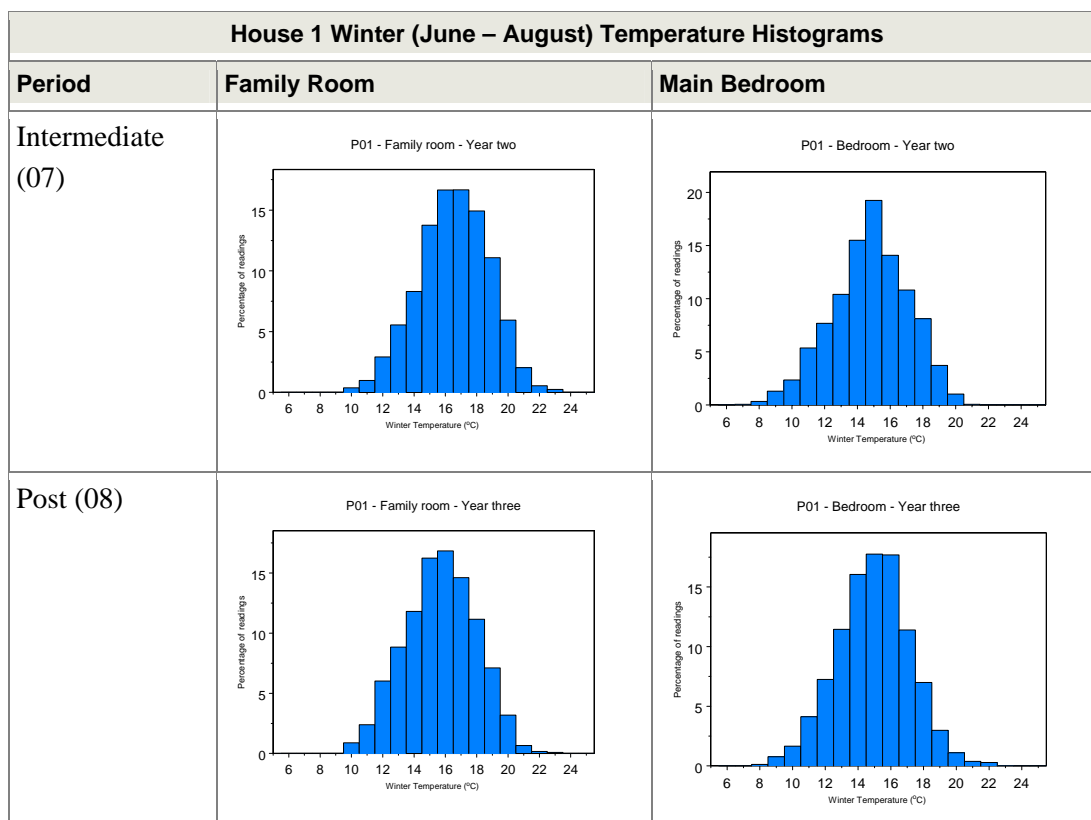
Figure 1: House 1 Winter Temperature Histograms

Figure 1 shows the frequency of different temperatures for the 3 winter months. These give a degree of subtlety that the other information doesn't provide and show that there has been an improvement in terms of in particular a reduction in the frequency of very low temperatures in both the family room and the main bedroom. Pre-retrofit the most common winter temperature in the family room was 14°C, whereas post-retrofit 16°C was the most common winter temperature. The lowest temperatures experienced in the family room also moved from 8°C to 10°C. When the main bedroom histograms are considered, a similar picture occurs, with the most frequent bedroom temperature being 13°C in winter 2006 pre-retrofit to becoming 15-16°C in winter 2008.

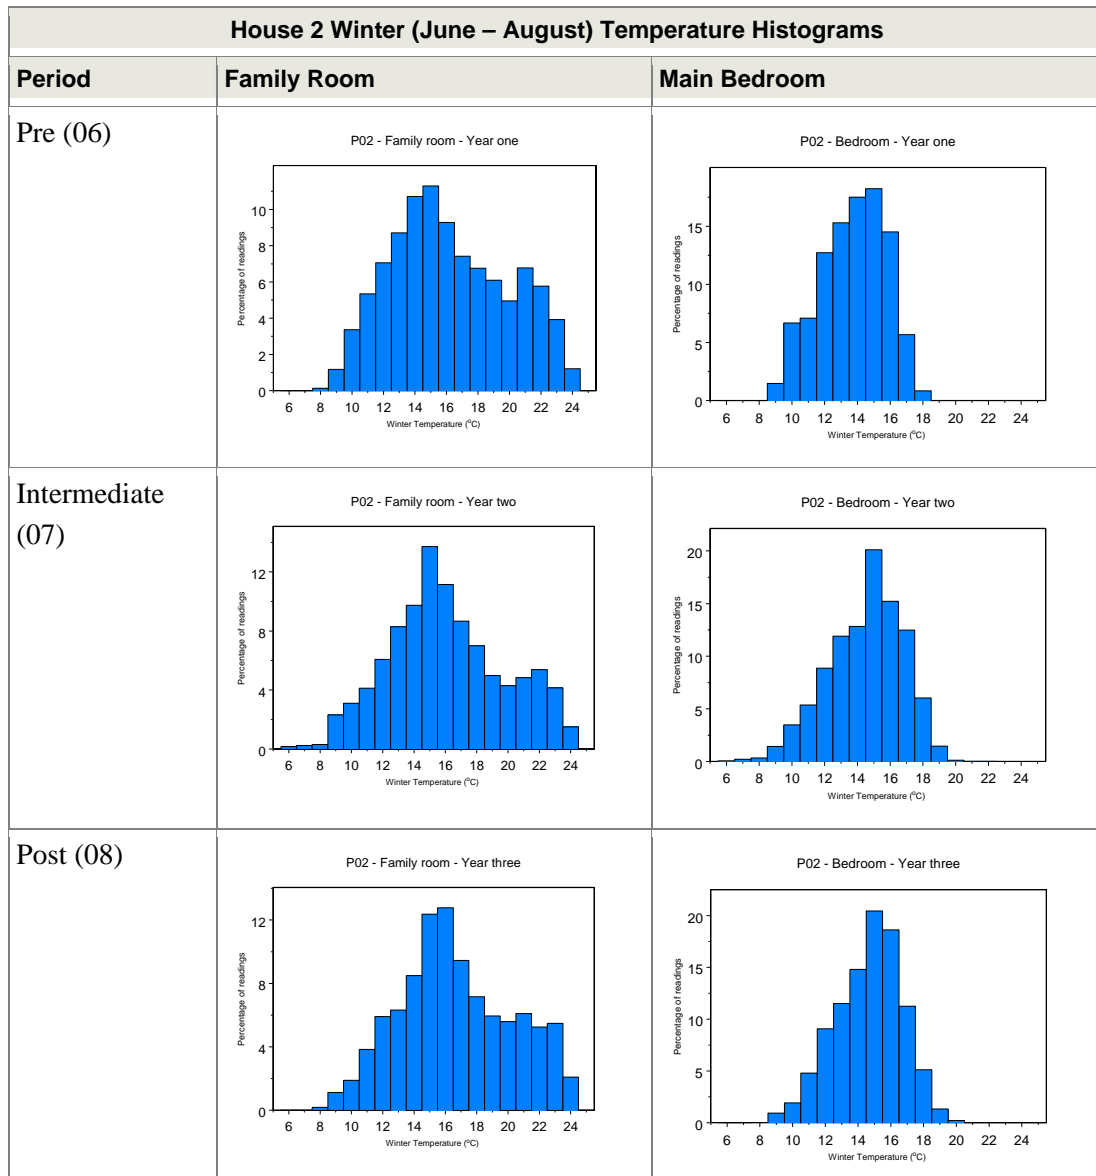
Figure 2: House 2 Winter Temperature Histograms

Figure 2 shows the frequency of different temperatures for the three winter months. These show that there has been a minor improvement in terms of the frequency of very low temperatures in both the family room and the main bedroom. Pre-retrofit the most common winter temperature in the family room was 15°C, whereas for the 2008 winter 16°C was the most common winter temperature. 15°C remains the most common temperature in the bedroom, although there is a reduction in the frequency of lower temperatures.

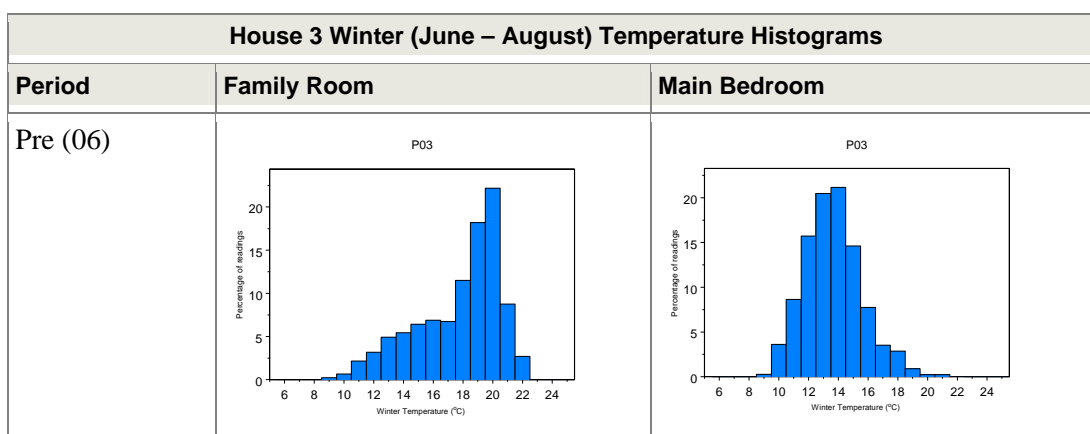
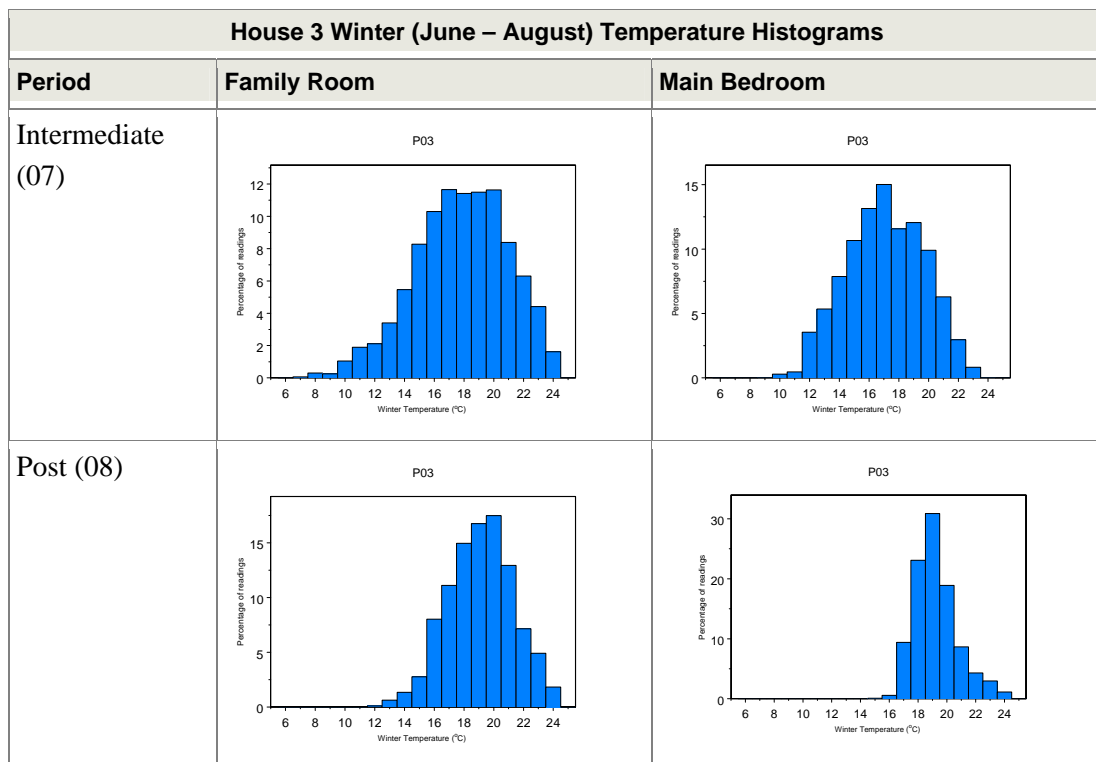
Figure 4: House 3 Histograms of Winter Temperatures

As can be seen from Table 14 and Figure 4, between winter 2006 and winter 2008, there were significant improvements in the proportion of time the family room and main bedroom exceeded healthy temperatures. The increase in percent of time the house fell below health temperatures in July in 2007, and this being substantially reversed in 2007 is probably largely due to the changes in heating method in the two years. As can be seen from Figure 4, 2007 saw a very large reduction in the frequency of very low temperatures in both the family room and bedroom with both heat pumps and a wood burner combined with heat transfer to bedrooms used in 2007. However the mean and median temperatures were still below the desired healthy levels. The change to a ducted heat pump system as the primary source of heating in 2008 resulted in further temperature improvements, to the point where very low temperatures were eliminated and the % time below healthy minimums was substantially reduced.

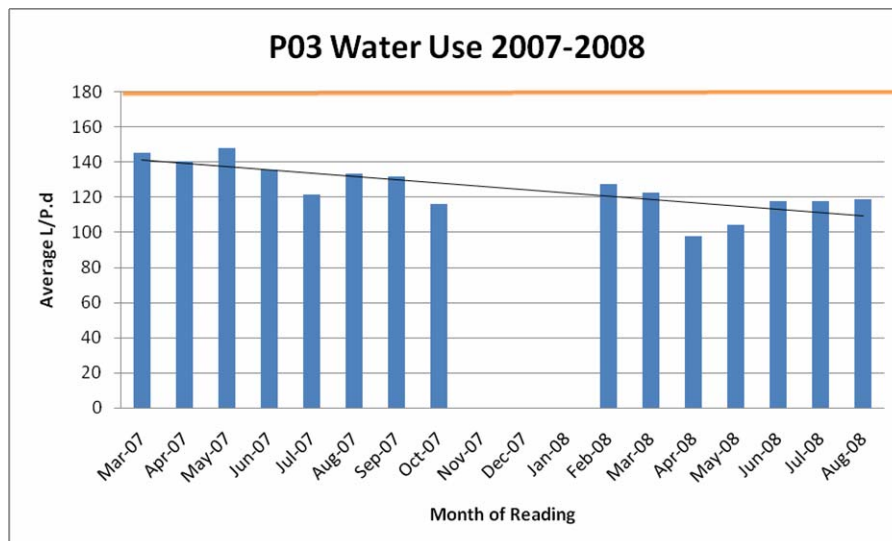
Figure 6: House 3 Water Use – March 2007 – Aug 2008

As noted above, the installation of the solar hot water system resulted in an increase of hot water energy use by the household of 21% between the 2007 and 2008 winter periods. Though data is not available this is likely to be paralleled with an increase in hot water as the hot water heating method was much more efficient. This combined with the presence of business staff of varying numbers during the life of the project, and the very short period of pre-retrofit data means a clear picture of water use is not available.

There are no statistically discernible trends in water use which can be attributed to the interventions, apart from the increased hot water use. However, like all houses where water monitoring occurred, there was a discernible downward trend in water use between the 2007 and 2008 years. The occupancy interviews identified that outdoor water use in the dwelling was minimal and that no particular water saving behaviours had been put in place, therefore the reduced water use can probably be attributed to the ceasing in use of the dwelling as an office in early 2008 and the installation of the dual flush toilets.

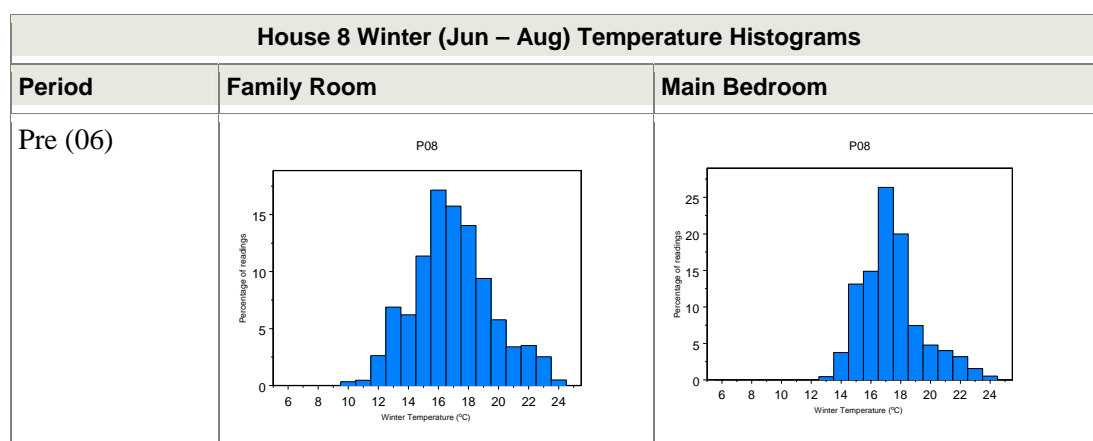
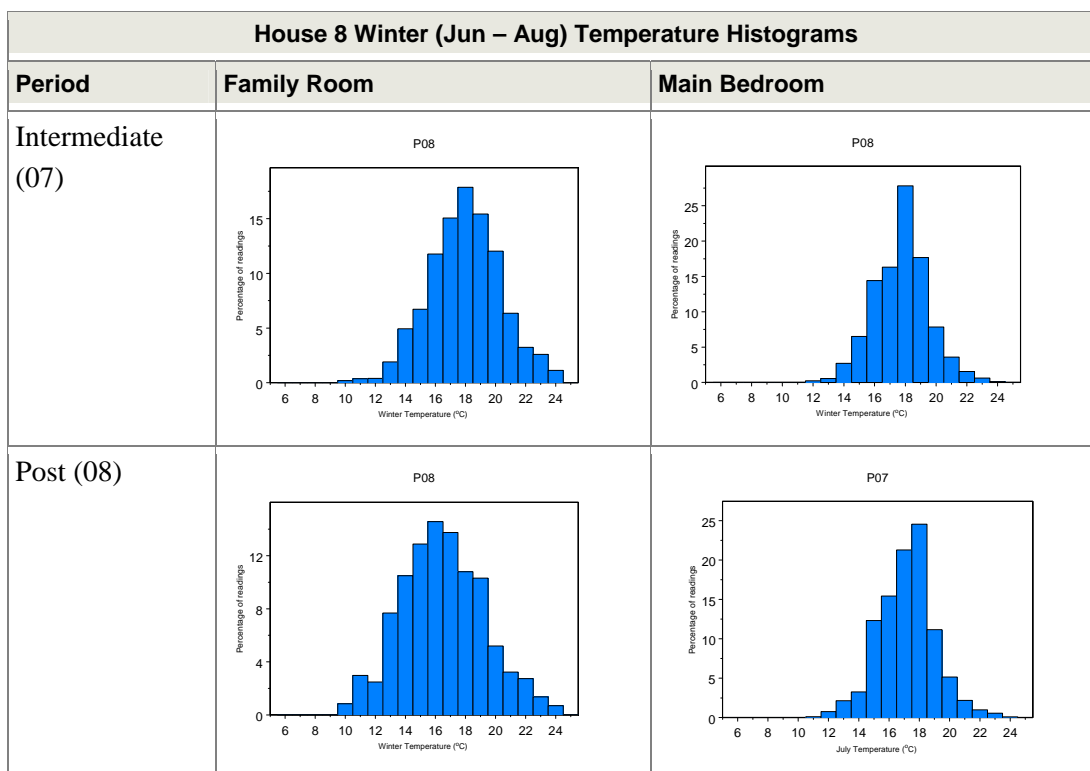
Figure 12: House 8 Winter Temperature Histograms

Between the 2006 pre-retrofit winter and the 2007 post-retrofit winter higher minimum temperatures are seen, and the frequency of lower temperatures decreased (Table 35 and Figure 12). This is likely to be due to a combination of improved thermal performance as well as slightly warmer 2007 winter temperatures. Heating energy use actually decreased at this time. In the 2007 winter mean minimum temperatures increased, particularly in the family room (refer Table 35) but there was also an improvement in the main bedroom (refer Table 36).

However these improvements were reversed in the winter of 2008, almost certainly because of a reduction in heating within the home. It is not known whether personal circumstances within the home changed over time, creating, for example, economic pressures to save electricity, but certainly this household were very high energy users even post-retrofit. This change could be a type of “reverse takeback”, where the occupants decided to revert to the pre-retrofit temperatures and comfort and gather further energy and cost savings from reduced heating. A clear recommendation for further retrofit to this dwelling would be to make changes in heating method, to a low emission wood burner, or as it is currently an all electric house, perhaps a heat pump. This would result in significant heating energy efficiency, and consequently quite probably improved temperatures within the home.

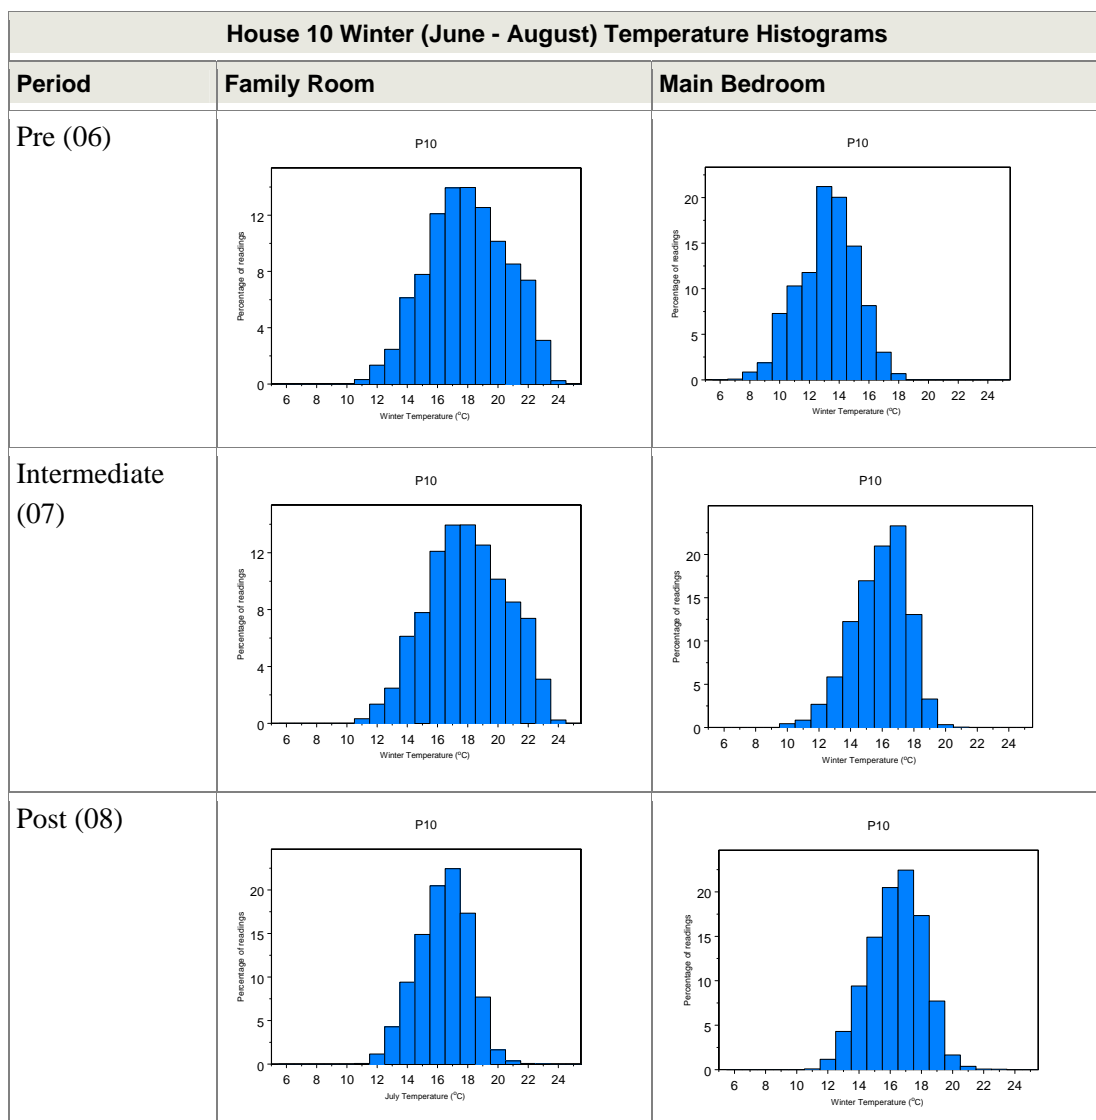
Figure 16: House 10 Histograms of Winter Temperatures

As can be seen from Table 44 and Figure 16, between winter 2006 and winter 2007 there were significant improvements in the proportion of time the family room and main bedroom exceeded healthy temperatures. These figures were however reversed in 2008 in the family room, but the trend continued positively in the main bedroom – possibly as a result of supplementary heating from the oil column heaters. It is interesting that this reversal of temperature improvement in the family room has occurred despite an increase in space heating energy. Comments from the homeowners on the difficulty of keeping the temperatures down to a comfortable level in the first year post-retrofit, perhaps suggest sub optimum operation of the wood burner may be an issue.

This house does not have a heat transfer system, so supplementary space heating in the bedroom (not separately monitored) paired with increased insulation levels are the most likely cause of the increasing overnight temperatures in the main bedroom.

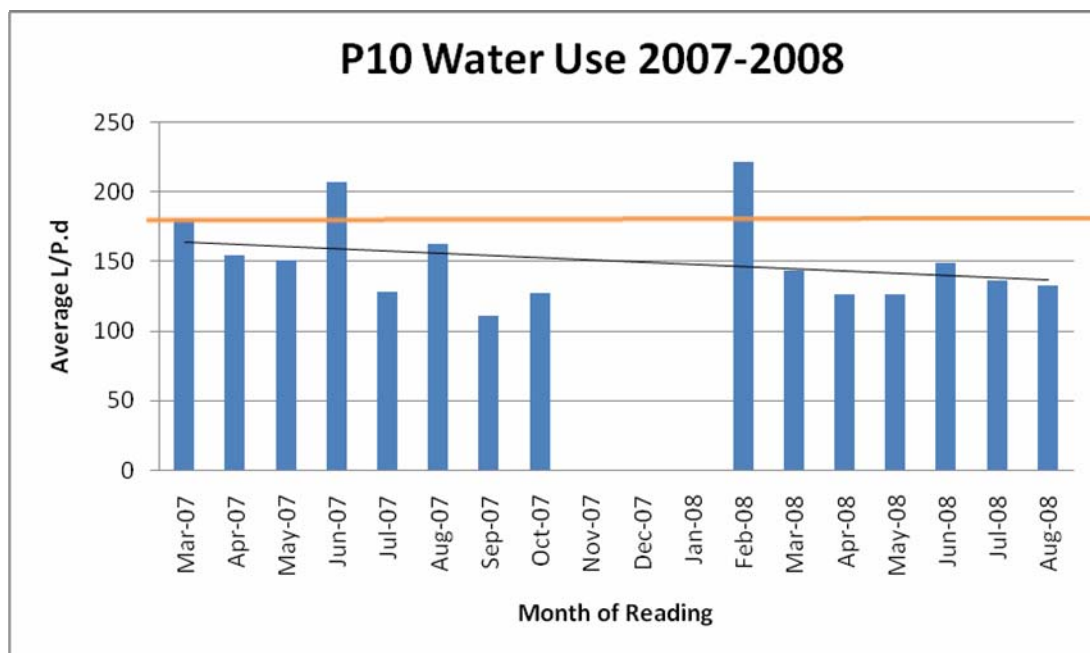
Figure 18: House 10 Water Use Data

The installation of a solar hot water system/ wetback (May 07) and the fixing of a leak found during the plumbing check (May 07) were the main retrofit measures which could be expected to impact on water use in this dwelling. Figure 18 shows the water use data for this dwelling. This shows no discernable trend for total water use. When the hot water data is considered, an increase of 21% was found between winter 2007 and winter 2008.
