NO202/4

Rotorua NOW Home® Final Performance Monitoring

**A report prepared for Beacon Pathway Limited
August 2009**

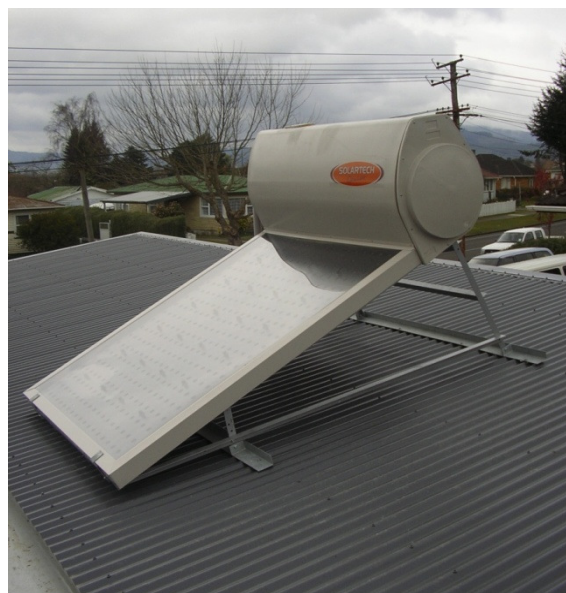
Figure 3: The flat plate thermosiphon SWH system in the Rotorua NOW Home®

The Rotorua NOW Home® included a Solar Genius low pressure thermosiphon flat plate collector SWH system. The installation is shown in Figure 3. The frame on which the SWH system sits resulted in a collector angle of 30°. This angle is shallower than the ideal angle of 38°, the same angle as latitude in Rotorua. The 30° angle was the achieved outcome because of the fixed frame provided with the system in combination with the low angle of the roof.

The storage tank and collector frame is made from one moulding of polyethylene. The 2.6m² collector covers one fully flooded cavity with no channels or pipes and is covered by an acrylic sheet. Polyurethane is used to insulate the system. The heat losses from the system (see Table 2) are higher than many other SWH systems due to the level of insulation surrounding the tank and the outside position of the cylinder being subject to colder outside temperatures compared to a cylinder that is inside the house, within the thermal envelope.

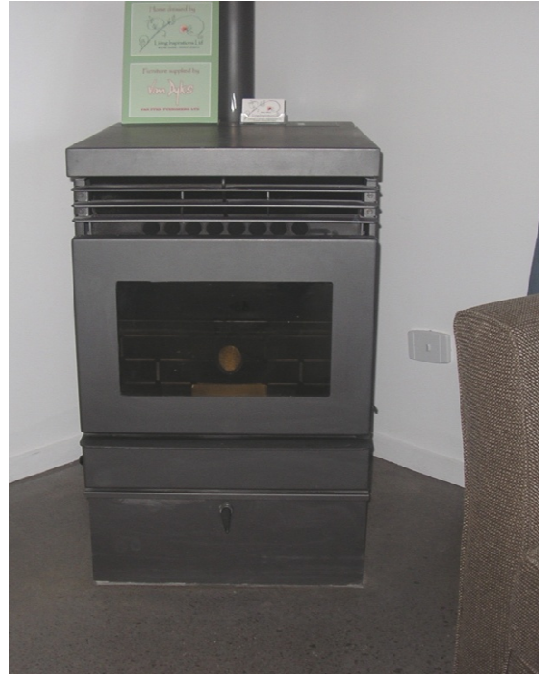
Figure 4: The Parkwood wood pellet burner

The space heating in the Rotorua NOW Home® was provided by a Parkwood 10kW wood pellet burner. This heater was located in the northwest corner of the living room as can be seen in the floor plan in Figure 8. Its position was influenced by safety (in terms of traffic flow) and practicality (in terms of seating arrangement) reasons. A photo of this pellet burner in place is shown in Figure 4.

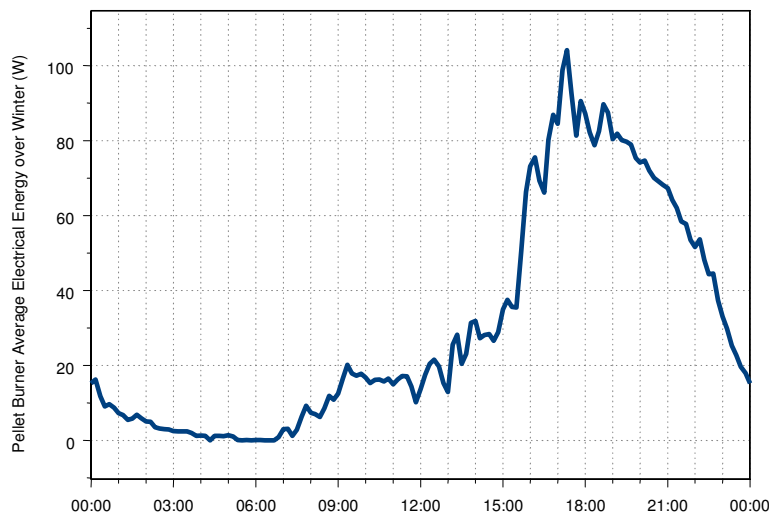
Figure 7: Average time of day use over winter for the electrical energy use of the wood pellet burner

Figure 7 gives an average time of day profile for the electrical energy use of the wood pellet burner which summarises some of the data from Figure 6. While there is occasional use during the day, the electricity demands for the wood pellet burner increase steeply between 3pm and 4pm suggesting this as an average time as to when it is turned on. The peak of the demand curve is more subtle, dropping away from about 8pm but having some usage in the early morning hours.

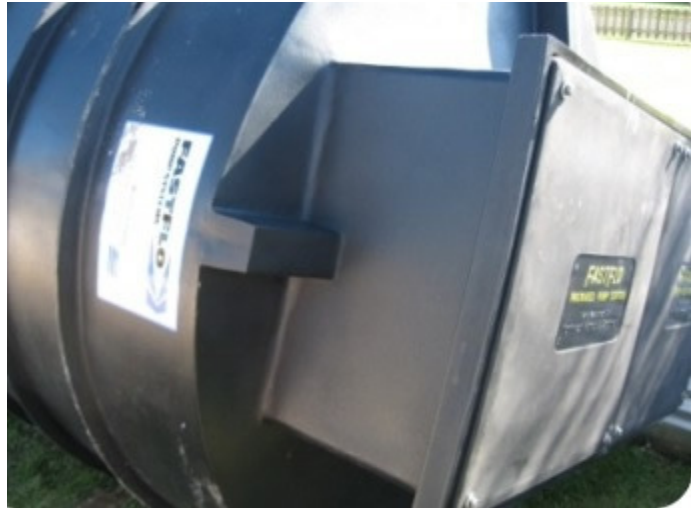
Figure 11: The Rotorua NOW Home® rainwater tank before installation (photo from Beacon Pathway website)

A major sustainability feature of the Rotorua NOW Home® was the use of a 4,000L polyethylene rainwater tank for the supply of water to the outside taps and the toilets. This tank (shown on its side in Figure 11 before installation) was buried to avoid restrictive positioning (setbacks from boundaries, closeness to water services, etc.), provide more usable space, and for aesthetic reasons. A disadvantage to burying the tank is the necessity to undertake a large amount of earthworks which requires the disposal of a large quantity of earth.

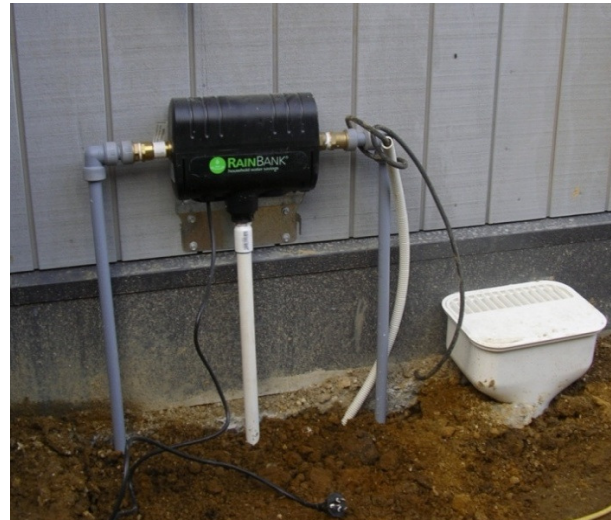
Figure 12: The Rainbank rainwater tank controller during construction

In the second year the unit developed an electrical fault that caused the residual current device connected to the laundry, the fridge freezer and the monitoring equipment in the house to be periodically turned off. As this fault had affected the monitoring system for an extended period of time during summer 2008, the Rainbank system was disabled so that data collection for winter 2008 would not be affected. This meant that the water consumption for the majority of the second year did not include any collected rainwater when the house could not access any rainwater.
