NO202/2

Rotorua NOW Home®: Interim Performance Monitoring

A report prepared for Beacon Pathway Limited

December 2007

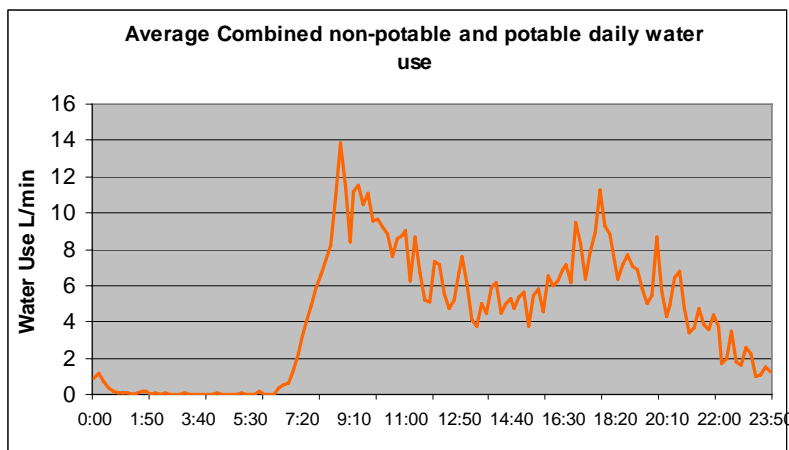
Figure 1 Average daily combined water use

The average of the total water use over the monitored period for the Rotorua NOW Home® is around 798 litres per day which is slightly higher than the 755 litres per day used in the Waitakere NOW Home®. The profiles of the Rotorua NOW Home® water consumption are shown below.

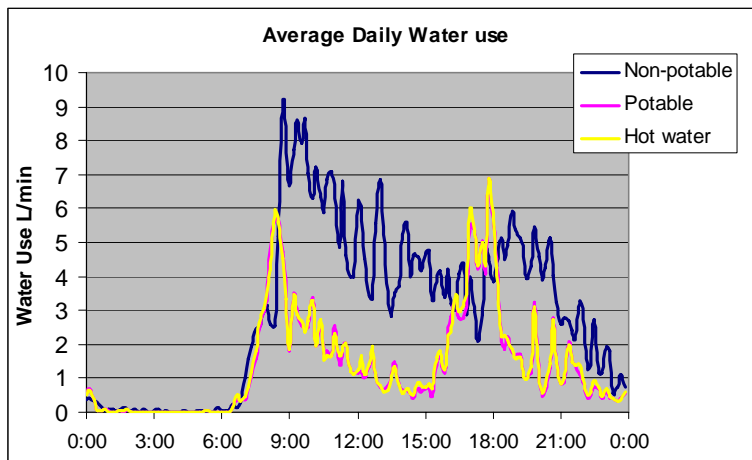
Figure 2 Average daily total water end use

The water use within a house depends greatly on the number of people within the house and water use figures have typically been expressed per person. The occupancy of the Rotorua NOW Home® has varied greatly over the monitoring period – guests have often stayed, a boarder occupied the garage for some time and several large gatherings have occurred where guests have stayed on. However, on most occasions there have been (approximately) four occupants and using this, the average potable and non-potable water use per person per day is 51 litres and 148 litres respectively resulting in a total water use of 199 litres per person per day.

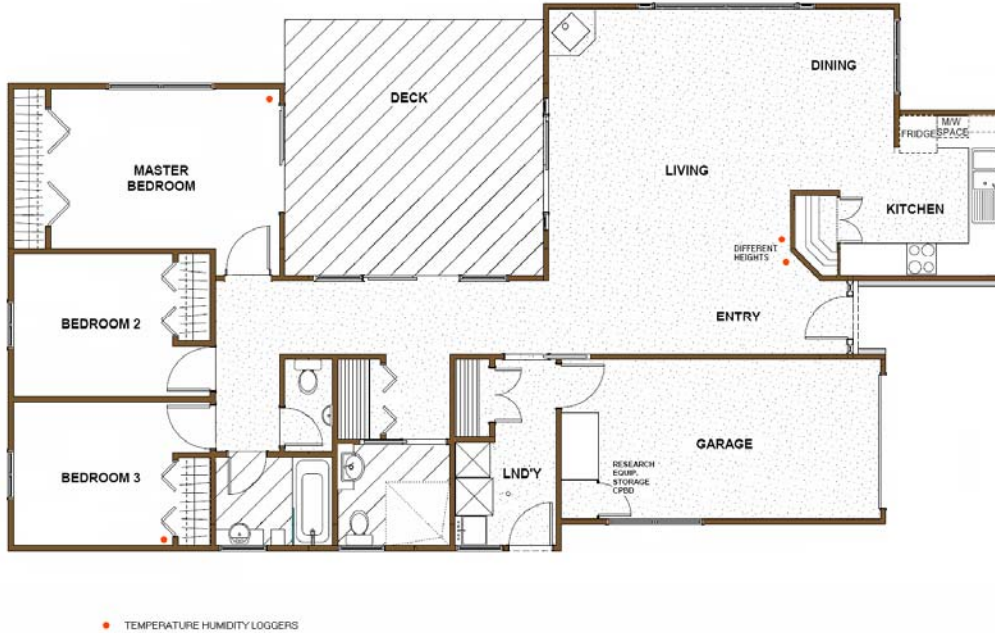
Figure 3 Floor plan of the Rotorua NOW Home® showing temperature sensor locations

Cold indoor winter temperatures have been a problem in New Zealand. To measure the Rotorua NOW Home®'s performance during this period, four temperature/humidity sensors were placed throughout the house as shown in the floor plan in Figure 3. The intention with the Rotorua NOW Home® temperature/humidity monitoring was to capture the ranges of temperature and humidity in the living zones rather than measuring each room as was undertaken for the Waitakere NOW Home®. The main living area had two temperature sensors placed at different heights to explore if there were any temperature stratification issues. Two extremes from the bedrooms were taken, one from the north side (master bedroom) with the other from the south side bedroom. Unlike the Waitakere NOW Home®, no measurements from the bathrooms were made.

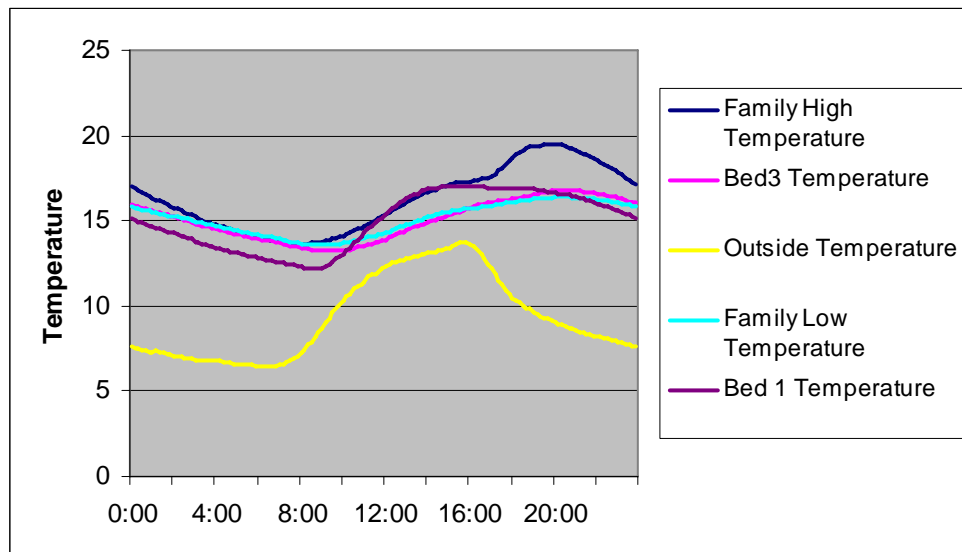
Figure 4 Average daily temperatures

The average temperatures over this period show the house to be kept at a range of 5–10°C greater than the outside ambient temperature. This results in acceptable temperatures throughout the house during the daytime period when averages are kept between 15°C and 20°C. However, this is not adequate to keep the house warm at night. The master bedroom in particular seems cold with an average temperature of about 12°C at 8.30 am.

Figure 4 shows the daily average temperatures in each of the monitored locations.

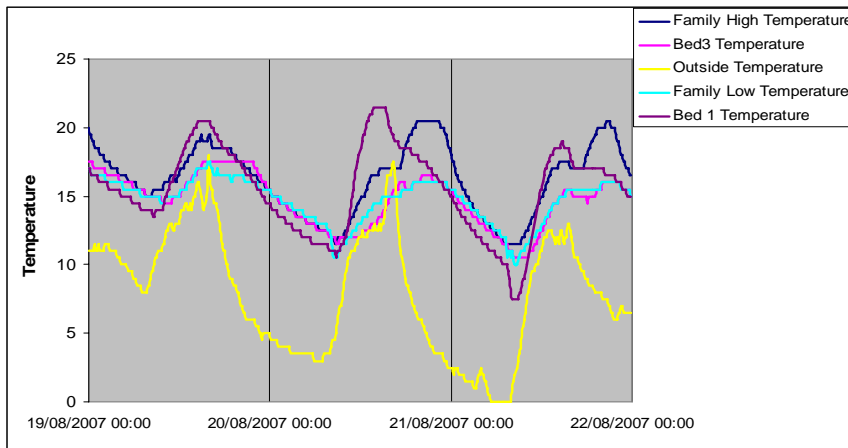
Figure 5: Temperatures from 19–21 August 2007

The picture given by analysis of the coldest three days (19–21 August 2007) is concerning with a low of 7°C reached within the master bedroom on 21 August. However, it is likely that the operation of the pellet heater improves the family room temperatures and further analysis of the pellet burner will be provided in the future.

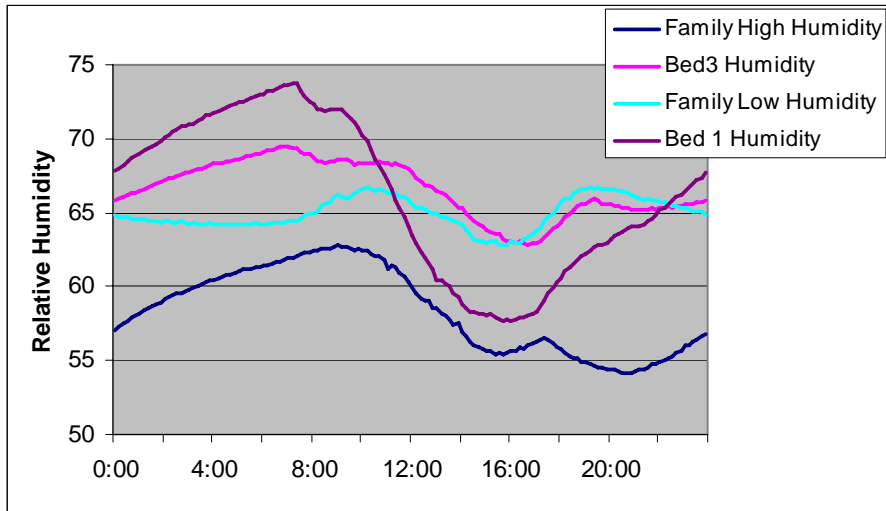
Figure 6: Average daily relative humidity

The average daily humidity level over the 7 May–8 October 2007 monitoring period is shown in Figure 6 where it can be seen that the most of the average humidities are below the 70% level. The exception is the master bedroom where the relative humidity in the early morning is above 70%.

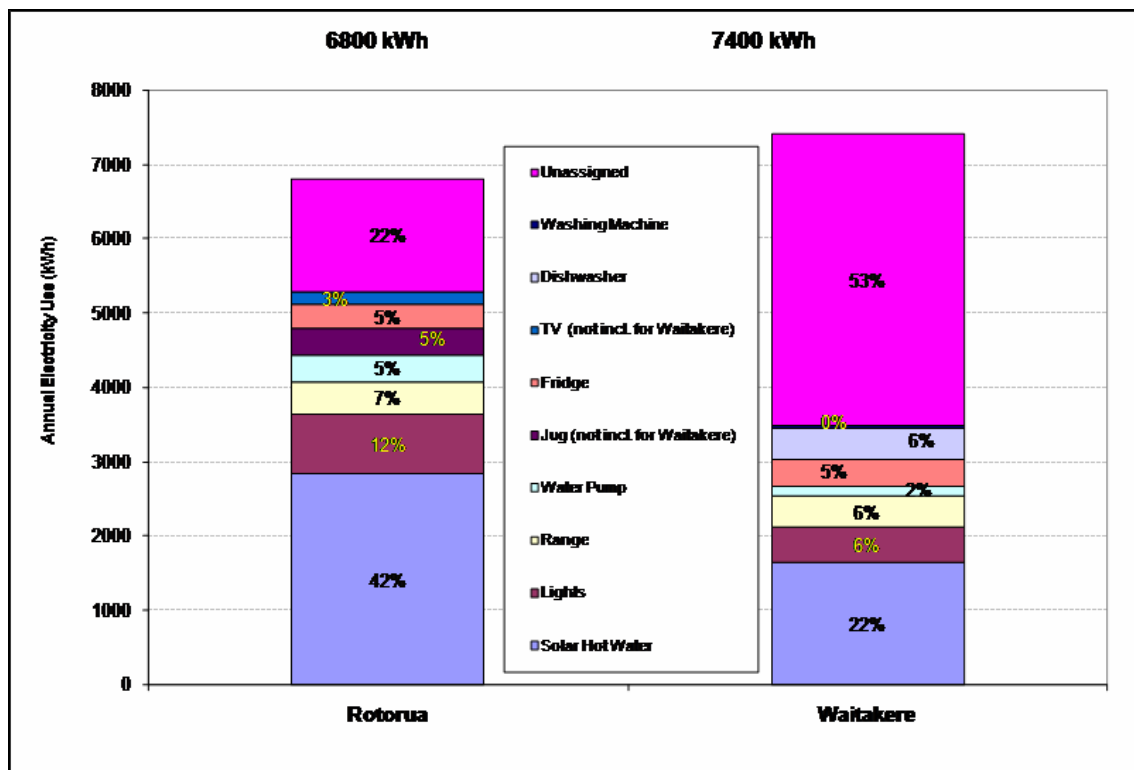
Figure 7 Electrical end use comparison between the Rotorua and Waitakere NOW Homes®

The following issues stand out when comparing the electricity usage between the Rotorua NOW Home® and the first year of the Waitakere NOW Home®:

- The **solar water heater** is using a much higher proportion of the electricity in the Rotorua NOW Home® than is the case for the Waitakere NOW Home®.

- The **water pump energy use figures** are considerable, approximately equal to that of the jug and fridge energy requirements. In straight energy terms, this is the equivalent of running a 40W bulb continuously for a whole year. When compared against the product literature figures that came with the pump, there is a large discrepancy between quoted and actual values. As a comparison, the Waitakere NOW Home®, which has a similar overall annual energy use, only used 2% on pumping water.

- The **percentage of “other” electricity end uses** is considerably reduced compared to the Waitakere NOW Home® – down from 53% to 22% of the all electricity energy end uses breakdown. This is encouraging, as it means that by far the majority of the energy end uses is being captured. Over the next monitoring period, this gap will reduce as further monitoring equipment has been installed on other appliances.

- The percentage of end use energy attributable to **lighting** (at 12%) is considerably more for the Rotorua NOW Home® than the Waitakere NOW Home® (at 6%). This difference could be due to the differing lighting arrangements or to differences in occupant behaviour.

- It is estimated that running the **pellet burner** over the “winter time” (more accurately described as the “heating season” as it is longer than just three months) makes up a sizable portion of the “other” end uses. Testing has shown that the pellet burner requires a minimum of 250W – to power the control panel, the fan and the auger. In addition, approximately twice this amount of power is required during the ignition process – however this process is relatively short lived.

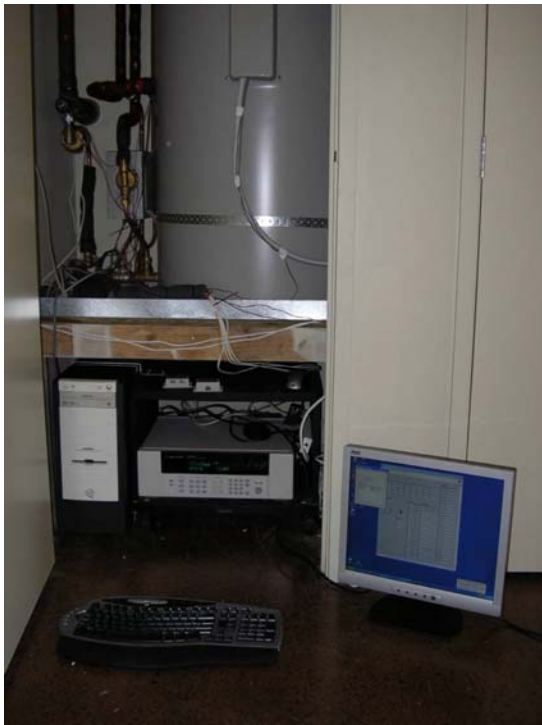
Figure 8 *The accessibility of the monitoring equipment in the Waitakere NOW Home® is difficult and working on the computer for more than one hour is difficult*

A key improvement between the Waitakere NOW Home® and the Rotorua NOW Home® has been the improved accessibility of the equipment. In the Waitakere NOW Home® the computer system and Agilent Data logger were placed under a shelf in the hot water cupboard as seen in Figure 8 which made adjustments of wiring difficult. The accessibility of the Rotorua NOW Home® computer (Figure 9) has been improved with greater space available as well as having the cupboard located in the garage which is less intrusive for the occupants of the house.

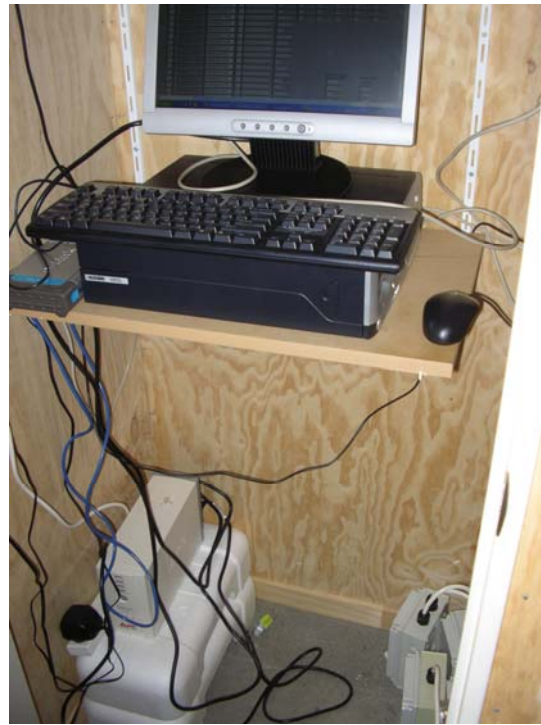
Figure 9 *The accessibility of the Rotorua NOW Home® monitoring equipment has been much improved*
