**BBS/10**

# **Spreydon 1: Build Back Smarter Case Study**

**A report prepared by Beacon Pathway Incorporated  
November 2013**

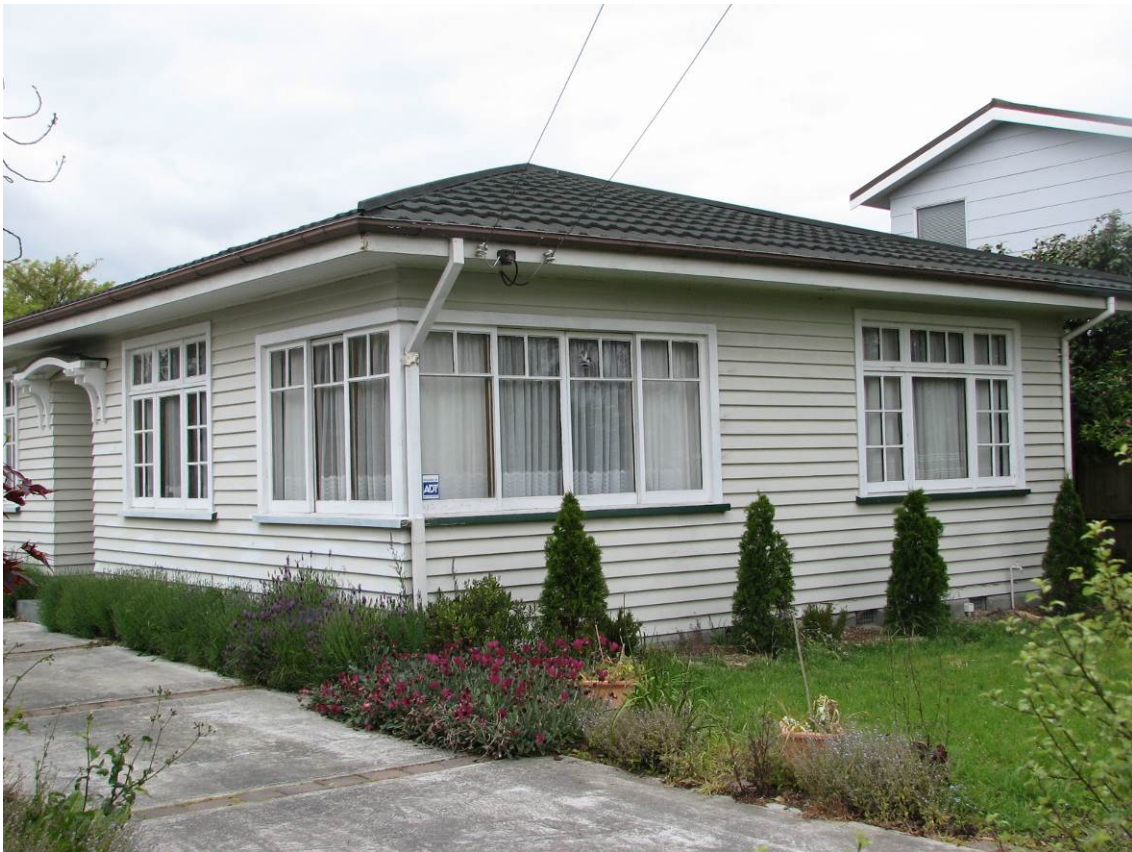
**Figure 1: Spreydon 1**

Spreydon 1 is a modest, 1930s weatherboard bungalow. The house consists of three bedrooms, a living room, dining room, kitchen, laundry and bathroom, with a separate garage. The exterior cladding of the house is timber weatherboard and it has a suspended timber floor. The internal wall linings were lath and plaster. The total dwelling area is 109m<sup>2</sup>. The roof is clad with chip coated steel tiles. Heating in the home was with an older inset woodburner combined with two heat pumps and hot water was supplied by a 1980s electric hot water cylinder combined with a wetback.
