**BBS/12**

# **Mt Pleasant 1: Build Back Smarter Case Study**

**A report prepared by Beacon Pathway Incorporated  
February 2014**

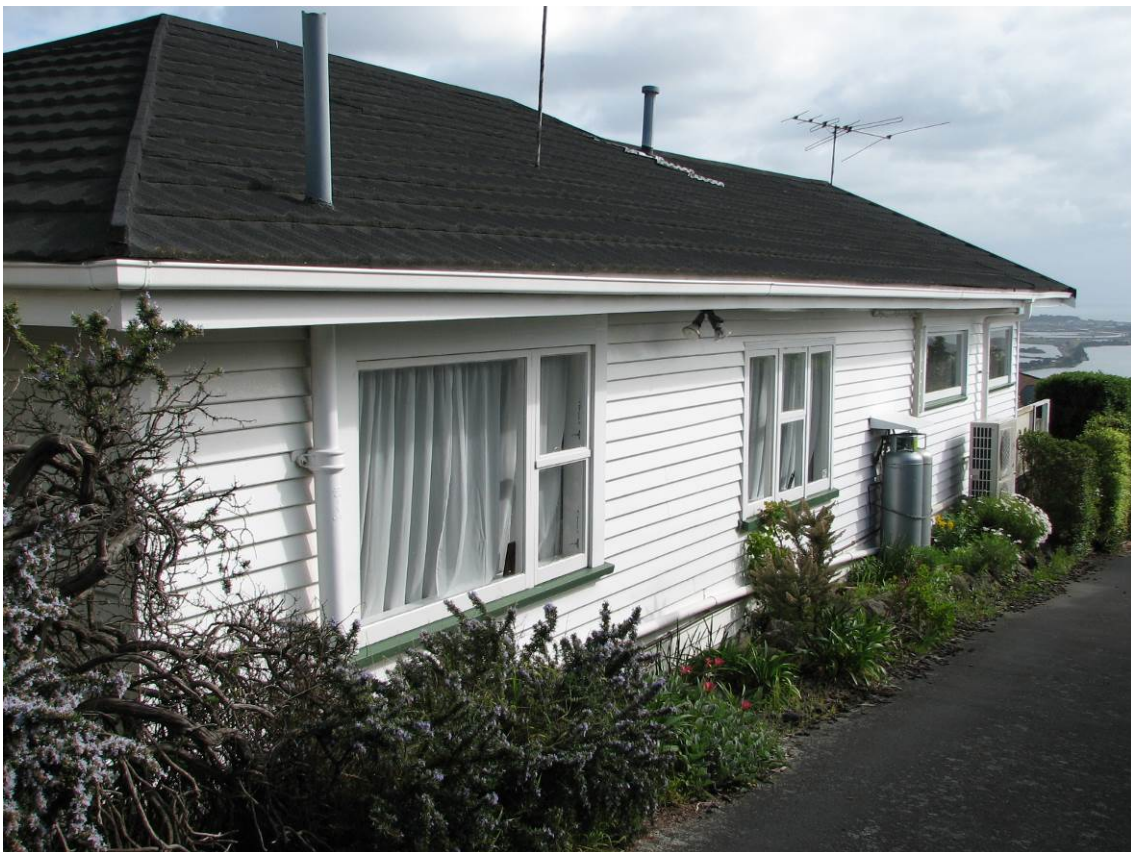
**Figure 1: Mt Pleasant 1**

Mt Pleasant 1 is a 1918 weatherboard bungalow with a large extension built in 2002. The house consists of four bedrooms, an open plan living room, dining room and kitchen, a laundry and two bathrooms, with a separate garage. Because of the extension and some wider modernisation undertaken in the house, it has downlights installed in the both the older and modern parts of the home. The house is served by a small 1996 electric hot water cylinder serving the ensuite and laundry and an instant gas hot water system for the main bathroom and kitchen.
