BBS/13

Redcliffs 1: Build Back Smarter Case Study

**A report prepared by Beacon Pathway Incorporated
March 2014**

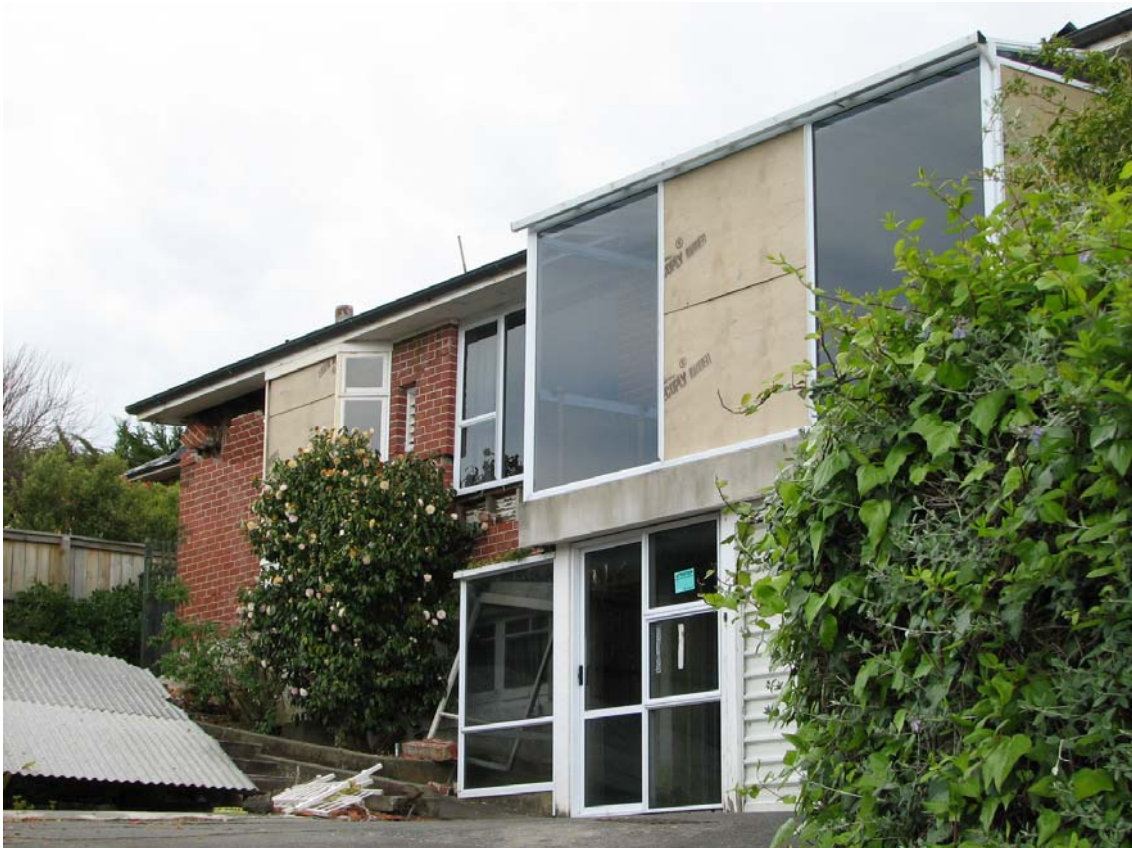
Figure 1: Redcliffs 1

Redcliffs 1 is a 1950s brick and tile home with a basement underneath. The house consists of four bedrooms, a living room, sun room, conservatory, kitchen and bathroom upstairs with a laundry and garage downstairs. The house has had some modernisation, with downlights installed in the bathroom, insulation installed in parts of the house and a relatively new electric hot water cylinder. A sunporch, conservatory and the dug out basement have all been added after the original construction of the home. The external cladding of the house is variable –
