BBS/6

Huntsbury 2: Build Back Smarter case study

**A report prepared for Beacon Pathway Incorporated
January 2013**

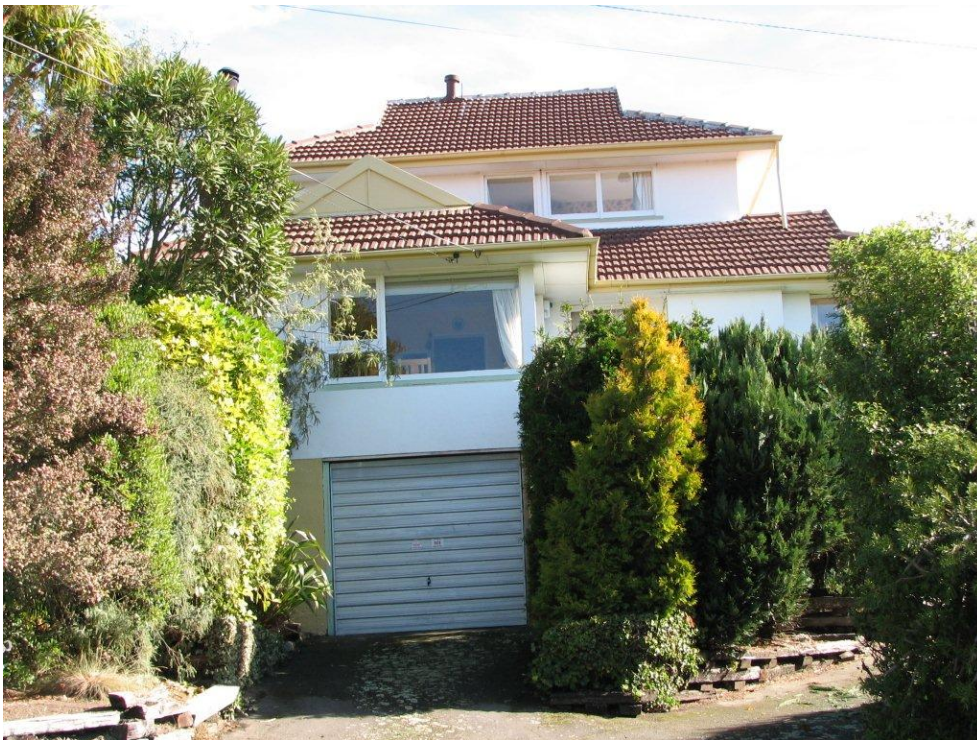
Figure 1: View of Huntsbury 2

Huntsbury 2 is a large 1960s brick and stucco house with a first floor extension built in the 1970s and a basement garage. The house downstairs area consists of two bedrooms, a living room, dining room, kitchen, laundry and bathroom, with the basement garage below the dining room. The first floor extension has two bedrooms and is accessed from downstairs through a large foyer. The exterior cladding of the house was originally stucco over block, with sheet cladding material upstairs. The total dwelling areas is 119m² with 63m² upstairs. Both the lower and upper floors have suspended timber floors. The roof is clad with clay tiles. Heating in the home was with an inset woodburner, and hot water is supplied by a 1950s electric hot water cylinder.
