**BBS/9**

# **Halswell 1: Build Back Smarter Case Study**

**A report prepared by Beacon Pathway Incorporated  
August 2013**

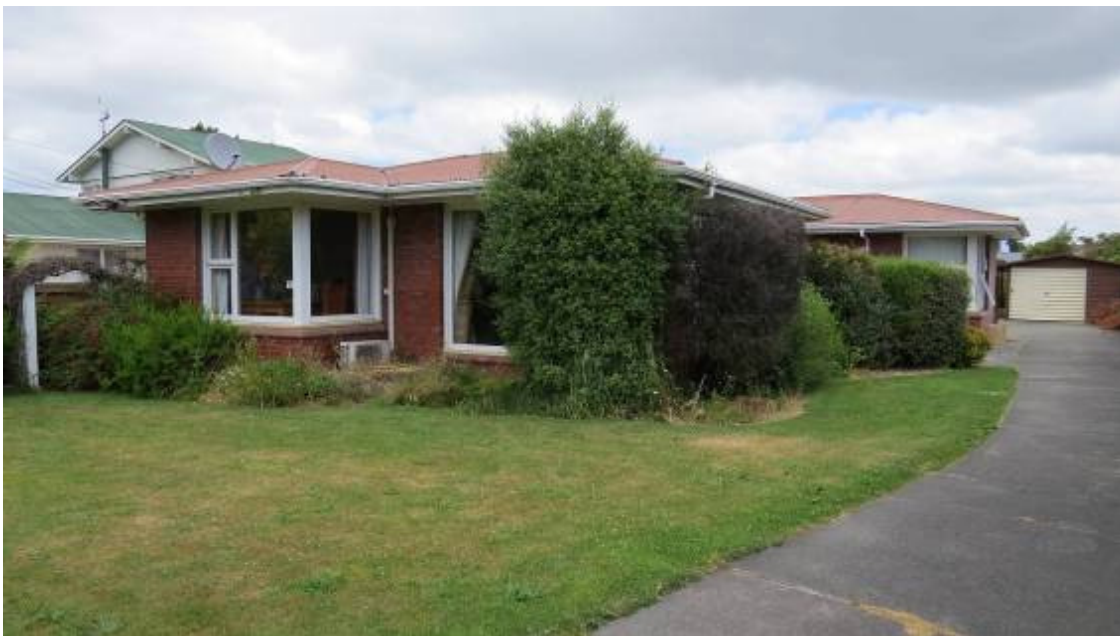
**Figure 1: Halswell 1**

Halswell 1 is a modest, late 1960s, brick clad house. The house consists of three bedrooms, a living room, dining room, kitchen, laundry and bathroom, with a separate garage. The exterior cladding of the house is brick and it has a suspended timber floor. The total dwelling area is 130m<sup>2</sup>. The roof is clad with corrugated iron. Heating in the home was with two heat pumps and hot water is supplied by a brand new electric hot water cylinder installed as part of emergency earthquake repairs when the old one was damaged.
