EN6570/9

New Zealand House Typologies to Inform Energy Retrofits

**A report prepared for Beacon Pathway Limited
November 2008**

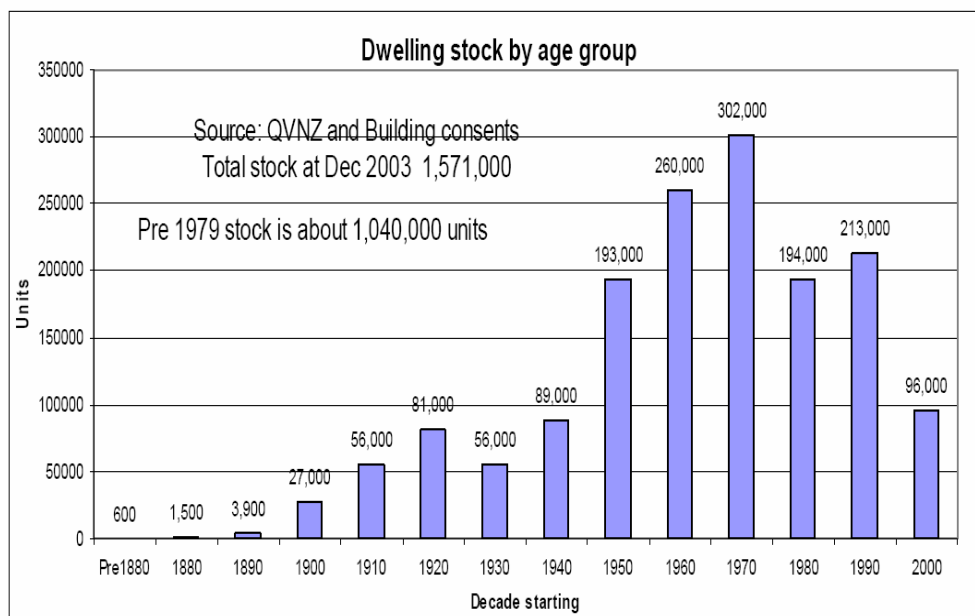
Figure 1: New Zealand’s dwelling stock by decade age group (Storey et al., 2004 as quoted in Amitrano et al., 2006)

Figure 1 indicates the numbers of houses by age group in New Zealand. Whilst this data does not align itself neatly alongside a set of different typologies based on physical characteristics of housing (e.g. bungalow vs state house), it does provide some understanding about where Beacon’s focus needs to be. In some cases, as with the early housing, it can assist Beacon in determining prevalence of certain modal housing types.

The limited number of houses of this type (40–60,000) as indicated in Figure 1 and the essential nature of the heritage characteristics suggest that this category of housing is not a priority for Beacon.

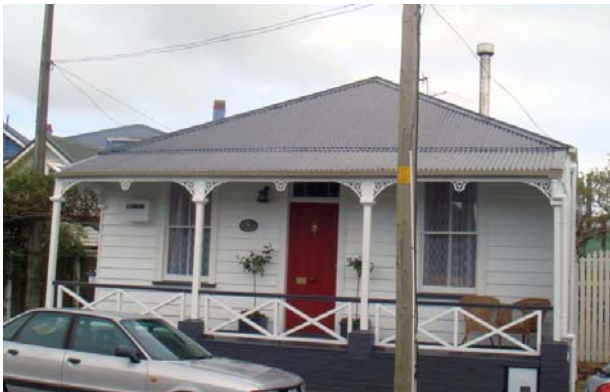
4.1 Early housing (pre-1890)

This category describes the simple early housing that was built in New Zealand before the end of the 19th century. The majority of these houses were timber framed, clad in plain or shiplapped weatherboards, with metal roofs. There are some examples of brick and stone being used. The main house form is based on a rectangular plan with a gabled roof and most are single storied. Most had an

open veranda facing the street and a fireplace. More prosperous houses of the period also utilised the roof space. These upper floor rooms are fitted into the attic space of the roof with low walls and sloping ceilings. Houses from this era were built with no insulation. The age of these houses means that those that remain have often undergone a significant number of renovations and alterations including reorientation of rooms, conversion to open plan living, new kitchens and extensions and insulation added in the attic space. From the single rectangle the most basic additions are lean-to roofs to the rear, or additional gabled rooms added behind or as return wings.

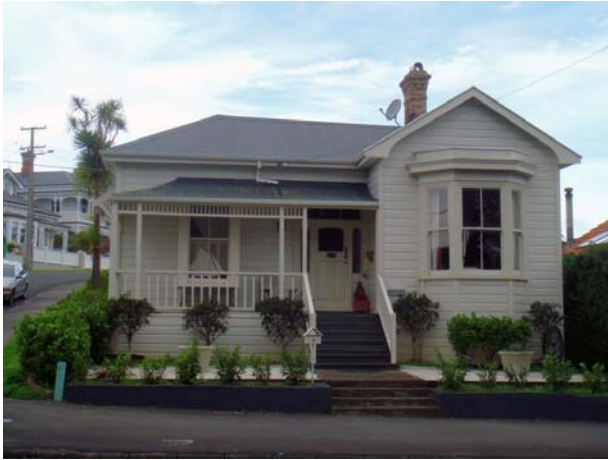
4.2 Villa (1880–1920)

Relatively speaking, villas show little variation within their category compared to other housing typologies. They are typically constructed in native timbers, square in plan with a gabled corrugated iron roof. Notable variants are twin brick and masonry villas with a few cob structures still in existence. Interior walls are typically sarked unless renovated and floors are usually of the suspended native timber tongue and groove variety. These

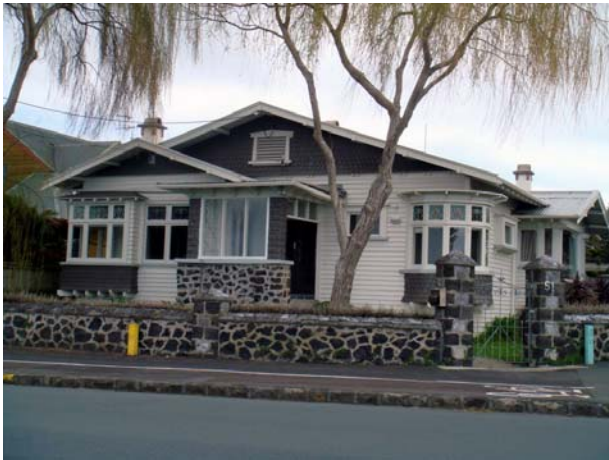
4.3 Bungalow (1920–1930/40)

The typical New Zealand bungalow is a relatively simple plan, single storey, gabled home built primarily from native timber and with a corrugated steel roof. A subvariant which may require further research is the English Cottage Style which has 1½ storeys typically and with a large garage or basement underneath. Floors are generally suspended native timber lifted off the ground by more than

500 mm. Wall construction is usually wooden weatherboard with no insulation and no building paper. Some renovations in the 60s and 70s saw the application of brick veneer cladding although solid brick bungalows are rare. The stud height is typically lower than that of villas, commonly being around 2.8 m. Glazing is single in the majority of cases and enclosed in timber joinery except where these have been replaced by single glazed aluminium as part of renovation. Insulation, which was not a requirement at the time of construction, is typically poor throughout although some may have been retrofitted with paper cellulose or older batts in the roof. Almost all bungalows have chimneys unless these have been sealed, with open fireplaces typically in living rooms and sometimes kitchens. Unflued wall heaters are common in areas with reticulated gas. Older style, smaller hot water cylinders are likely to be present in a significant number of these houses presenting an opportunity for retrofit with more efficient cylinders linked to solar or heat pump hot water heating. Bungalows are often oriented to the street rather than the sun. There are pockets of bungalows in neighbourhoods as many of these were built as developer subdivisions.

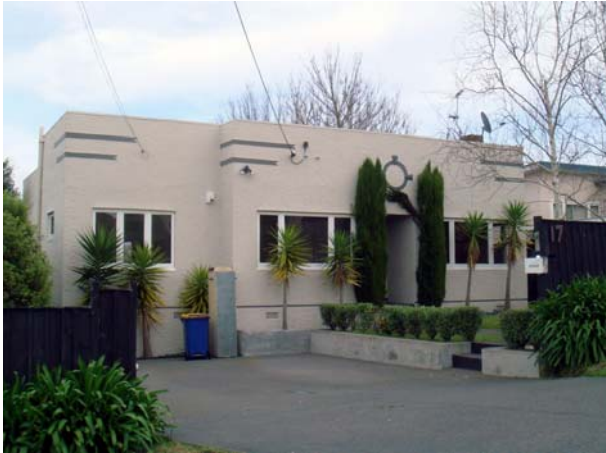
4.4 Art Deco (1925–1935)

Art deco houses are similar in size and layout to the bungalow though they are constructed using quite different materials and techniques. Typical house size is less than 110 m² and most face the street. The majority are constructed with wooden frames although some are built in brick. Claddings are typically stucco (estimated to be 70%) with a smaller proportion brick (estimated to be 15%) and the remaining

in timber (estimated to be 10%) and fibrolite (estimated to be <5%).³ The roof is a key feature of the art deco style, typically featuring a parapet with a flat roof behind. Materials used include steel, mathoid and tile. Failures of the roofing system mean that a significant number of these houses have a new roof installed over the old one. Inside the house the ceilings are often a feature and exhibit ornate plaster work. Heating in the majority of cases will be supplied by plug in electric with few having open fires and wood burners. In terms of regionality many of these houses are located in the Hawkes Bay and in neighbourhoods carved out in the 1930s.

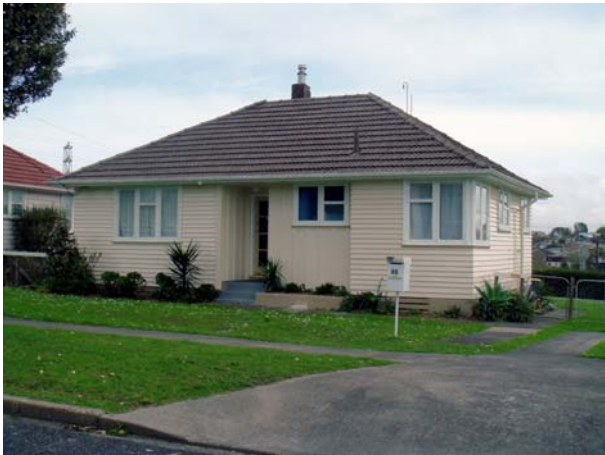
4.5 State house and mass housing (1930–1970)

The New Zealand state house is typically small (less than 100 m²) and has a simple square plan. Many state houses show an orientation to the north with living spaces designed to capture the sun as opposed to the early colonial housing which typically faces the street. Roofs are usually hipped and typically have a reasonable pitch (30–40°). Manufactured concrete block starts to appear more commonly as a

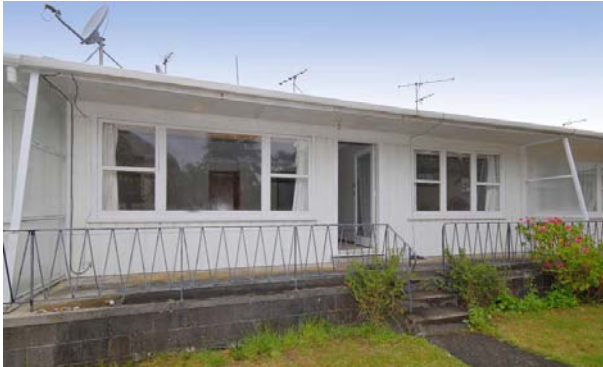
4.6 1960s and 1970s Multi Unit Housing

1960s multi unit housing has a typical rectangular house form. Almost all are constructed as light frame concrete block wall on concrete slab, with some brick units evident in some areas. Most are in original condition and rarely have additions or extensive renovations been made. Walls are almost exclusively

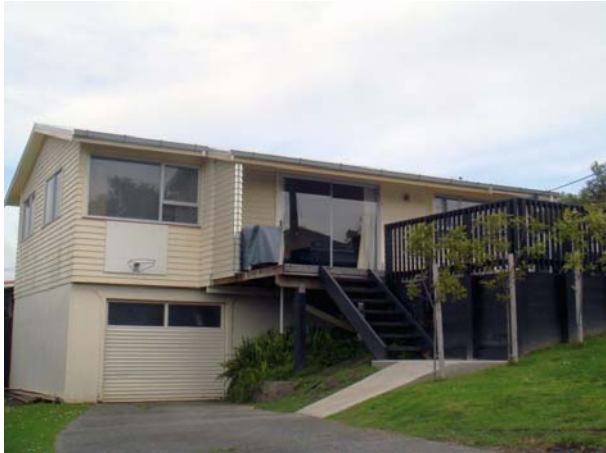
4.7 70s House (1970–1978 pre-insulation)

From the 1970s onwards significant variation in both the design and materials used across the housing stock starts to appear. In the period of 1970 through to the introduction of basic insulation standards in 1978, houses in New Zealand were predominantly of timber and chipboard construction with a growing number of examples of concrete construction. Split levels start to appear to

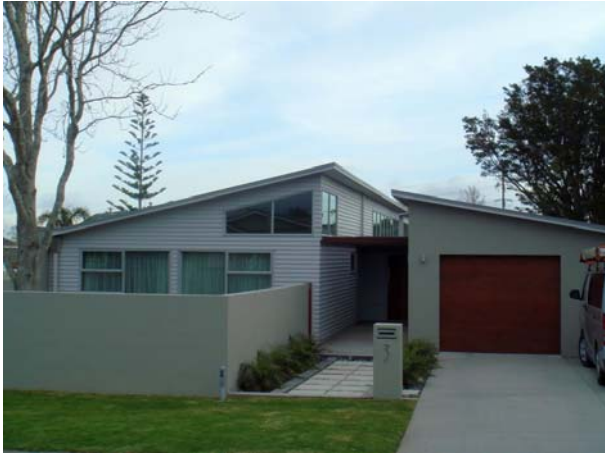
4.9 Early 90s (1990–1996, pre-revamped Building Code)

Variation between houses becomes more widespread in this era of construction leading to the possibility of several subtypologies. This may require additional research to develop an understanding of the level of relevant detail and how that might affect the application of retrofit interventions. However, as with other varied typologies, some generalisations can be drawn.

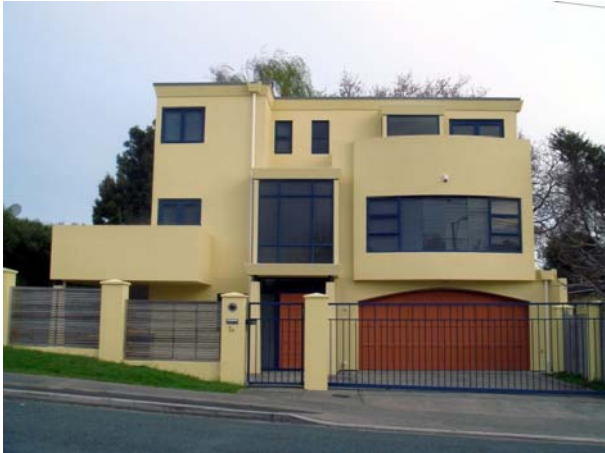
4.10 Last decade (1996–2007, post-insulation upgrade)

Houses built in the last decade were, in the majority of cases, built as part of large subdivisions and developments. Most could be said to be airtight and well insulated — but a significant number are also prone to leaky building syndrome. Orientation of these houses is typically toward the street — in most cases, to provide vehicle access to large garages that are common throughout. This era sees

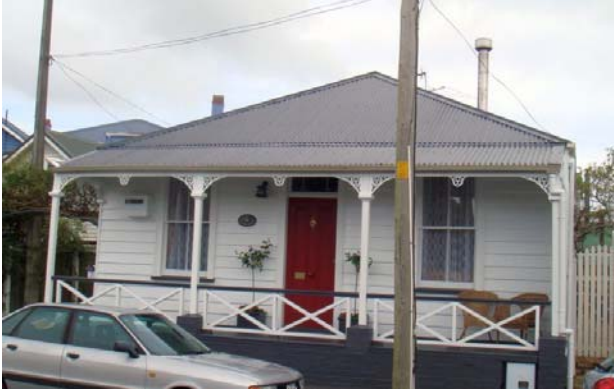
<p>House Type Simple Early Housing</p>

<p>Basic description</p> <ul style="list-style-type: none"> • Principal material — wood (hard timbers) • Large number of modifications homes (e.g. additions, change in lay-out, reorientation of rooms, e.g. moving lounge and bedrooms, open plan living) • Often orientated to road etc., rather than sun 		
<p>Era/age Late 19th century</p>	<p>Main construction type/materials</p> <ul style="list-style-type: none"> • Timber frame • Suspended floors — replaced with concrete piles • Roof cavity usually good, but little or none in the lean-tos) 		
<p>House Form</p> <ul style="list-style-type: none"> • Originally square • Some have attics • Verandahs <p>(Most common example — square box with verandah in front and lean-to at the back)</p>	<p>Estimated percentage Number of storeys</p>		
<p>Location</p> <ul style="list-style-type: none"> • Mostly rural and small towns 	<p>1 storey most houses</p>	<p>2 storey — some houses</p>	<p>3 storey</p>

<p>Main system features</p>		<p>Significant variations (if significant then add to possible subtypes below)</p>	
<p>Floors</p> <ul style="list-style-type: none"> • Timber floor <ul style="list-style-type: none"> ➢ low to the ground ➢ good quality hard wood (often exposed) • Sloping sections (!), majority on flat (?) • Underfloor access can be difficult depending on section 			
<p>Walls</p> <ul style="list-style-type: none"> • Timber frame <ul style="list-style-type: none"> ➢ sarking, serim still present ➢ plasterboard retrofit (?) ➢ more upright framing ➢ a lot of modifications ➢ different distances between joists • External cladding <ul style="list-style-type: none"> ➢ wood ➢ sometimes extensive patching 			
<p>Ceilings</p> <ul style="list-style-type: none"> • Plaster/sarking/some ornate

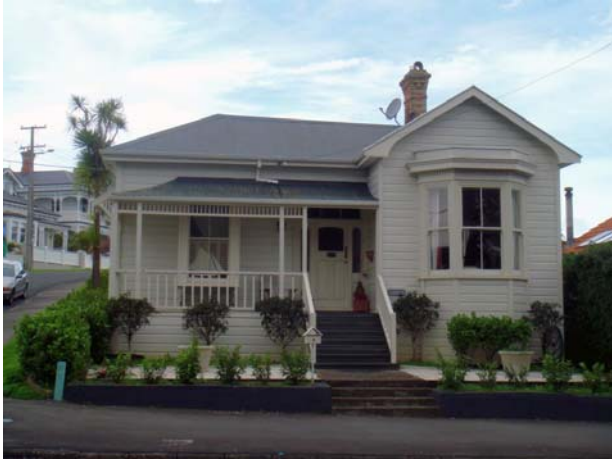
House Type Villa

Basic description		
	House Form Square and simple		
	Main construction type/materials Iron and native timber some thermal mass in chimneys		
	Estimated percentage Number of storeys		
Era/age 1900–1920	1 storey most	2 storey some	3 storey
Main system features Solid structure, highly adaptable, serious architectural features		Significant variations (if significant then add to possible subtypes below)	
Floors 6 inch or wider floorboard			
Walls Sarked unless renovated; hallway lined		Some high thermal mass, twin brick, cob, pebble	
Ceilings 12 ft stud		Coved ceilings difficult to insulate	
Glazing Wooden joinery, single glazed, sash = complicated Multipane = non-retrofittable			
Roof Iron; large cavity; high pitch; inbuilt			
Insulation Roof and renovated walls? No building paper			
Heating system Complete gamet; unlikely to be only electric; solid fuel common; heat transfer			
Other (e.g. garage under house common)		2 storey often converted into multiple flats

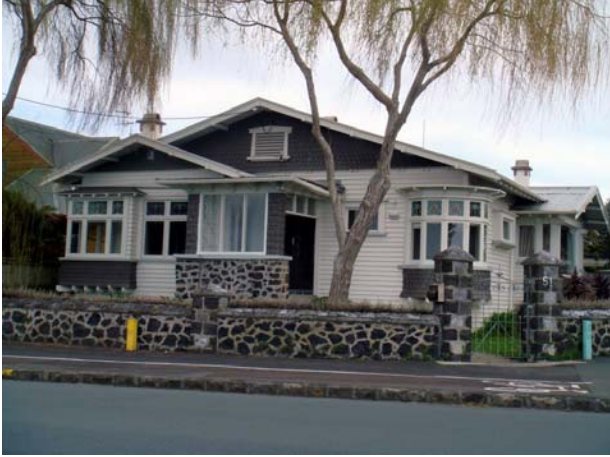
<p>House Type Bungalow</p>

<p>Basic description Single story gabled home. There is a subvariant, the English Cottage Style, which are all 1½ stories with generally a garage/basement underneath</p>		
	<p>House Form</p>		
	<p>Main construction type/materials Wooden weatherboard (rimu), wooden floors (rimu or matai), corrugated steel roof</p>		
	<p>Estimated percentage Number of storeys</p>		
<p>Era/age 1915–1930</p>	<p>1 storey 99% bungalows</p>	<p>1½ storey 99% of English Cottage style</p>	<p>3 storey</p>
<p>Main system features</p>		<p>Significant variations (if significant then add to possible sub types below)</p>	
<p>Floors Always have a suspended timber floor. Mainly greater than 600 mm and often very high underneath (for Dad’s shed)</p>			
<p>Walls Wooden weatherboard, no insulation, no building paper. Some now clad in brick veneer as a result of 60s and 70s renovations; brick bungalows are rare, as some with stucco over chicken wire and fibro cement</p>

<p>Ceilings Stud height around 2.8, originally cast plaster ceilings with pseudo beams. Cavity ceilings and roofs framed with 100 x 50 rafters</p>			
<p>Glazing Wooden joinery with casement windows and fanlights above, in the 60s and 70s these were often replaced with aluminium windows single glazed</p>			
<p>Roof Pitched roof 24–27° (can be down to 18°), mostly steel, some tiled and some asbestos sheet in tile form or corrugated form</p>			
<p>Insulation Paper mache in ceiling or early batts common, walls uninsulated, underfloor insulation uncommon</p>			
<p>Heating system All have chimneys (mostly in living room, sometimes in kitchen also), wall</p>

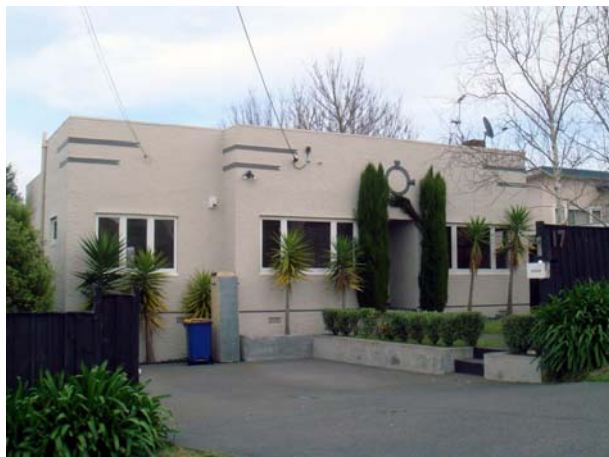
House Type Art Deco

Basic description Similar size and layout to a bungalow 3–4 bed, have curves!		
	House Form <110m ² curved, face the road		
	Main construction type/materials Wooden frame majority (minor brick) Stucco 70%, brick 15%, timber 10%, fibrolyte (<5%)		
	Estimated percentage Number of storeys		
Era/age 1931–1939 Traditionally seen as a Spanish style (curved front) 1931–39, 1934–40 depression, war	1 storey 90	2 storey 10	3 storey
Main system features Whole house poorly orientated. Poor internal layout		Significant variations (if significant then add to possible sub types below)	
Floors Suspended timber strip (high value wood matai), concrete piles			
Walls Wooden frame (majority), rest brick. Stucco 70%; timber 10% /panels fibrolight 5% /brick 15%. Difficult to access for insulation			
Ceilings Ornate plaster. High stud 8–9 ft			
Glazing No eaves, <20% of wall area, leadlight features. Pelmets fashionable (70–80%)

Roof key feature Parapet with x-flat roof behind (80%) <ul style="list-style-type: none"> - steel - mathoid - tile Failures mean some have a new roof built over existing — difficult/impossible to insulate because of air gap Hipped roof (20%)		Christchurch reroofed over fouled mathoid (with ventilation gap so insulation useless)	
Insulation 40% no ceiling insulation; <5% floors; <2% walls		Ceilings — ornate plaster; people want to keep	
Heating system Plug in electric — 68% Open fire — 15% Wood burner — 10% Heat pumps — 7%			
Other (e.g. garage under house common) Garages if home built on hills

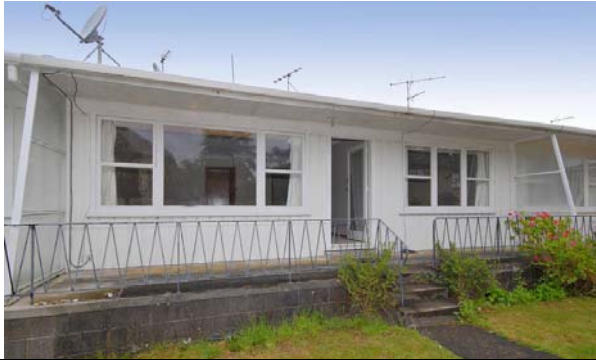
<p>House Type 1960s multi unit</p>

<p>Basic description</p>		
	<p>House Form Rectangular, no additions</p>		
	<p>Main construction type/materials Concrete block, concrete slab; timber frame joinery; rimu floorboards 4–6 inch; iron roof</p>		
	<p>Estimated percentage Number of storeys</p>		
<p>Era/age 1960s</p>	<p>1 storey All 100%</p>	<p>2 storey</p>	<p>3 storey</p>
<p>Main system features Non-renovatable/adaptable</p>		<p>Significant variations (if significant then add to possible subtypes below)</p>	
<p>Floors Low underfloor height if timber Concrete slab common</p>			
<p>Walls Block (8 inch) between units; light frame concrete block wall</p>		<p>Some firewalls go into ceiling cavity — some stop at 8 ft</p>	
<p>Ceilings Textured ceilings (asbestos) or pinex tiles</p>			
<p>Glazing Wood; single glazing; modulised</p>			
<p>Roof Corrogated iron/corrogated F Cement/asbestos low cavity space if any</p>

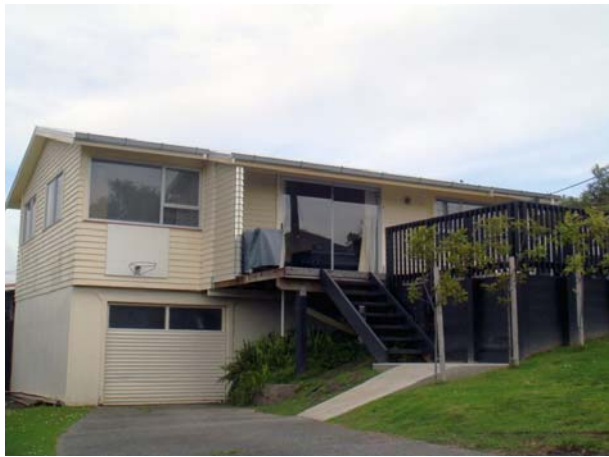
House Type 1970s house

Basic description		
	House Form		
	Main construction type/materials		
	Estimated percentage Number of storeys		
Era/age 70s House (1970–1978, pre-insulation)	1 storey 95%	2 storey 5%	3 storey
Main system features		Significant variations (if significant then add to possible subtypes below)	
Floors Predominantly timber/chipboard — some concrete			
Walls Light timber frame, foil backed Gib, concrete block		Foil backed Gib a problem	
Ceilings Skillion roofs have sarked ceilings			
Glazing First aluminium, some glazing floor to ceiling, sliding doors			
Roof Predominantly pitched, some skillion			
Insulation Little insulation		May find some limited retrofit attempts	
Heating system Fires, the first log burners appear, night store heaters, panel heaters			
Other (e.g. garage under house common)			
Can we say anything in relation to climate and/or region? Regionally and budget dependent — brick weatherboard and fibro cement

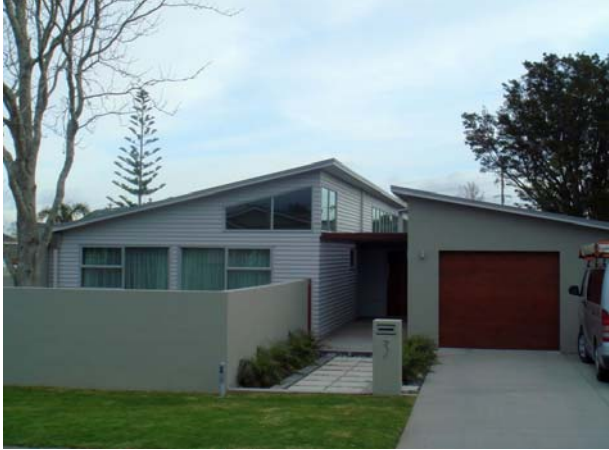
<p>House Type 1990s house — 1990–1996, pre-insulation changes to Code</p>

<p>Basic description</p>		
	<p>House Form Incredibly variable</p>		
	<p>Main construction type/materials Predominantly timber frame [untreated timber] Usually concrete slab on flat land, sometimes particle board floor on hills, predominantly metal roofs, some concrete tiles and sheet shingles (asphalt) and butyl rubber on flat roofs and bituminous torch on membranes on flat roofs</p>		
	<p>Estimated percentage Number of storeys</p>		
<p>Era/age 1990–1996</p>	1 storey	2 storey	3 storey
<p>Main system features</p>		<p>Significant variations (if significant then add to possible subtypes below)</p>	
<p>Floors Mostly concrete slab on flat land (uninsulated), sometimes suspended particle board on hillsides, suspended floors have foil draped underneath</p>			
<p>Walls Three main types: brick veneer, fake weatherboard (e.g. lineboards) and monolithic cladding (Insulclad® and polystyrene plaster system direct fixed to studs common, these are leaky buildings)</p>

<p>Ceilings Small ceiling cavity, tiled ceilings common in BOP</p>			
<p>Glazing Often 40% glazing in living areas, single glazed in aluminium windows, no louvres or overlights, minimal eaves</p>			
<p>Roof Generally low pitch and low ceiling stud (2.4 m) or trussed ceilings with small roof spaces</p>		<p>Whole subdivisions in Auckland and BOP of brick veneer and tiled homes</p>	
<p>Insulation To Code — sometimes a foil lined Gib product was used in walls — which is already failing; where suspended floors have foil draped underneath which is often failing</p>			
<p>Heating system Generally in northern parts of the country no in built heating systems.</p>			
<p>Other (e.g. garage under house common) Often multi level. Generally have electric hot water cylinders, but in</p>

Auckland can have instant gas or gas storage	
Can we say anything in relation to climate and/or region?	
Can we say anything in relation to ease of retrofit to Beacon HSS™?	
Energy — hard to retrofit insulation into ceiling due to lack of space, concrete slab floors relatively hard to retrofit, often a hazard of rot encountered during retrofits — these are often leaky buildings; orientation for the sun was not a consideration for these homes, therefore are often poorly oriented and cold	
Water	
Waste	
IEQ — generally have ventilation fans, these are often broken now	
Materials	
Potential subtypes based on variations	Significant? Estimated % of stock

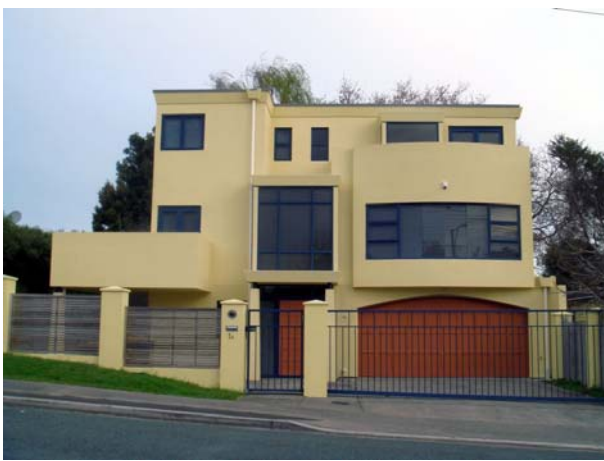
House Type Last decade housing

Basic description Large and leaky; subdivisions; airtight; well insulated; orientation toward street; onset of multiunit residential		
	House Form Complete roof; multiple cladding		
	Main construction type/materials Timber framing; poly/mono claddings — flat sheet; cavity construction; aluminium joinery		
	Estimated percentage Number of storeys		
Era/age 1996–2007 (post-1996 insulation upgrade)	1 storey 40%	2 storey 50%	3 storey 10%
Main system features		Significant variations (if significant then add to possible subtypes below)	
Floors Concrete mostly; midfloor timber; particle board			
Walls Timber frame; steel frame; small number concrete; some lightweight timber frame			
Ceilings Ceilings with holes (downlights); only 90% insulated due to penetrations/timber			
Glazing Aluminium, double glazing in south; not thermally broken; no longer have pelmets			
Roof Truss; metal claddings; some flat

Insulation Well insulated — though lots of penetrations; uninsulated slab; downlights means not so effective insulation; no insulation in garage but mostly lined			
Heating system Many types; lpg; some underfloor; minimal pellet burners; heat pumps; A grade water cylinders		A grade water cylinders	
Other (e.g. garage under house common) Garage facing street and attached			
Can we say anything in relation to climate and/or region? Designs not site-specific			
Can we say anything in relation to ease of retrofit to Beacon HSS™? Big potential to reveal leaky homes issues when retrofitting		So many variants that it is difficult to know what you are dealing with	
Energy Size of houses requires large appliances needed			
Water

1990s big leakers — retrofit may reveal bigger issues — nightmare
 More research on healthy houses? (for modern houses)
 Over heating in summer
 Assume well insulated
 Air tight/poorly ventilated
 Formaldehyde
 Complex software generating roof structure
 Double garage and standard (integral)
 Enclosed decks (over living)
 Covenants in subdivision — large subdivision — gated communities
 No eaves/parapets/integral gutter/internal of fascia gutter
 Concrete landscape
 Light steel frame (6%)
 Sealed not ventilated
 Non thermal break aluminium joinery
 \$\$ on visible parts of house
 Garage faces street
 Large openings
 Monolithic cladding/kiln dried untreated timber frame
 Large number of downlights
 High pressure hot water
 Lots of appliances
 Underfloor heating/concrete floor
 Top soil removed from site
 Two lounge rooms
 Level entry — high ground level
 Uninsulated garage/lined
 Plethora of materials/junctions/complexity
