TE106/13

Interim Performance Monitoring from Papakowhai Renovation Project

Report to Inform the Home*Smart* Renovations Project

A report prepared for Beacon Pathway Limited
June 2008

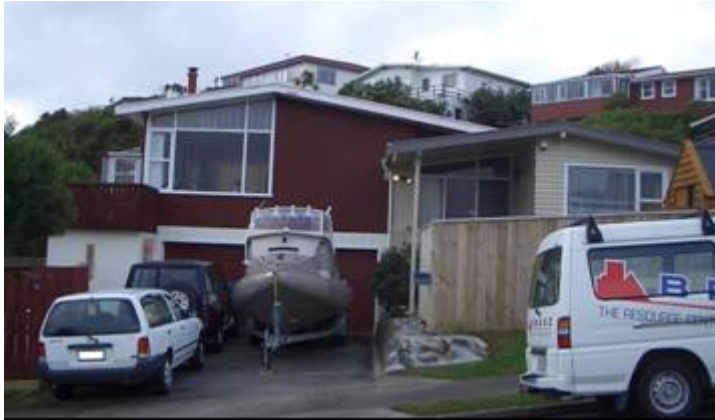
Figure 2: P01 Photo.

P01 is a split-level three bedroom home constructed in the mid 1970s with a living area floor size of approximately 120 m². It has a skillion corrugated iron roof, and a mixture of sheet and weatherboard cladding around the outside. The lower storey has a concrete slab floor, while the upper floor over ground has a timber suspended floor with an exterior concrete perimeter wall. The home was thought to be entirely uninsulated, but was found to have fibreglass insulation in the skillion roof when the interventions began. Most of the windows were timber-framed, except for an aluminium ranch slider in the master bedroom and an aluminium window in the shower room, and all were single glazed. Draughts were noticeable at times.

A woodburner was used to heat the open plan living areas in winter, while oil column heaters were used to heat the second and third bedrooms. Remnants of a disconnected diesel-fired furnace of around the same age as the home were found underneath the home.

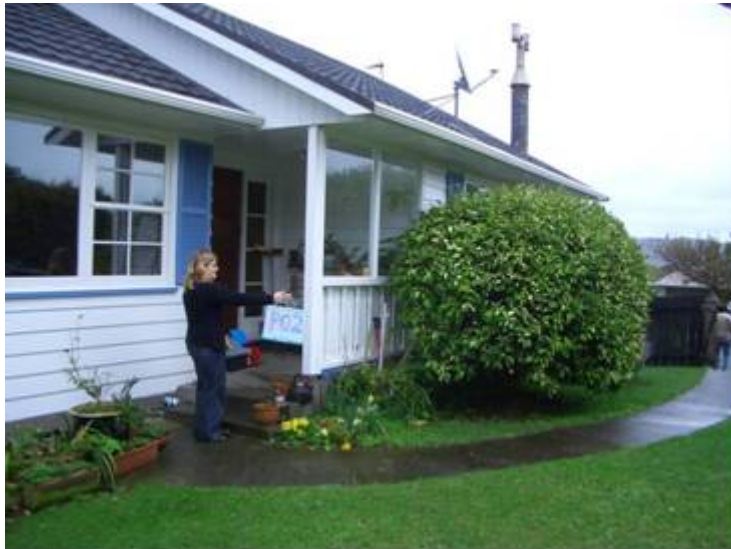
Figure 4: P02 Photo.

P02 is a two-storey colonial-style home with four bedrooms constructed in 1970. The home has a coated metal tile roof and a mixture of weatherboard and sheet cladding. The windows are mainly timber, with three new aluminium windows in the master bedroom, which was recently extended by around a metre. The lower storey appears to have been an addition put in soon after the home was built, and contains the garage, a bedroom and service rooms. It is smaller than the upper storey, and is set into a bank. The majority of the upper storey has timber suspended floors, some of which is over a subfloor space, while the lower storey and the new section of the upstairs master bedroom have a concrete slab floor.

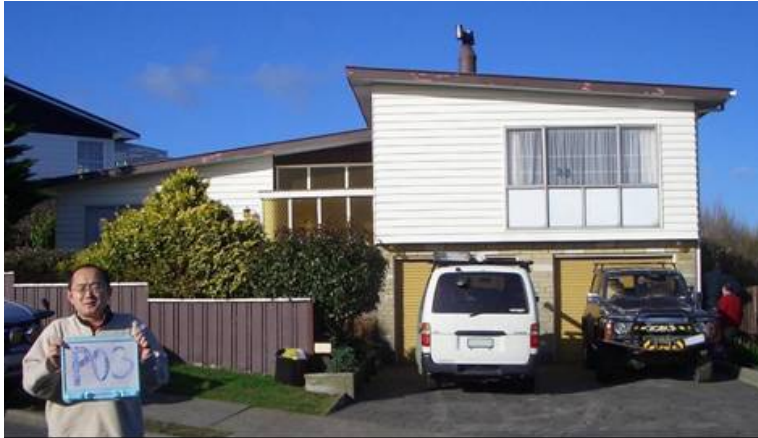
Figure 6: P03 Photo.

The lower floor has a concrete slab floor, while the upper floor has timber suspended floors. The original corrugated iron roof was in a state of disrepair and had been leaking – it was described by the homeowners as made water resistant only through the presence of a vast amount of duct tape. The roof is partly skillion, partly cavity. The windows were all older, unventilated single-glazed aluminium, which were badly degraded and in need of replacement.

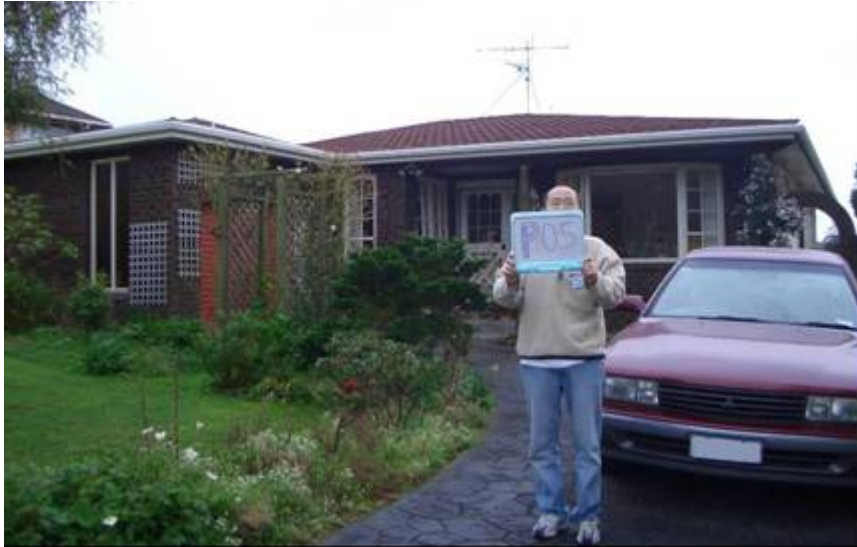
Figure 8: P05 Photo.

P05 is a one-storey three bedroom home constructed in 1978 just before insulation became mandatory under the Building Code. It has an open plan living areas and a sunken lounge. The home is clad with brick on the road frontage, and weatherboard around the rest of the house, with an enclosed subfloor perimeter wall. The timber-framed windows are in good condition, apart from having worn out stays leading to draughts, especially through the living areas. The home has a metal tile roof. The majority of the floor of the living areas is suspended timber, apart from the concrete slab floor of the sunken lounge and the attached garage. The living area floor size is approximately 130m².

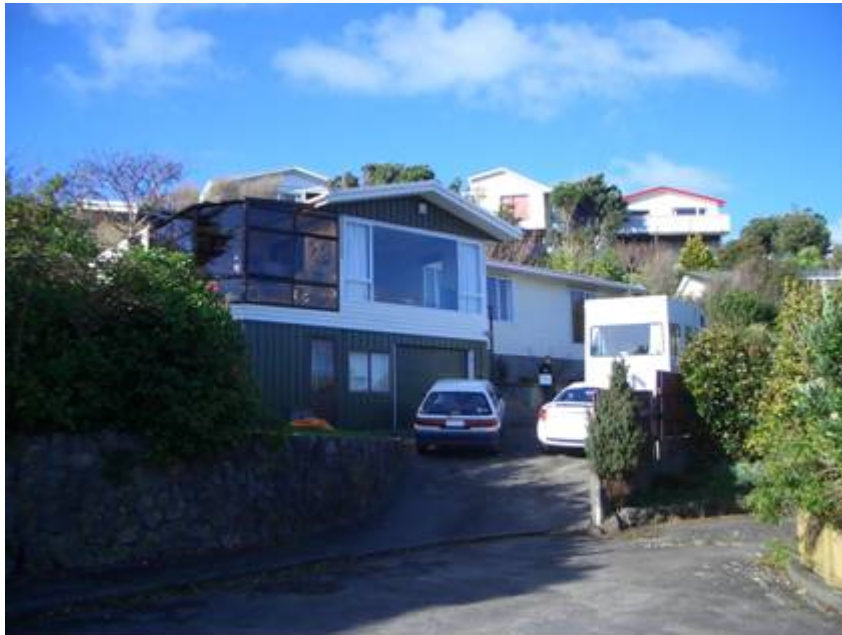
Figure 10: P06 Photo.

P06 was constructed during the early 1970s. The home is mainly lightweight construction clad with weatherboards, with some sheet cladding around the lower part of the house. A family room was added around the 1980s, and is solid construction with concrete block walls. The majority of the home has timber suspended floors, with concrete slab floors in the garage and family room. The windows are half newer aluminium-framed single glazing on the southern side of the house, while on the northern side they are a combination of older aluminium and timber. The home has a large conservatory area which has been placed outside the thermal envelope in this work. This space is not believed to have been heated from a reticulated energy source.

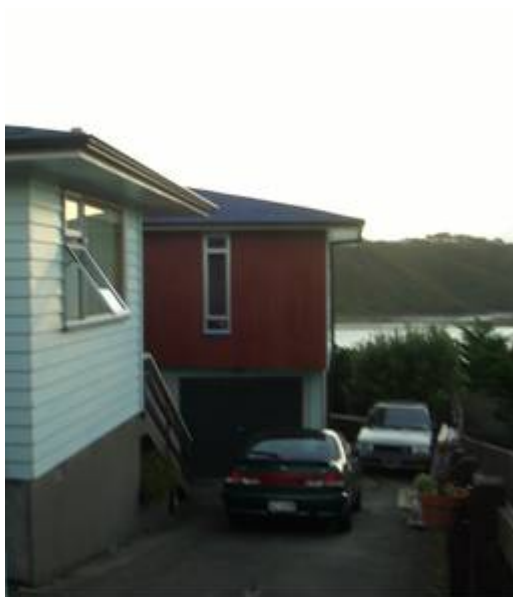
Figure 12: P07 Photo.

The original part of P07 was built around 1970. The home is mainly clad in weatherboard, with some sheet cladding. The home has a ventilated concrete perimeter wall, a suspended timber floor upstairs, and an uninsulated concrete slab floor downstairs in the garage, utility and rumpus areas. The home has a coated metal tile roof. The older aluminium windows in the upper part of the home were recently replaced with 10 mm laminated glass and new frames with the intention of reducing noise and providing better insulation. Downstairs (which was not considered to be part of the living spaces of the home in this project) the windows are a mixture of timber and aluminium, all in poor condition. Over the past few years, the living areas of the home have been insulated, re-lined and new windows put in. A lounge was added on top of the garage and the wall and ceiling insulation appropriately meets the 1996–2007 Building Code minimum levels for Zone 2. The living area floor size is approximately 160 m².

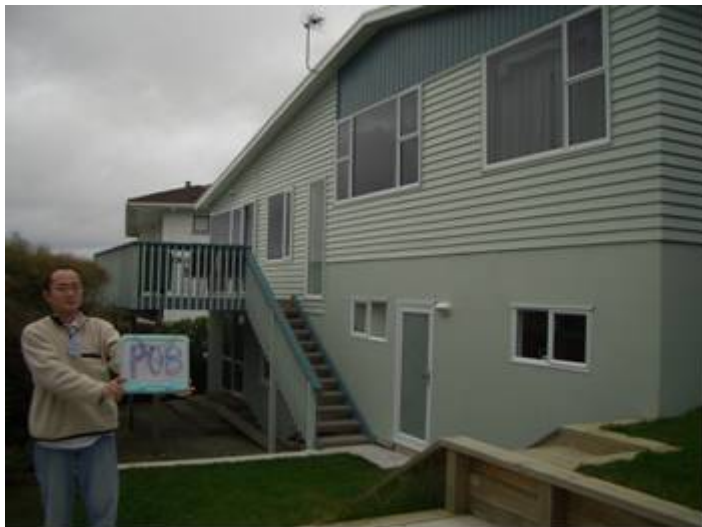
Figure 14: P08 Photo.

P08 is the oldest home in the sample, having been constructed around 1968. The home is predominantly lightweight construction. The upper split-levels of the home are mainly clad in timber weatherboards, with some sheet materials below the apex of the long-run iron roof. The lower part of the home is clad in sheet material, and the back wall of the downstairs gym is uninsulated concrete block.

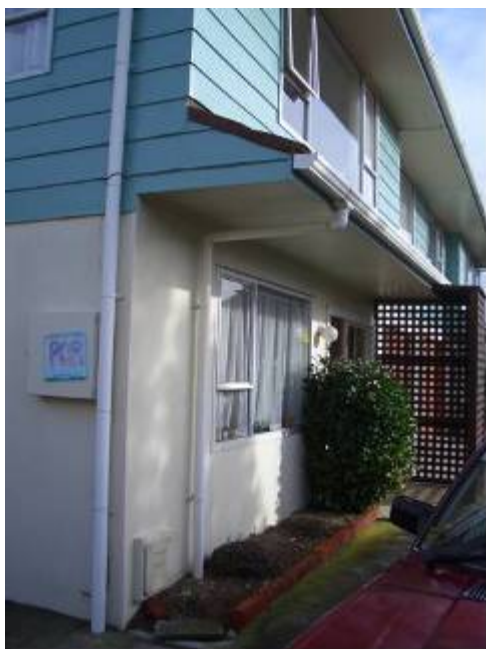
Figure 16: P09 Photo.

P09 is a timber-framed double-storey townhouse built in 1976. The lower storey is clad in sheet material and has a concrete slab floor, while the upstairs is clad in fibre-cement weatherboards and has a timber suspended floor, some of which is over a subfloor space. The windows are all single glazed with older aluminium frames. This semi-detached townhouse has a concrete block firewall on the western wall between it and the neighbouring unit. The roof is clad with concrete tiles. The thermal envelope of this dwelling is different from the other homes in this study given that it has a shared wall. The heat transfer (or effective insulation value) of this wall is therefore affected by the amount of heating that is performed in the adjacent space, which was not monitored in this work. It is assumed that if the neighbouring occupants do heat their dwelling, P09 will benefit from the heat that is lost through the shared wall. However, considering the adjacent rooms are bedrooms (the HEEP study revealed few New Zealand bedrooms are heated), the real benefit is expected to be slight. The living area floor size is approximately 95 m².

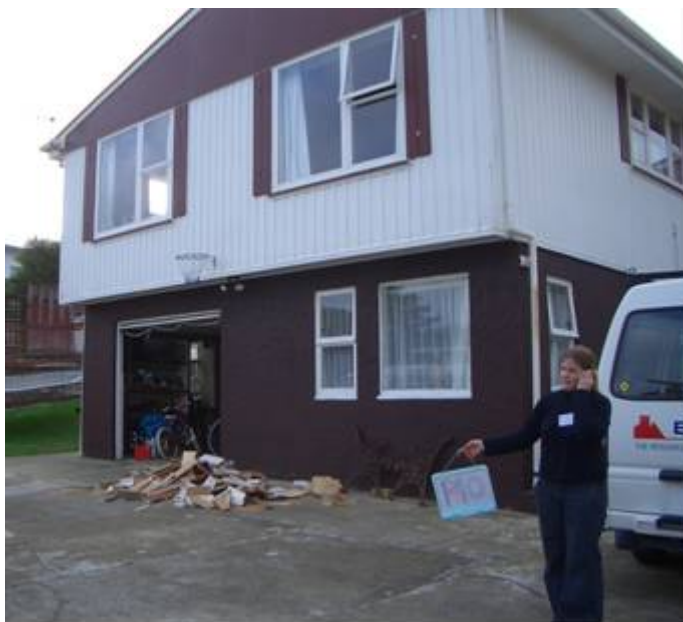
Figure 18: P10 Photo.

The householders purchased P10 as a renovation project in 2005. The home seemingly had not been touched since it was built in the early 1970s. The home had been poorly (or not) maintained. The original timber window frames had rotted through in places and were overall in need of immediate replacement. The new owners dealt with drainage problems (including a relatively minor flood of the lower storey in the first few months of living there), and leaks in the building envelope. The owners then started progressively re-lining and insulating walls in parts of the bedroom wing of the house, and installed double-glazed window units in the bedroom wing during the summer of 2006–2007, between the monitoring periods.
