**IEQ7570/3**

# **Forced Air Ventilation Systems**

**A report prepared for Beacon Pathway Limited  
June 2010**

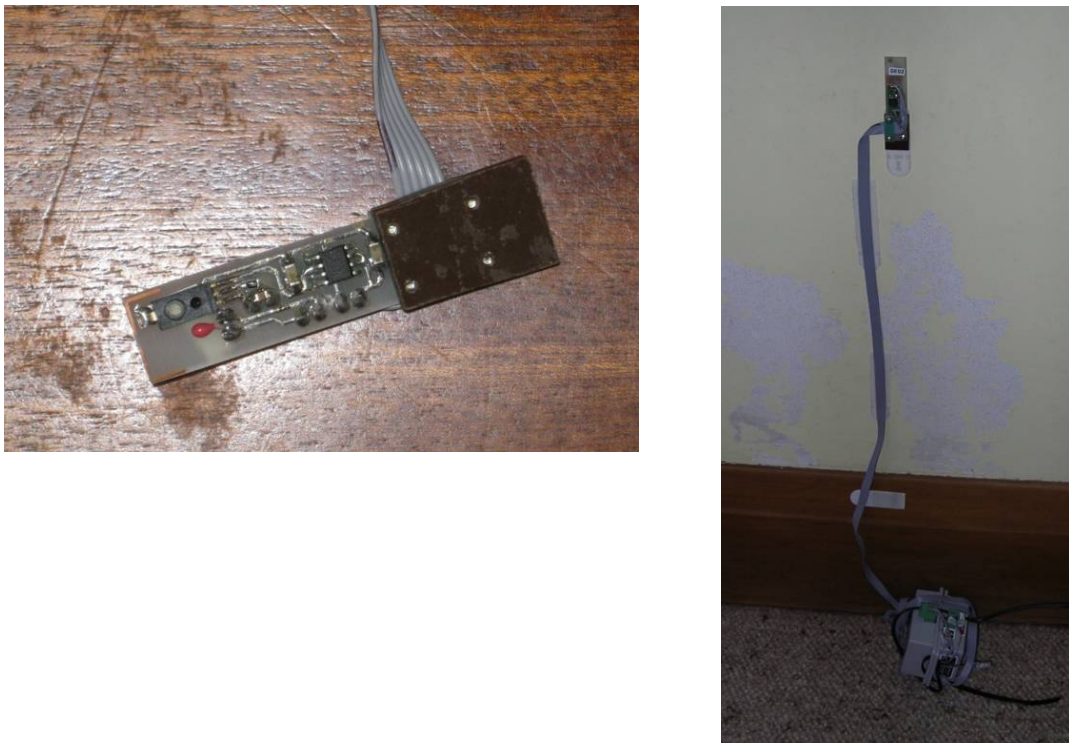
For greatest dampness risk within the house, the surface humidity and temperature were measured on the external wall in the Cold Room within the house. This measurement was made about 400 mm above the floor (see Figure 5) away from the studs in the wall. The thermal resistance of the wall is lower away from the stud if there is no insulation in the wall. Two of the houses (House E and House I) did have wall insulation in the Cold Room, but for the sake of consistency the measurement of the surface humidity for these two houses was also made away from the wall stud.

**Figure 5: Surface temperature and humidity probe developed for this project**

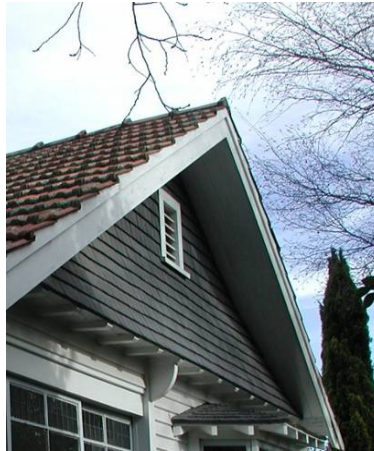
Most of the roofspaces were well enclosed. Two of the houses (B and E) had tiled roofs and a degree of leaf debris on the ceiling insulation, suggesting a highly ventilated roofspace. House B also included a passive roofspace vent as shown in Figure 7.

**Figure 7: Roofspace vent in House B**

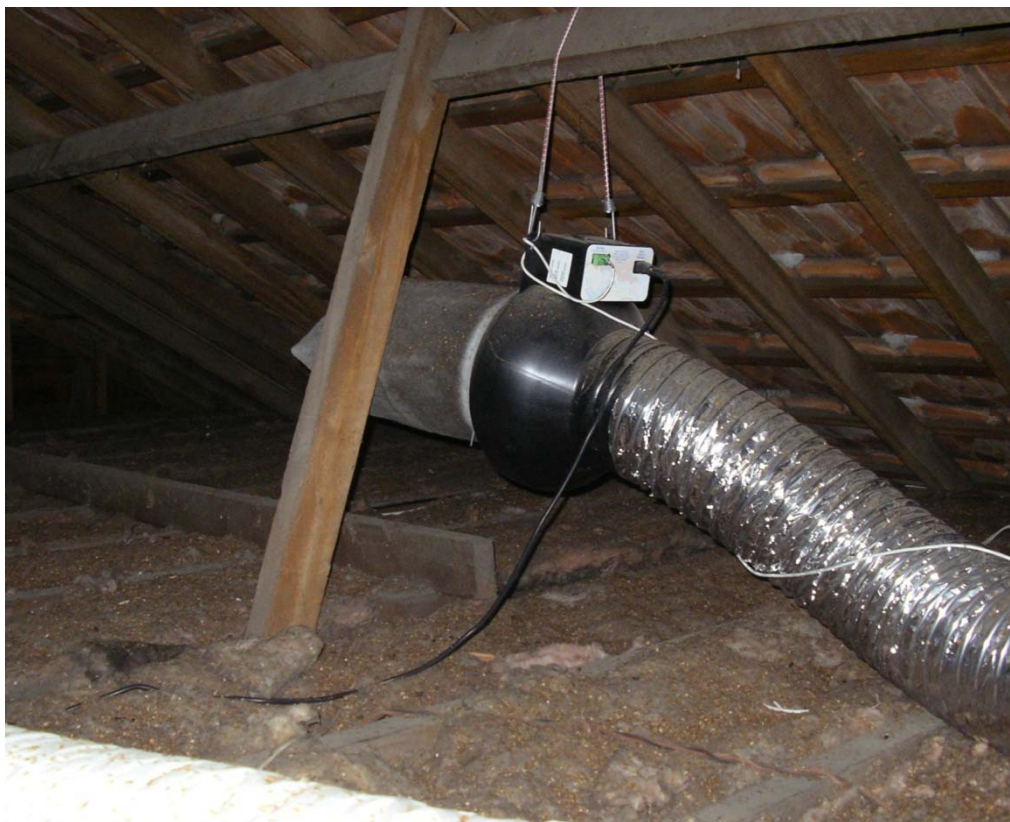
Except for one case, the fan units were suspended by a bungy cord or strapping to purlins or rafters. This allowed the fan unit to be placed mid-way within the roofspace (see Figure 8 for example). Suspending the fan unit using the cord also suppressed any vibration or noise from the fan unit being transferred into the building.

**Figure 8: Fan unit suspended from purlin (House B)**

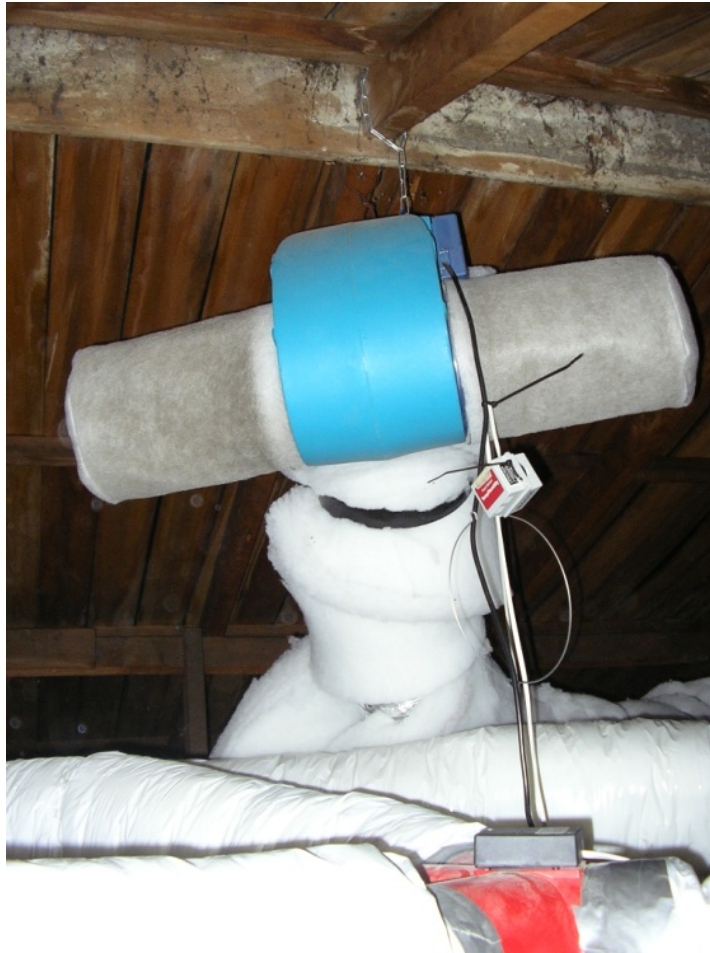
Air filters were installed external to the fan unit system, except for the House G system. The House C system shown in Figure 10 had two air filters. Many of the filters exhibited signs of blackening. The length of time since the last filter replacement was not picked up in the study.

*Figure 10: Air filters for the system in House C*

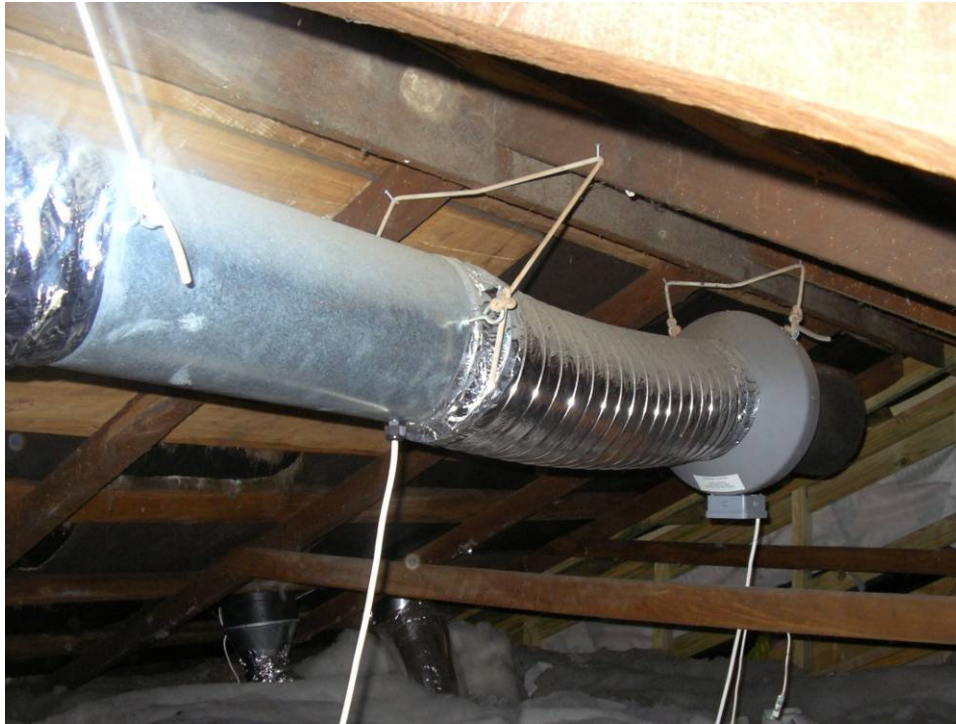
The systems in House A and House E had additional components that were suspended. The House A system (shown in Figure 11) had the in-line heater suspended while the system in House E (shown in Figure 12) had the ductwork suspended. There is no clear reason why they have chosen to install the ductwork this way. This was an older installation and this may reflect old practice. The remaining system's components were unrestrained and lying on top of the insulation. The pressure-averaging tubes (PAT) used for this study were placed after the fan unit and were supported by the ceiling joists (an example is shown in Figure 13).

**Figure 11: Suspended in-line heater (section of metal ductwork) for the House A system**

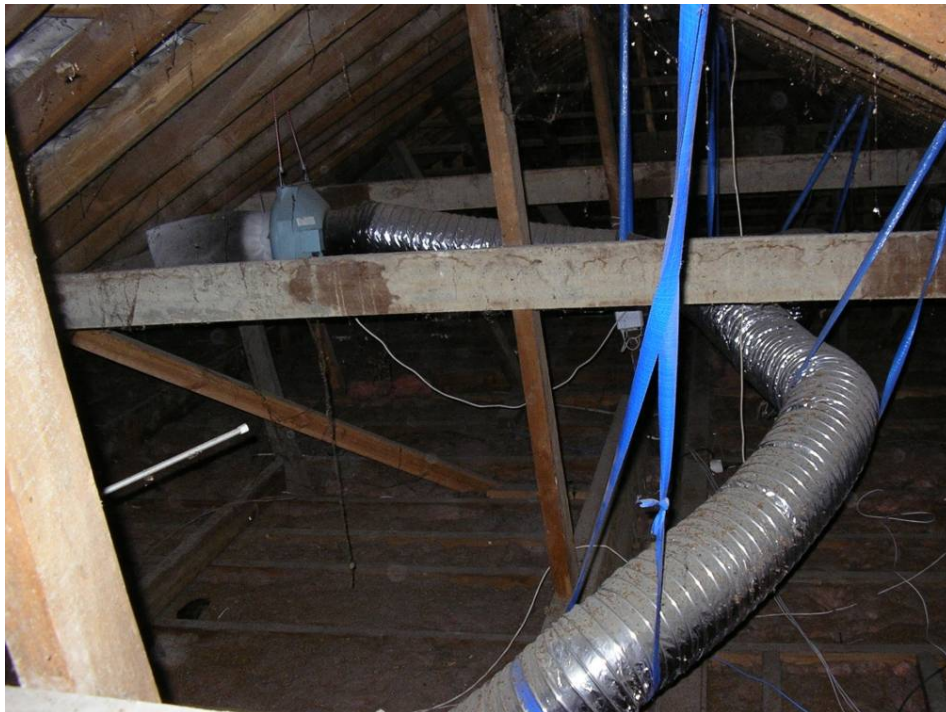
**Figure 12: Suspended ductwork in House E**

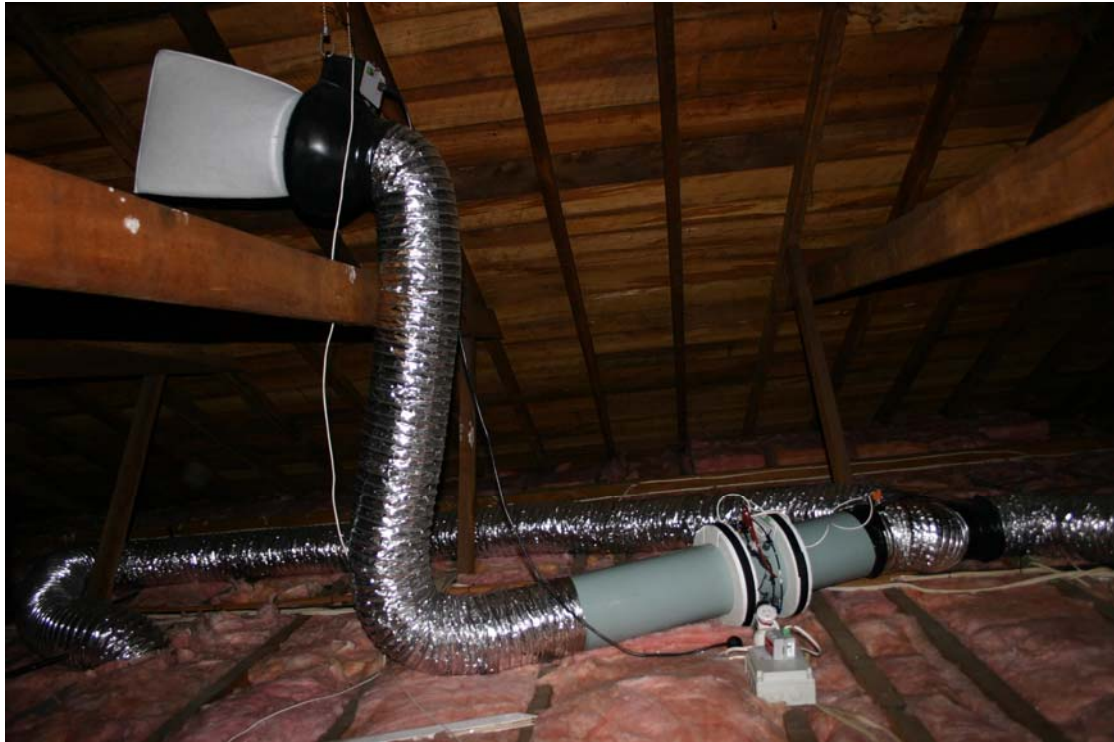
*Figure 13: Pressure-averaging tube placed after the fan unit (note the clean air filter)*

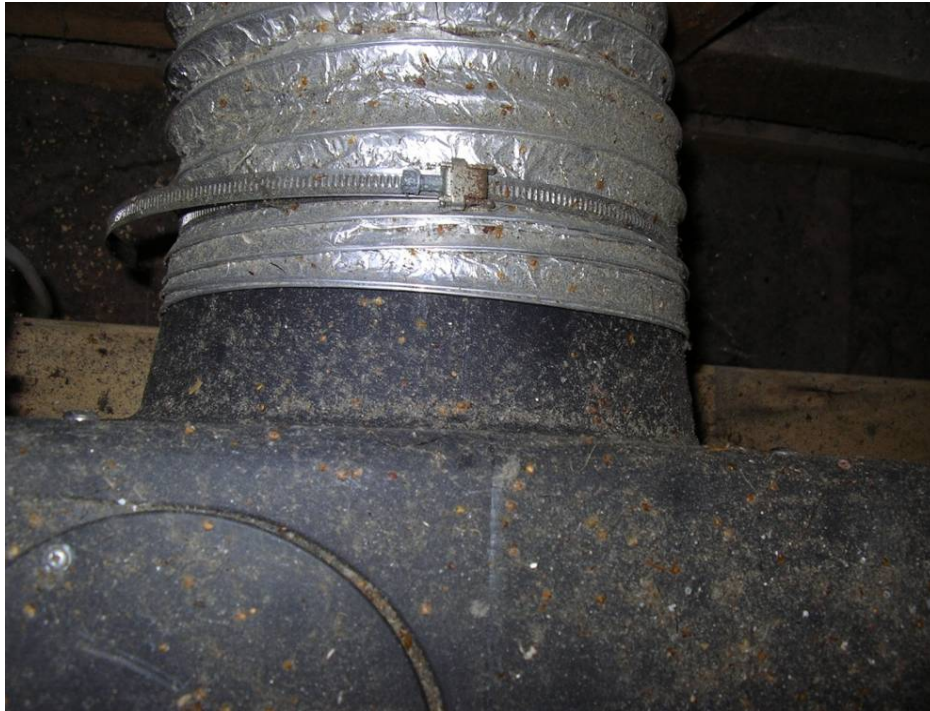
The standard means used for these systems to attach the fan units to the ductwork was to use PVC tape or duct tape and generally a secure connection was made. Work by Walker and Sherman (2004) has identified concerns about the durability of some fixing methods, in particular duct tape. The House G system provided only a mechanical fixing using a hose clamp as shown in Figure 14. This arrangement provided a poor seal around the duct and the duct could be disconnected and reconnected without adjustment to the screw.

**Figure 14: Poor connection on the House G system**

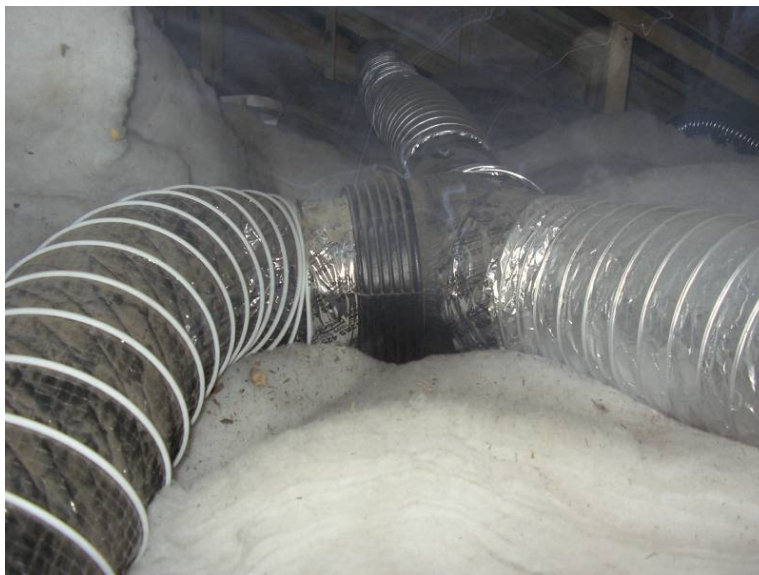
All of the systems featured 200 mm diameter flexible ducting. This ducting featured a stiff metal or plastic coil with plastic or metal walls. Intersections were either mounted plastic or sheet metal. An example of an intersection is shown in Figure 15.

**Figure 15: Example of a plastic intersection within the ductwork**
