Case study

Achieving good solar water heater performance

Beacon Pathway has used solar water heaters in five live research homes. Two were new homes, the Waitakere NOW Home and the Rotorua NOW Home. Three were renovations to homes in the Papakowhai Renovation project.

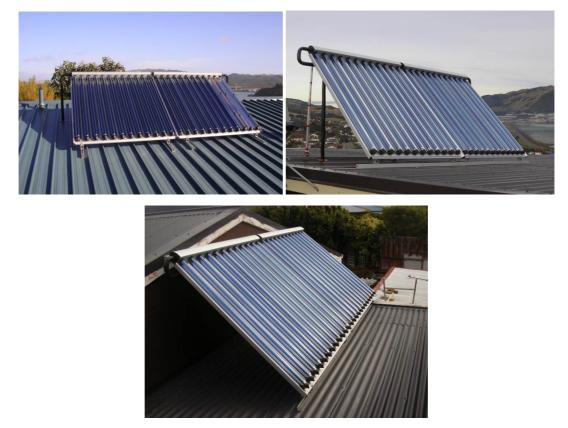
Good size, good angle, good result

The Papakowhai panels sat at 41° to match the latitude of the site. Two twelve-tube panels were connected, forming a large collection area, and 300 litre hot water cylinders were installed with lagged pipes.

A controller limited the amount of supplementary heating provided while the circulation pump is operating (and therefore when solar energy is available) but, again, there was no timer preventing unnecessary supplementary heating.

These systems provided between 70-75% of hot water for these families.
