## Warmth and energy savings in Papakowhai

**Full insulation and an efficient heat source led to substantial reticulated energy savings and indoor temperature improvements.**

### Renovating House 3

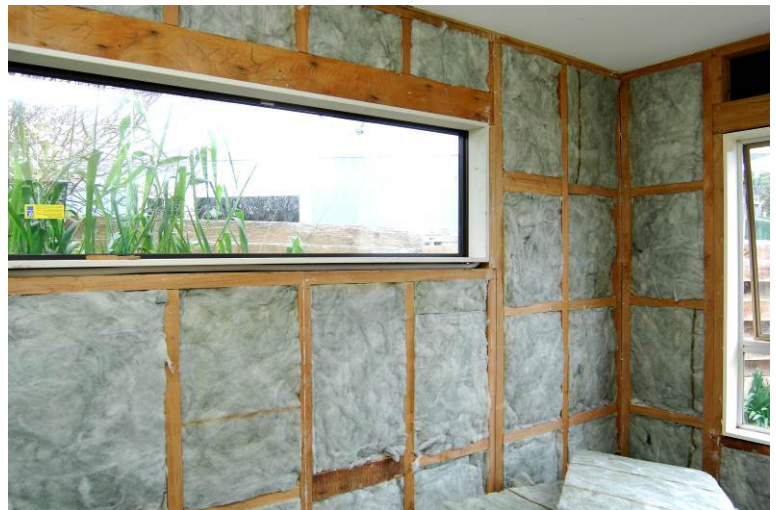
To improve its performance, House 3 underwent a major renovation:

- Double glazing was installed
- Insulation was fitted in the walls (R2.4 batts) and under the floor (R2 foil backed batts and polythene vapour barrier)
- The skillion ceiling was lowered and insulated with R3.6 batts, and the remaining ceiling insulation was re-laid and overtopped with R2.6 blanket
- A variety of heaters were replaced by an NES-compliant wood burner and a ducted heat pump system; a solar hot water system and a newly wrapped 300 litre cylinder were installed
- Flow restrictors on the shower heads and dual-flush toilets reduced water use
- A kitchen rangehood replaced a broken extraction fan.

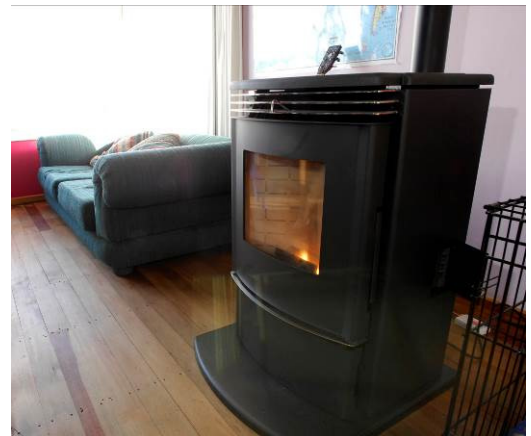
Inside the house, the family enjoyed much warmer, healthier living. The average winter temperatures in the family room rose by 1.7°C and in the bedroom by 3.8°C. Even better, the bedroom rarely dipped below 16°C overnight and the family room rarely below 18°C in the evenings. These are the minimum temperatures recommended by the World Health Organisation for healthy living.
